ŞADIRVAN AL-JAZZAR

Architectural Documentation and Conservation Report
of the Ablutions Fountain of al-Jazzar Mosque

Alison Hortig
July 2010

International Conservation Center

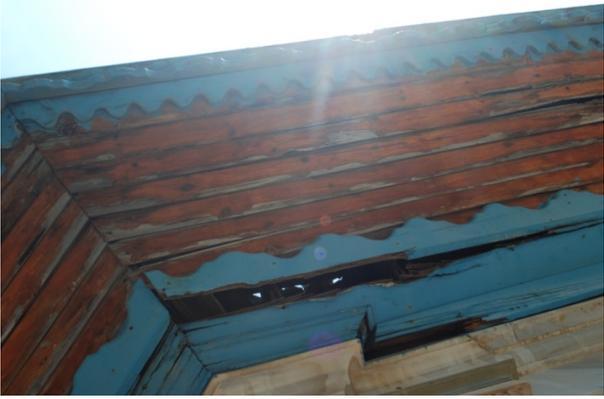
Damage	Definition	Image
Unstable wood elements	Cantilevered wood roof frame unstable at areas, in danger of falling.

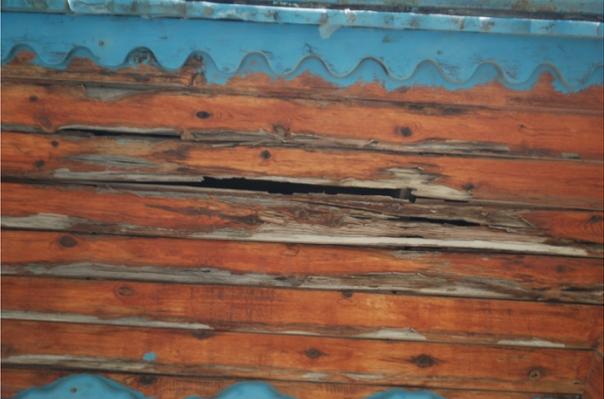
Damaged wood frame	Cantilevered wood roof frame damaged by degradation. Wood splitting and paint chipped.

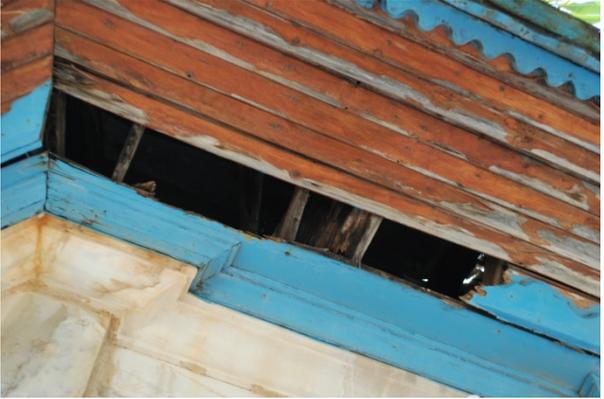
Missing wood panels	Cantilevered wood roof missing panels of wood, exposing interior frame to elements and risk of birds nesting.

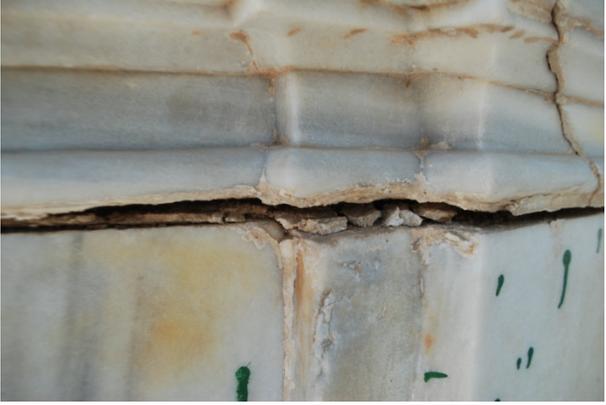
<p>Disintegrated joints</p>	<p>Mortar between joints, primarily between cornice and base of interior well, nearly completely disintegrated.</p>

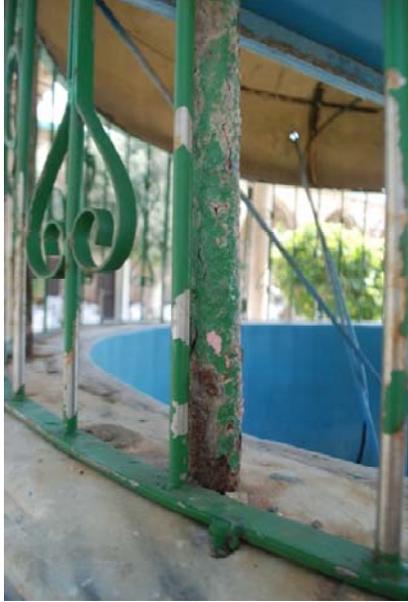
<p>Rust</p>	<p>Remaining iron rusted, at joints with marble causing cracking of stone.</p>

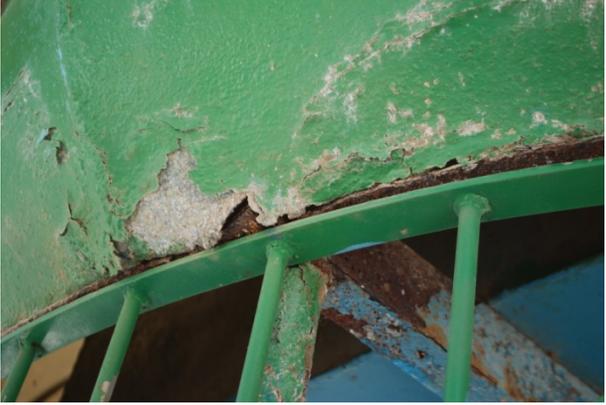
<p>Metal disintegration</p>	<p>Remaining iron interior cupola disintegrating and unstable due to extensive rust and degradation.</p>

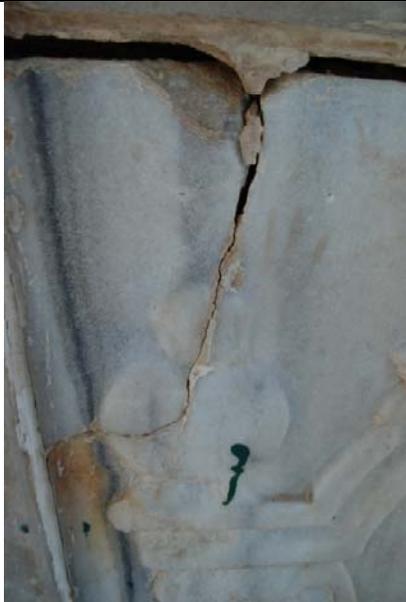
<p>Cracks</p>	<p>Marble exhibiting cracks throughout entire structure.</p>

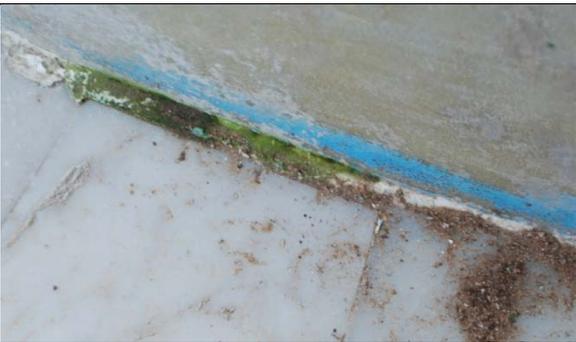
<p>Biological</p>	<p>Mold and moss growing in dark areas where water is present.</p>

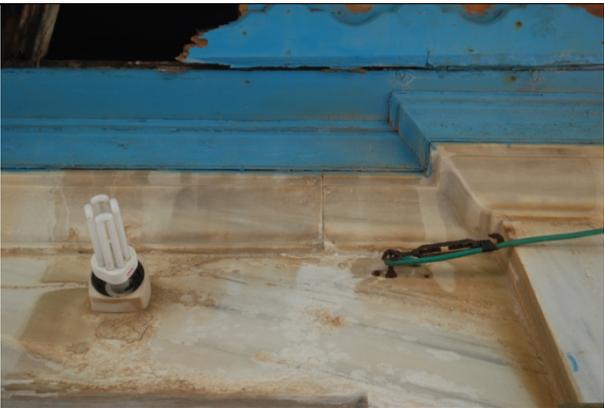
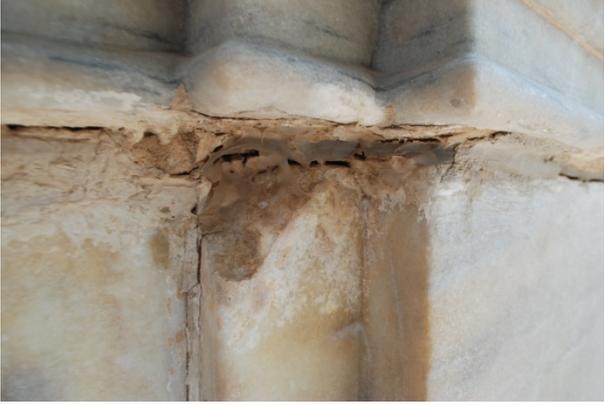
<p>Modern additions</p>	<p>Modern plumbing and light fixtures have been added to assist in functioning of structure. Concrete and silicones have been used in lieu of mortar at joints.</p>

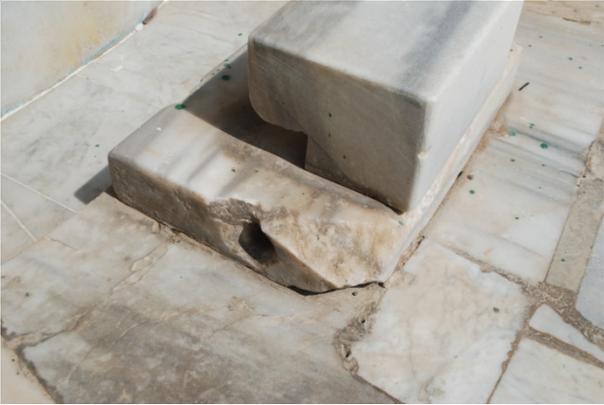
<p>Missing stone</p>	<p>Pieces of marble have been chipped and gone missing throughout the life of the structure.</p>

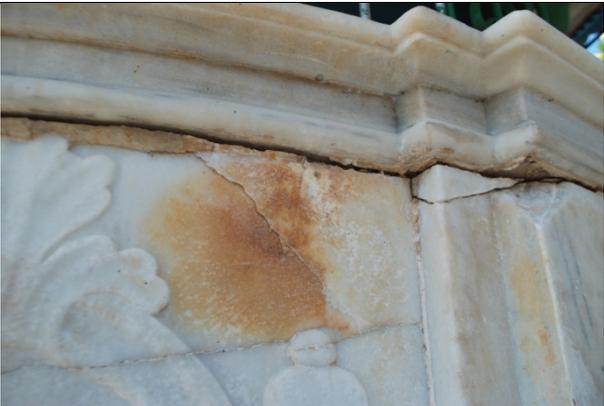
<p>Coloring</p>	<p>Rust staining</p>

11	Coloring	Rust staining	1%	Clean localized areas
12	Coloring	Paint overspray	2%	Clean localized areas
13	Coloring	Biological staining	1%	Clean localized areas
14	Warping of metal roof material	Under frame disintegration/ varies	30%	Relative to needs of wood frame

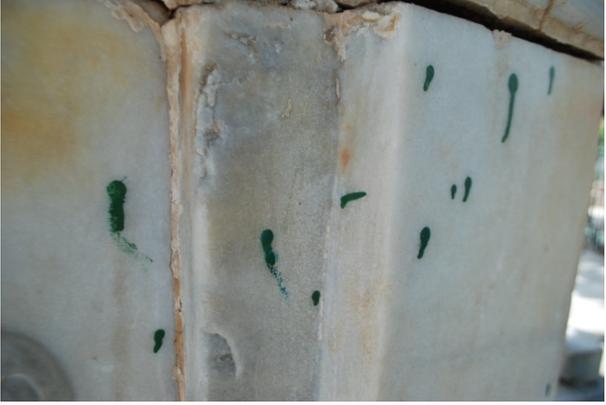
<p>Coloring</p>	<p>Paint overspray</p>

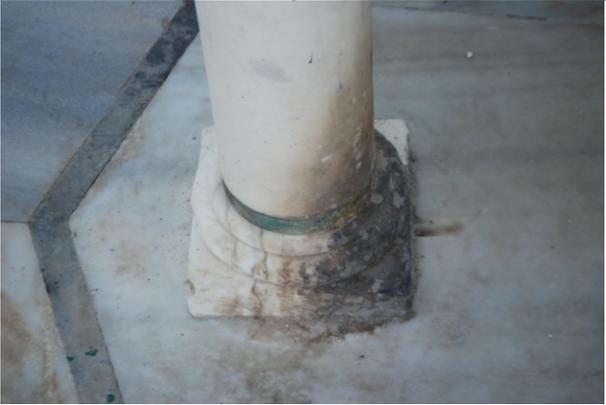
<p>Coloring</p>	<p>Biological staining</p>

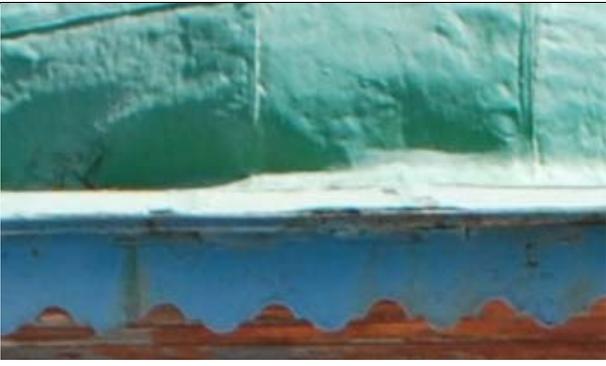
<p>Warping of metal roof material</p>	<p>Zinc roof tiles have warped throughout the life of the structure</p>
