Grouting for Caesar: The Vault Complex and High Level Aqueduct  
at Caesarea After 20 Years

A Pilot Project Presented to the:

Israel Antiquities Authority  
and  
International Conservation Center, Citta di Roma

August 2012

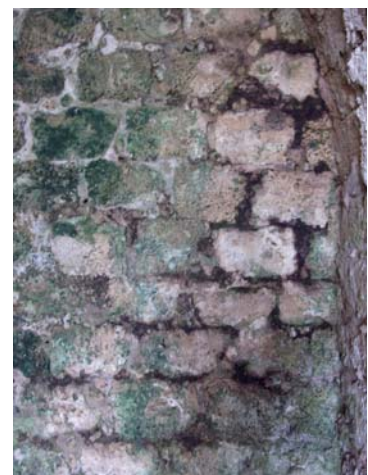
The structure of Vault 1 makes it particularly susceptible to environmental causes of deterioration. The 30m length of the windowless vault traps salty moisture and humidity, leading to large amounts of biological growth and a constant layer of fresh, wet salt to penetrate and corrode the stone (Figures 14-16). Water

Figure 14. Biological Growth and Salt Crystallization. Vault 1. East Wall.

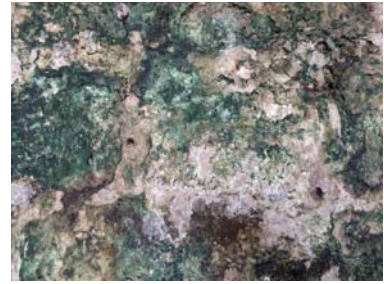
Figure 15. Biological Growth and Salt Crystallization. Detail. Vault 1. East Wall.

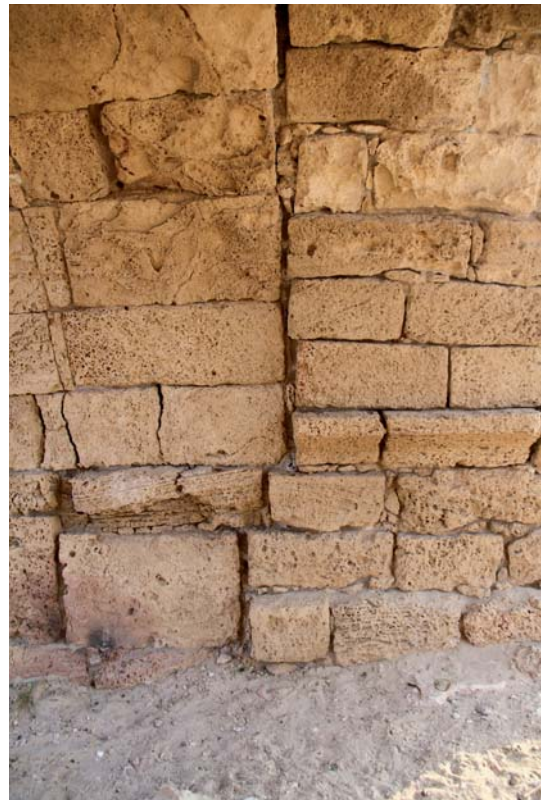
The High Level Aqueduct at Caesarea was built to be and still is a high quality building (Figure 27). It was repaired throughout its centuries of use, as is evidenced by the occasional difference in building style, numerous interventions, buttressing of the western arches (Figure 28), and even inscriptions. By and large, the eastern aqueduct (A) has remained stable throughout the centuries and has proven to be a much higher quality than the later western addition. This is largely due to the fact that the western aqueduct (B) protects the former from the effects of the sea, although it does cause structural problems in some areas. Since the western aqueduct is built against or a few centimeters away from the eastern aqueduct and overlaps the foundation of the earlier building, one structure's problems can drastically affect the integrity of the other structure, especially in cases where the western aqueduct leans on the eastern (Figure 29).

Figure 29. B Leaning on A, Causing Cracks. (David Zell, IAA)

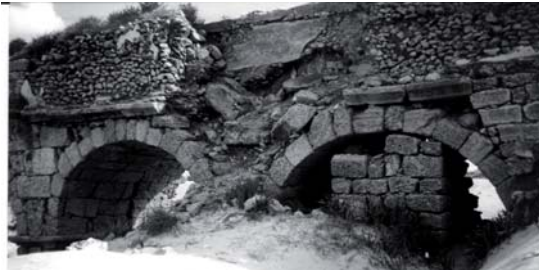
Figure 30. Collapse. (IAA)

Some areas of the High Level Aqueduct did suffer from collapse (Figures 30, 32-33), destabilization of the core of the structure or foundation (Figure 31), stone deterioration, and mortar decay (Figure 33) over time. These problems were consolidated through joint filling (Figure 34), restoration for stabilization (Figure 35), stabilization of foundations (Figure 36) and, of course, grouting.

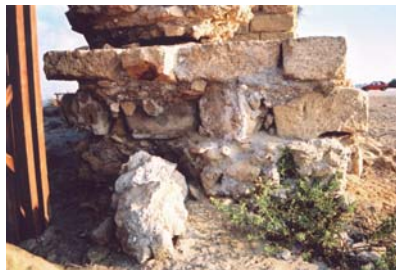
Figure 31. Exposed Rubble Fill and Foundation. (IAA)

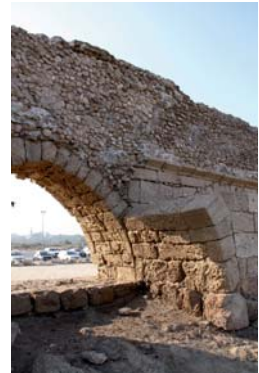
Figure 32. Collapse of B.

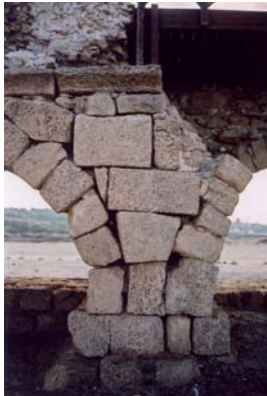
Figure 33. Missing Mortar and Collapse of B. (IAA)

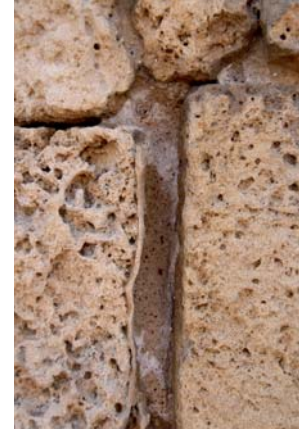
Figure 37. Salt Crystallization.

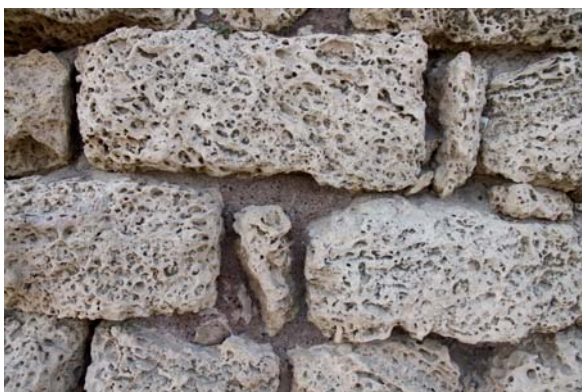
The main causes of deterioration are the deterioration of mortars and the occasional use of weak pieces of sandstone (Figures 39-40). As mortar deteriorates and falls away, more surface area of the stone and core of the structure is exposed to the elements, which speeds their deterioration. Since sandstone is a natural building material and particularly porous, its quality is variable. Sometimes this is evident only with the passage of time.

Figure 39. Deterioration of Mortar and Sandstone.

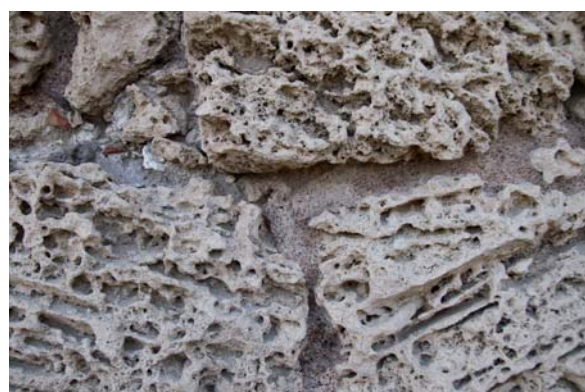
Figure 40. Deterioration of Mortar and Sandstone. Detail.

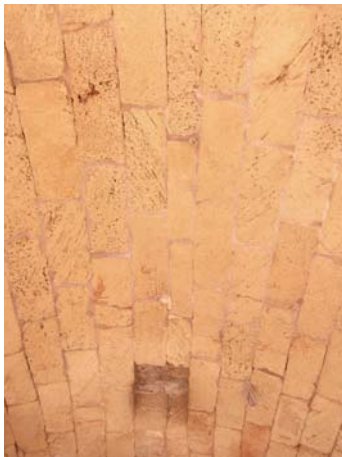
Figure 61. Joint Fill. Vault 1, Ceiling.

After almost 20 years of exposure, the joint fill in Vault 1 is in very good condition, with little sign of deterioration (Figures 61-66). The structure and orientation of Vault 1 (See “2.2 Building Technology”) protect the arch from abrasive winds, although salt accumulation and bio-attack are still problematic (Figure 64). Even the joint fill in sections of the north and south walls that are without covering is in good condition (Figures 65-66).

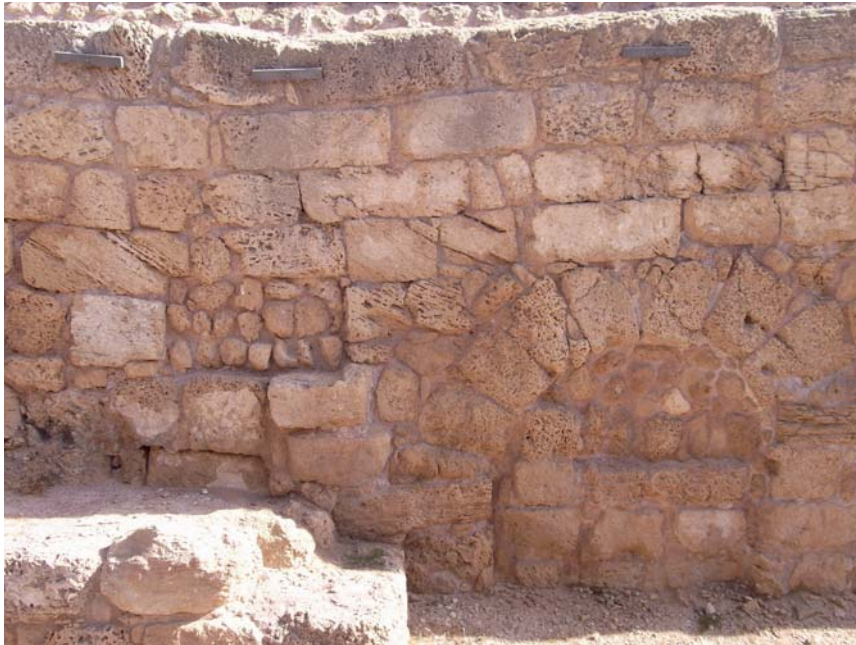
Fig 65. Joint Fill. Vault 1, South Wall (Uncovered).

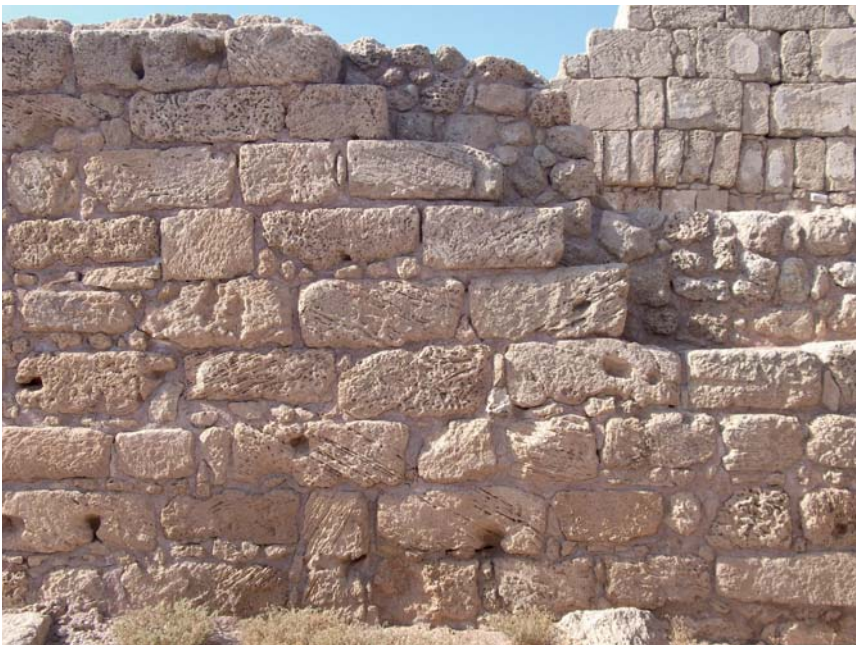
Fig 66. Joint Fill. Vault 1, North Wall (Uncovered).

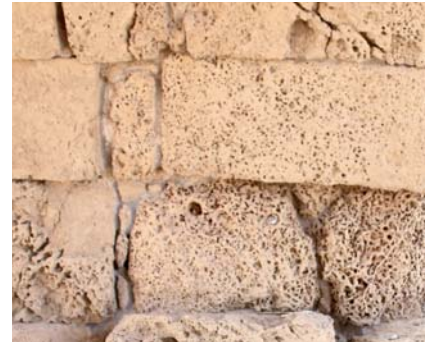
After 20 years of continued exposure to natural conditions common to life by the sea (See “3.4 Causes of Deterioration”), including a major storm that damaged parts of the High Level Aqueduct and other sites along coastline in 2010, the joint fill on the aqueduct at Caesarea is in various stages of disrepair. The western facade shows the most wear since it faces the sea and has maximum exposure to salt, water, wind, and blowing sand. The joint fill shows signs of weathering and deterioration but is mostly intact with gaps here and there (Figure 69-72). The joint fill on the facades that are protected, including the arches and eastern facade, is generally in better condition.

Figure 69. Joint Fill 2012. Example 1.

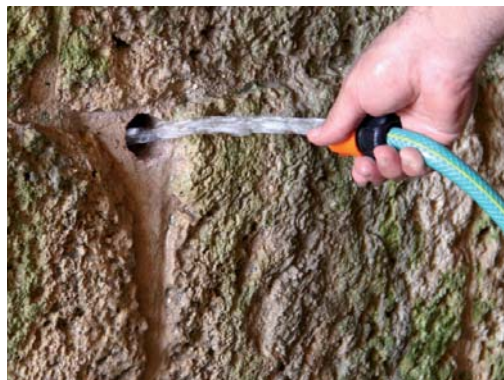
Figure 88. Pouring Water into the Void, Drill #5.

Since drill #5 produced no stone or grout but was 100% void or washed out by wet drilling, we tested the sample area by pouring water into the hole with a hose. The water did not exit the wall in the 10 seconds we did so, which suggests a void in the core of the wall (Figure 88).

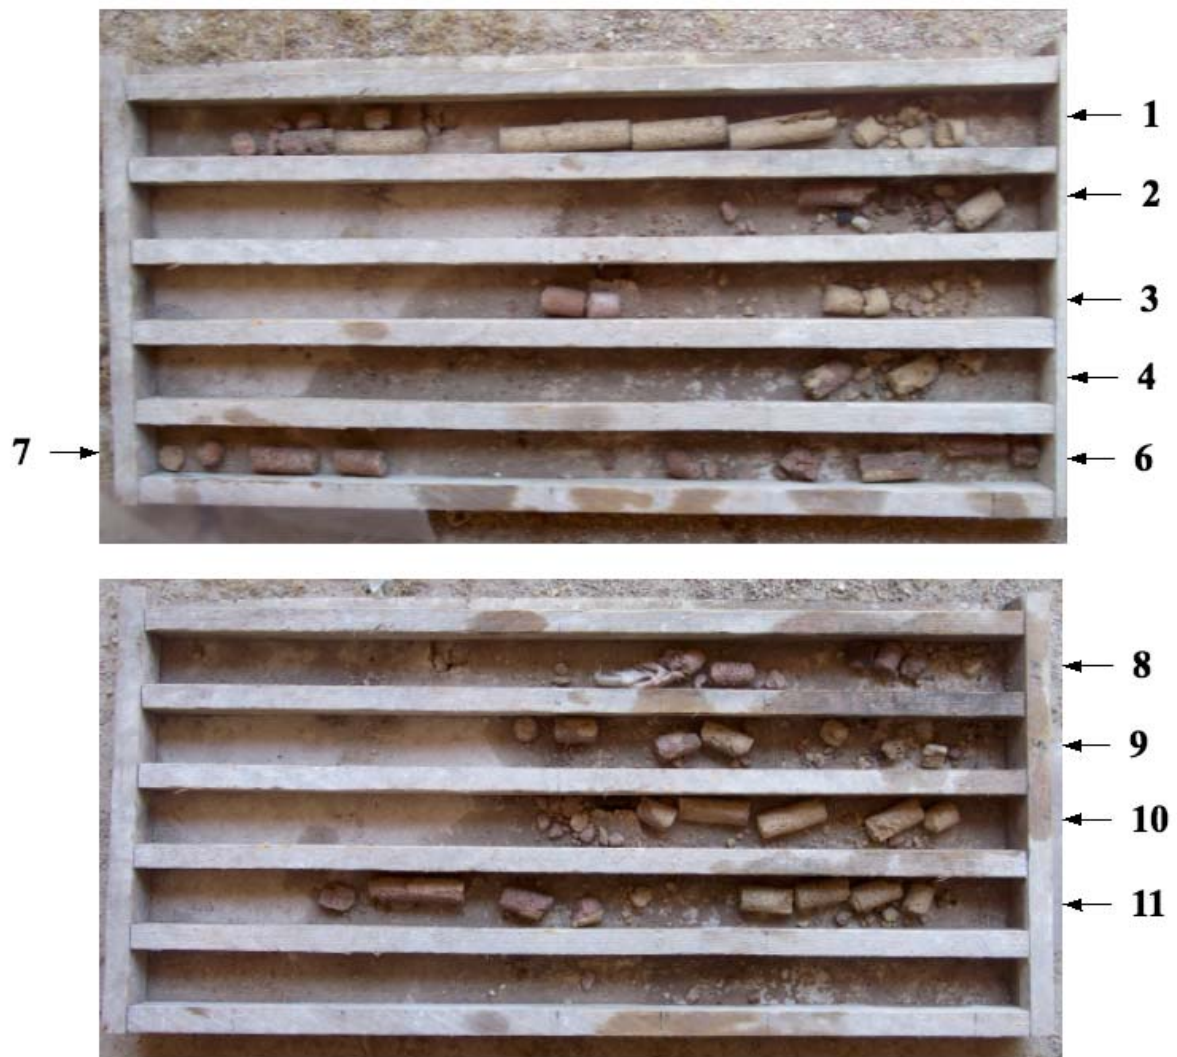
The eleven core samples suggest that Vault 1 may be in need of further intervention in the near future. On average, the walls are 74% earth or void and only 12% stone, 4% grout, and 10% stone and grout combined (Chart 1). The black or brown-red color of the water that came out during wet drilling suggests that those areas of the wall are filled with earth or sand, whereas clear water suggests a void in the wall (Chart 1; Figures 85-87). Sometimes the black or brown-red water was accompanied by a foul odor, possibly indicating the presence mold or some other form of biological growth in the core of the wall. The presence of earth or sand suggests that the washing procedures carried out before injection were only partially effective.

Figure 89. Core Samples, Vault 1 (No Material Extracted During Drill #5).

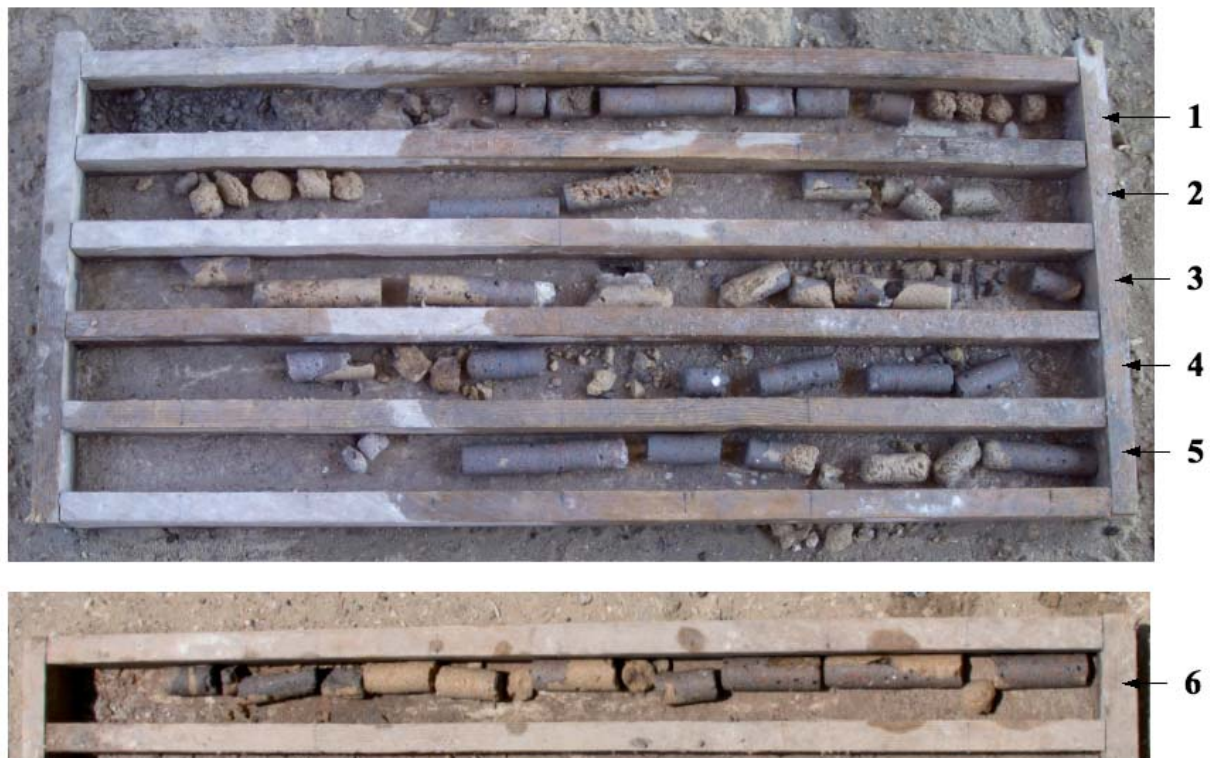
The six core samples taken from arches 55-57 suggest that this particular area is in good condition but should be monitored at regular intervals. On average, the walls are 35% earth or void, with 14% stone, 18.5% grout, and 32.5% stone and grout combined (Chart 2). The clear water that came out of the wall during wet drilling suggests that the washing procedures performed on the western aqueduct were effective at removing the earthen material that had filled the wall in the centuries between its construction and conservation. The color of the water also suggests that the areas we tested were 15-47.5% void. In comparison to the results of drilling at Vault 1, which is an estimated 74% void, the aqueduct is in good condition. However, it should be monitored at regular intervals to insure that the structure remains stable.

Figure 94. Core Samples, High Level Aqueduct. Western Aqueduct.
