DOCUMENTATION, ASSESSMENT AND INTERVENTIONS TO THE MAIN CHURCH OF DAPHNI MONASTERY

E. Vintzileou
Acre, Dec. 17th, 2012

The Dafni Monastery (built in the 11th century) is one of the most important byzantine monuments in Greece (mainly because of the mosaics of the Katholikon, (UNESCO-list of world monuments)).

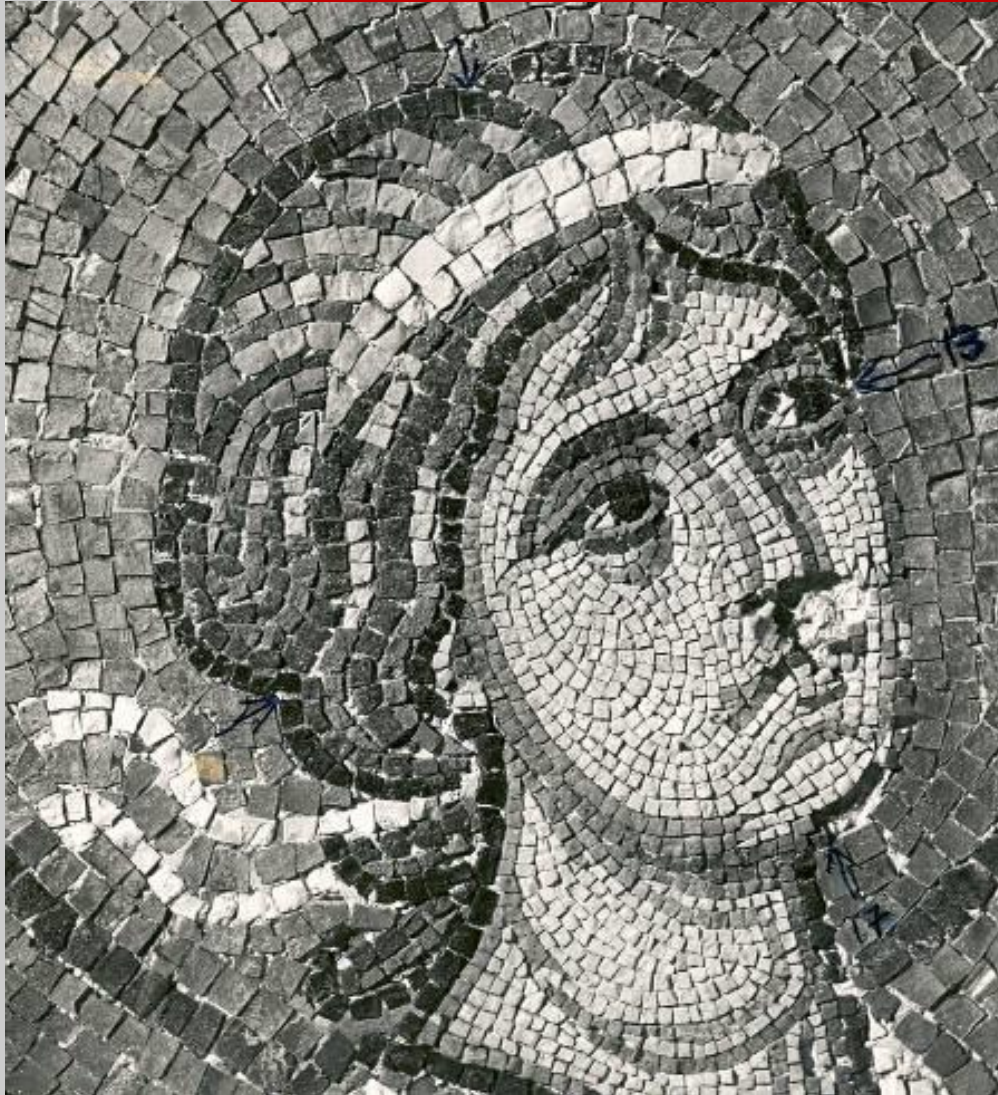
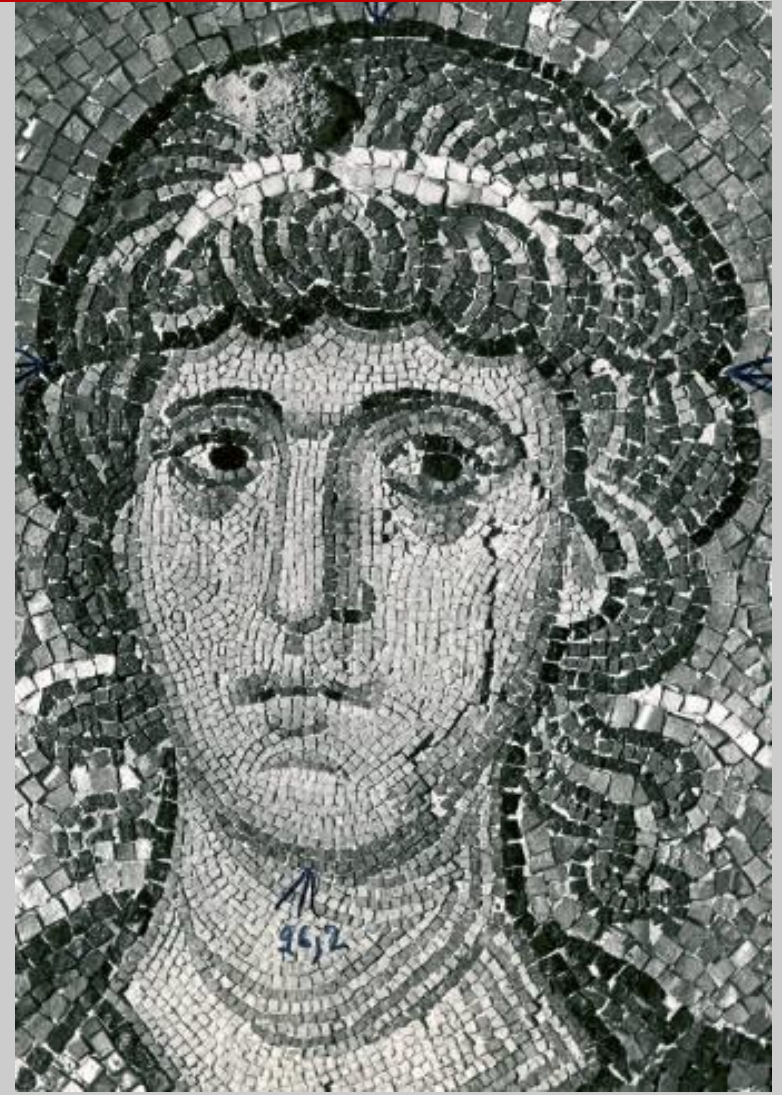
Rather minor damages to the mosaics due to the 1981 earthquake-No measures were taken

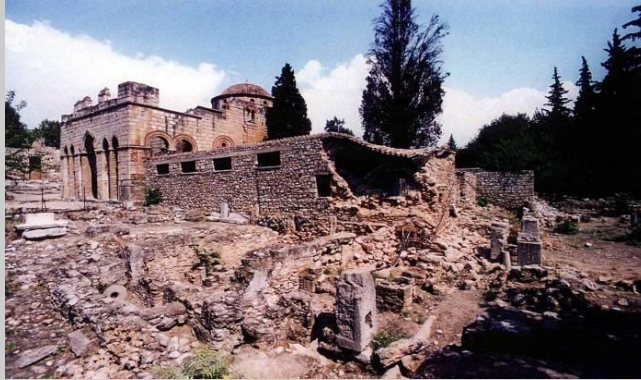
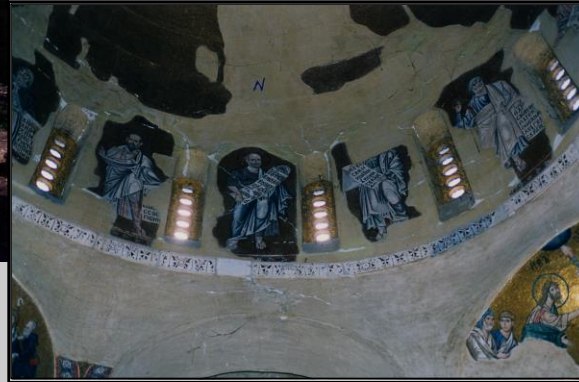
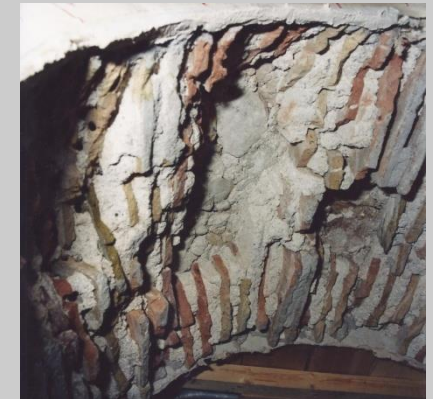
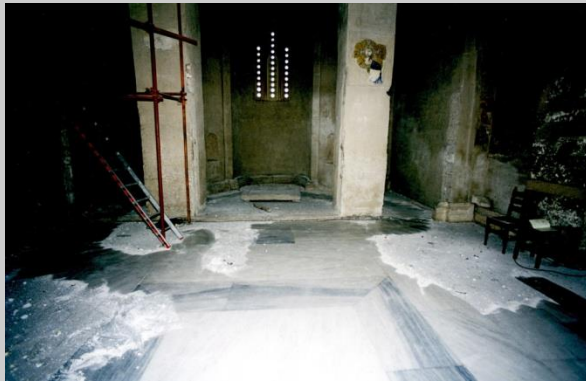
Severe
damages

- Catholikon
- Cells
- Walls
- Auxiliary buildings

Numerous inlays were covering the pavement.
They were collected systematically and nets
were placed under each mosaic as a first
protective measure (to avoid losses).

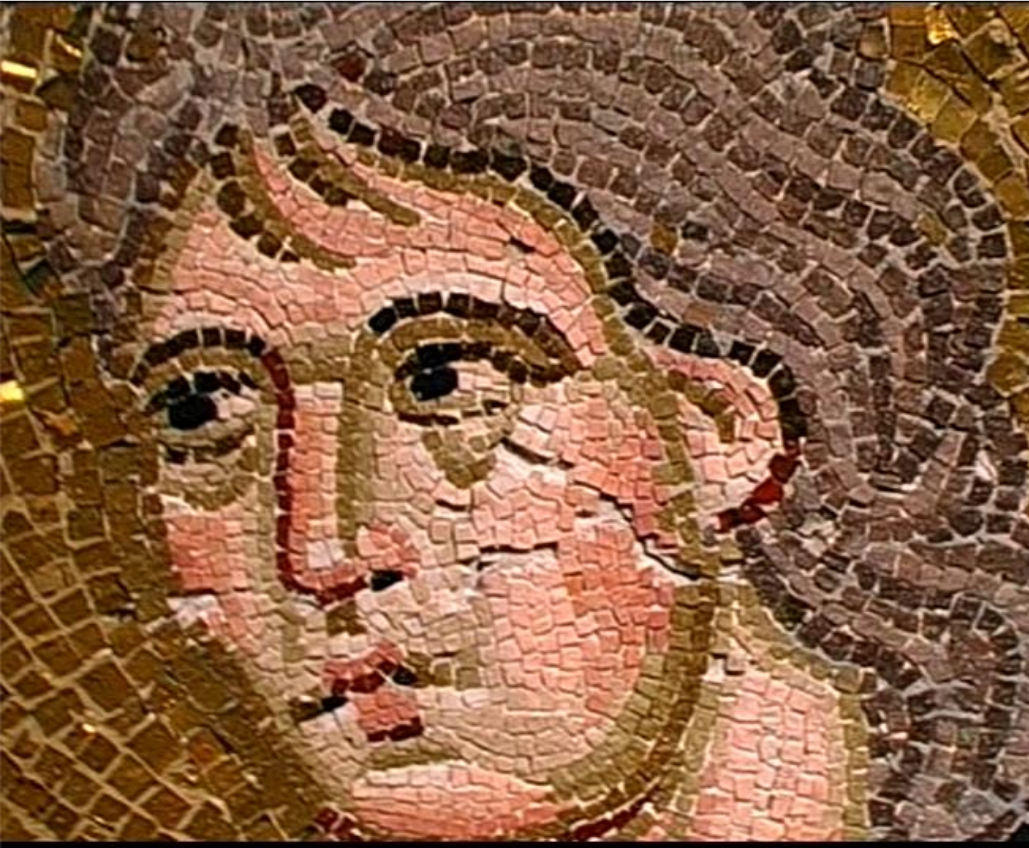
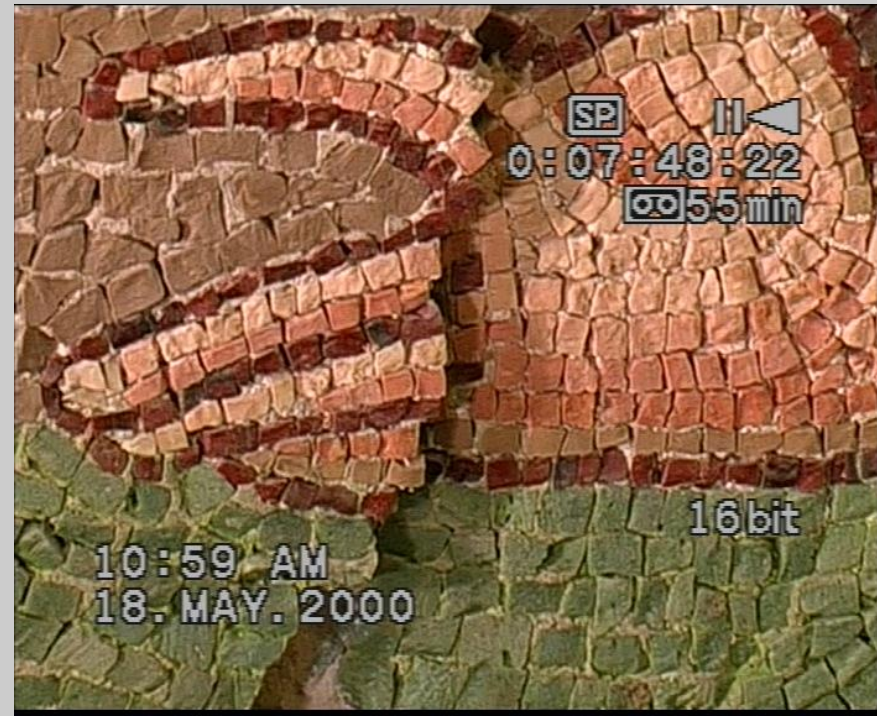
Severe damages in the mosaics, even in locations where masonry was not cracked

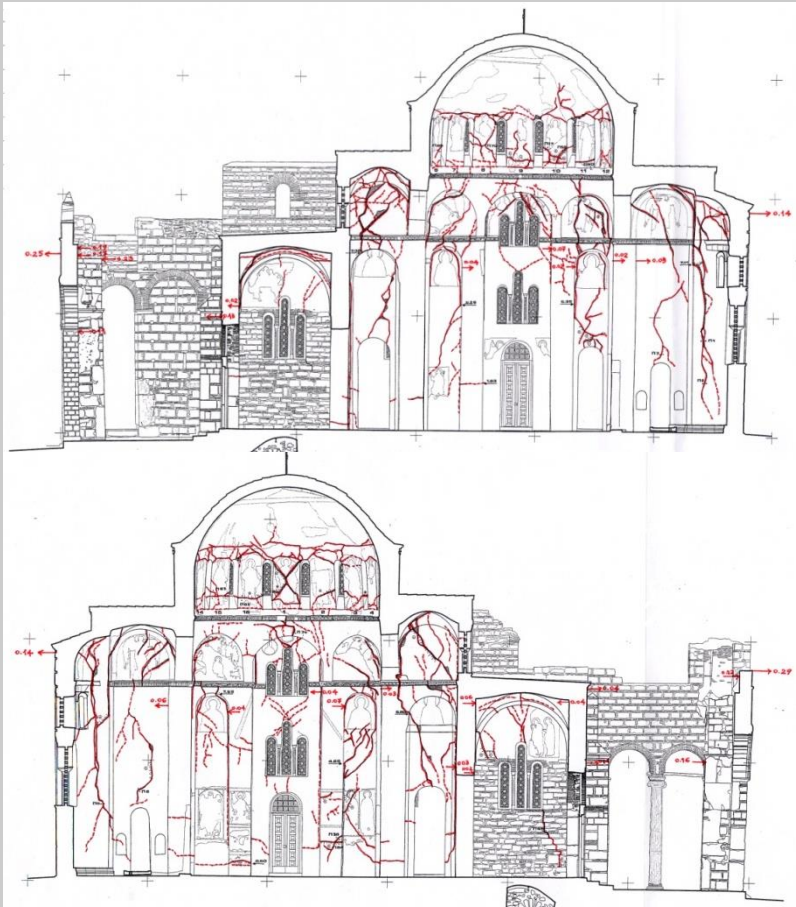
LONGITUDINAL SECTIONS

**MORE SEVERE DAMAGES
TOWARDS THE WEST**

**EAST: PIERS OF THE ALTAR, EAST STRONG WALL
WEST: FREE STANDING ISOLATED PIERS
NARTHEX: ONLY PERIMETER WALLS**

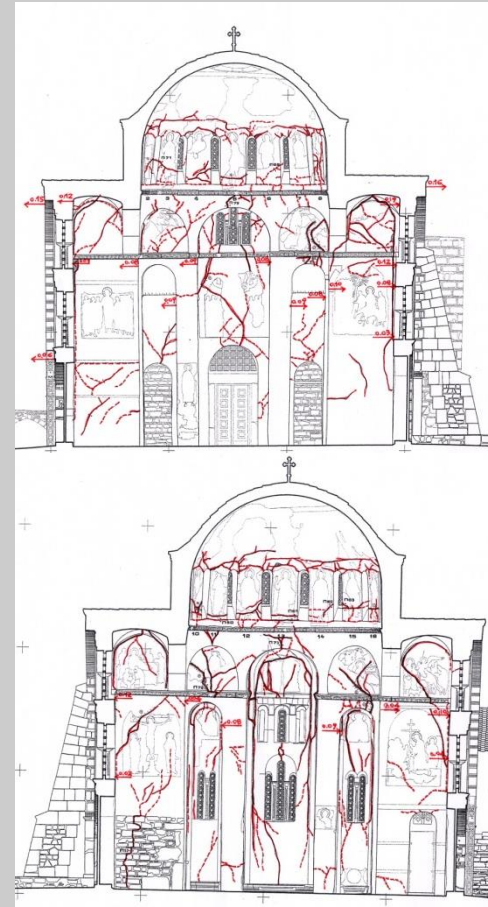
TRANSVERSE SECTIONS

**MORE SEVERE DAMAGES TOWARDS THE
TOP (WHERE MOSAICS ARE LOCATED)**

**SIGNIFICANT OUT-OF-PLANE DISPLACEMENTS
OF THE WALLS, ESPECIALLY ALONG THE N-S
DIRECTION (SMALLER STIFFNESS)**

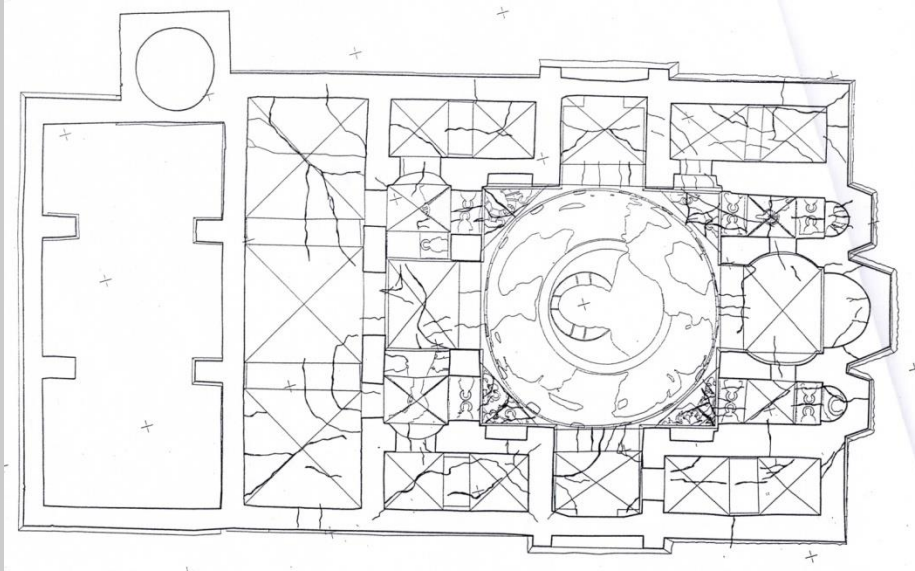
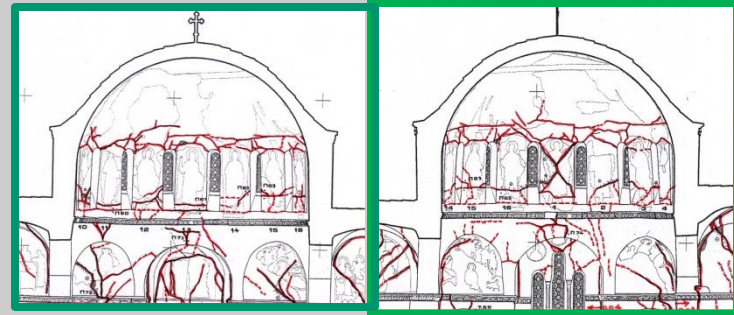
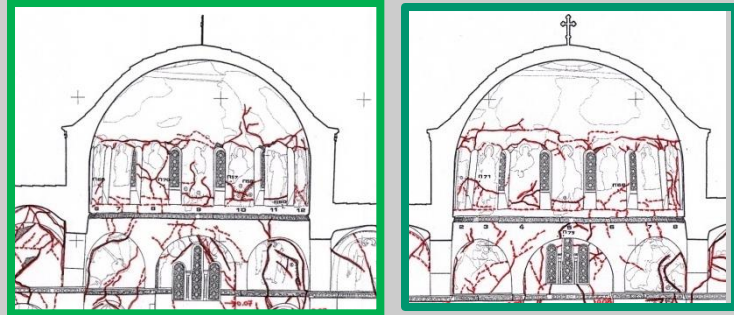
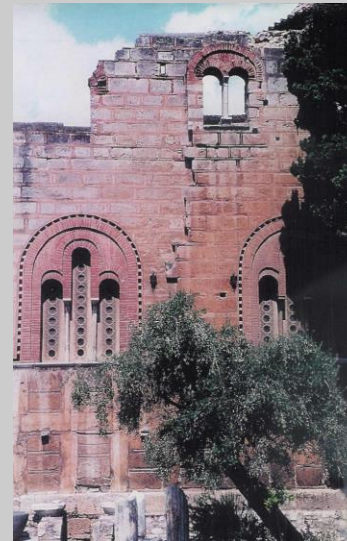
PATHOLOGY OF DOMES AND VAULTS

Documented by the frozen out-of-plane displacement of south wall, as well as by analytical work.

Sum of crack openings in east-west direction

Therefore, there is a tendency of the building “to open” in the north-south direction

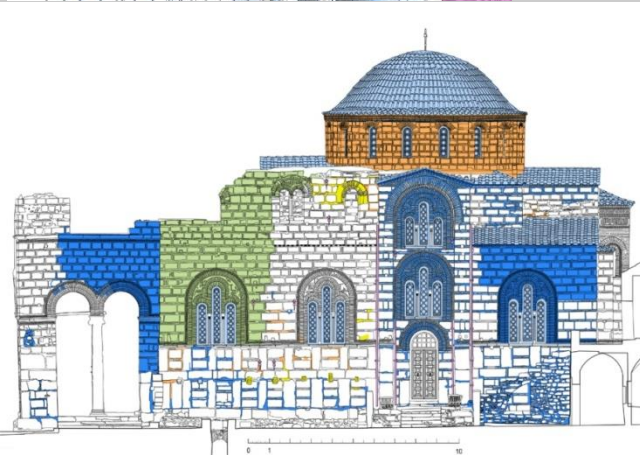
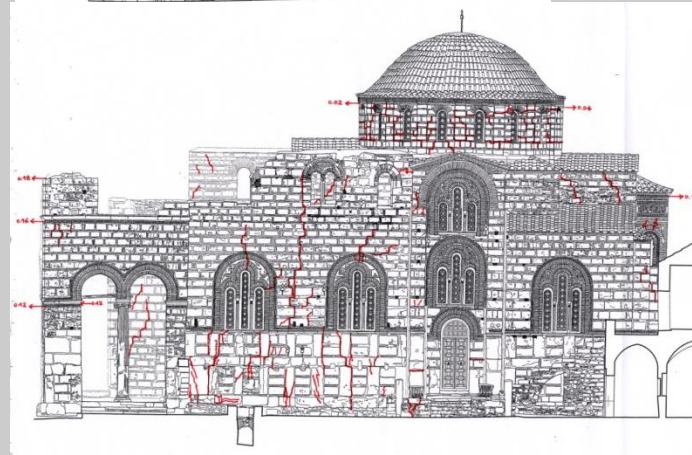
**FURTHER OUT-OF-
PLANE DEFORMATIONS
TO THE
RECONSTRUCTED
REGIONS**

SIMILAR DAMAGES
