NIKER WORKSHOP

MALLORCA CATHEDRAL

Pere Roca

**NEW INTEGRATED KNOWLEDGE BASED APPROACHES TO THE PROTECTION
OF CULTURAL HERITAGE FROM EARTHQUAKE INDUCED RISK**

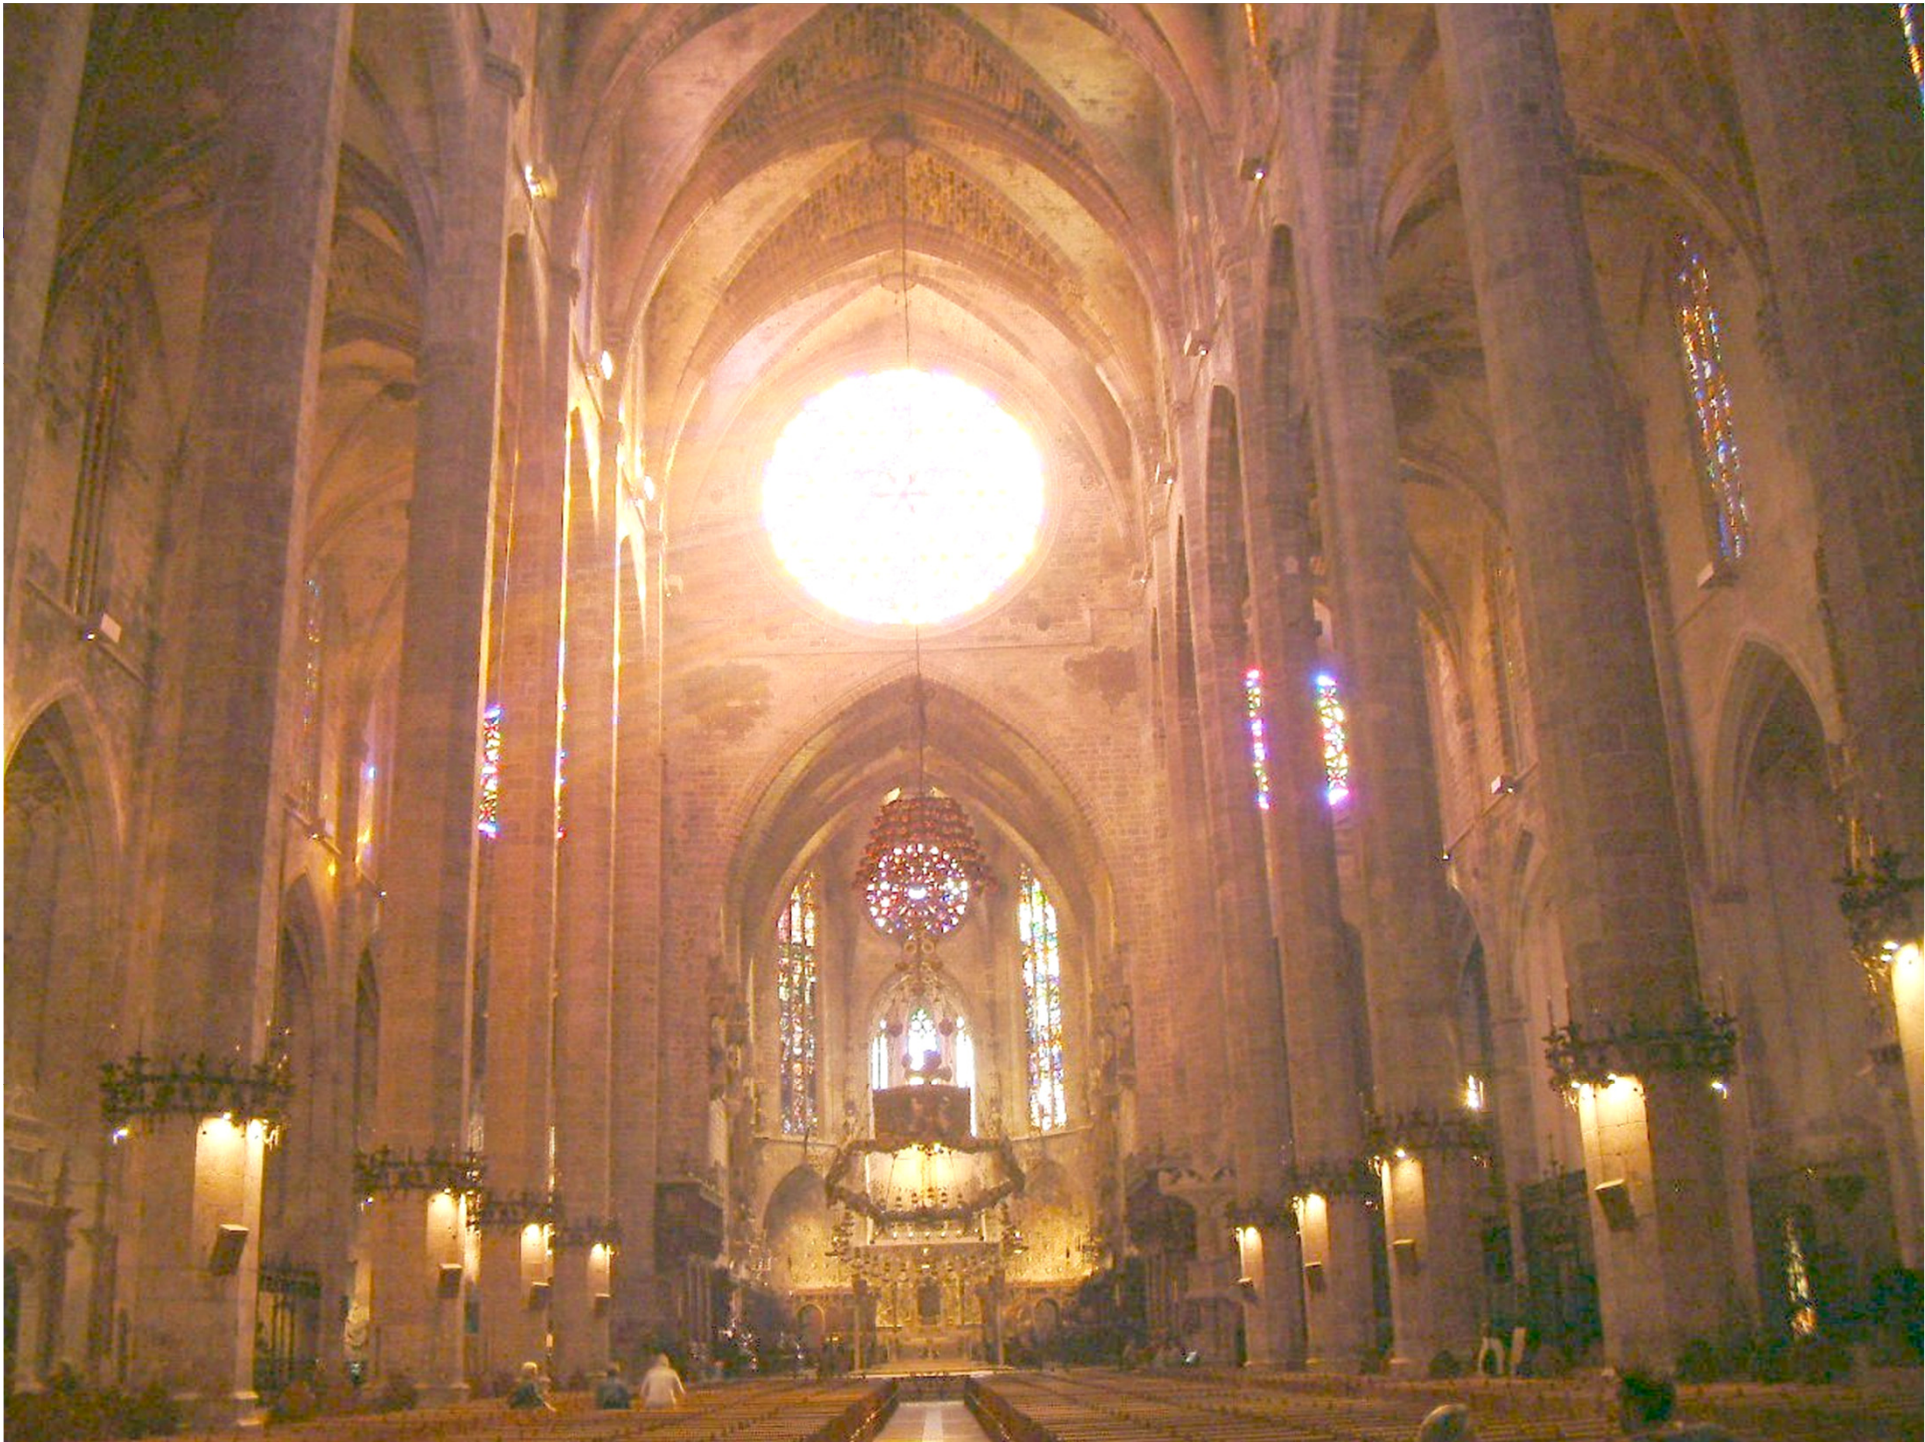
Repair interventions, especially during the
18th and 19th centuries

(4th vault partially collapsed 30 years after
the construction, repairs of many vaults,
dismantlement of Renaissance façade in
1851 due to 1.3 m out-of-plumb)

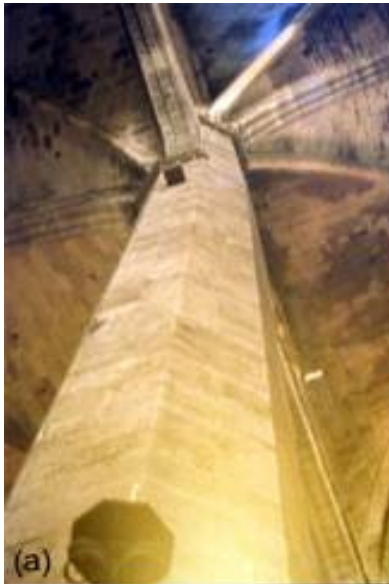
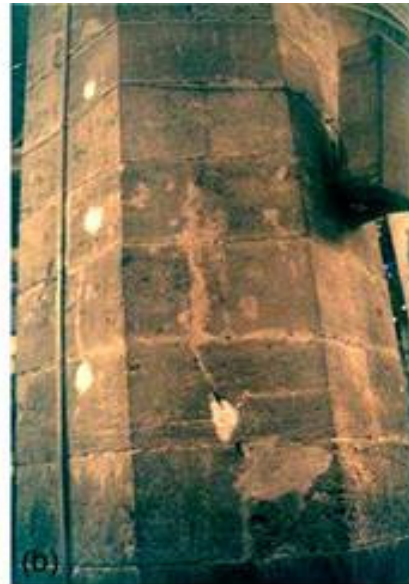
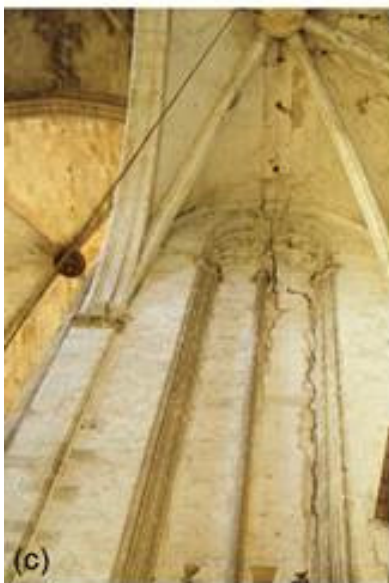
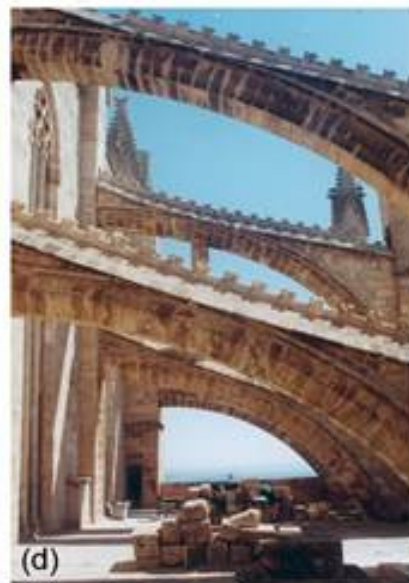
- a) Large lateral deformations of the slender piers (even $1/90 H$). The deformation is progressing at a rate of **0.1 mm per year** (monitoring from 9/2003 to 9/2008)
- b) Cracks at the base of some piers (stable)
- c) Cracks in buttresses following the perimeter of false windows
- d) Deformation of flying arches

- **General maintenance** works including, in particular, the **repointing** of joints showing deteriorated mortar or loss of material.
- **Deep grouting or injection** (depending of crack width) of major cracks existing in clerestory walls and buttresses. In cases with only superficial repair, the sealing material will have to be extracted.
- **Implementation of ties** in the longitudinal direction to improve the connection between the east and west façades and the nave (1 level)
- **Monitoring after the intervention** (both static and dynamic) allowing an incremental approach.

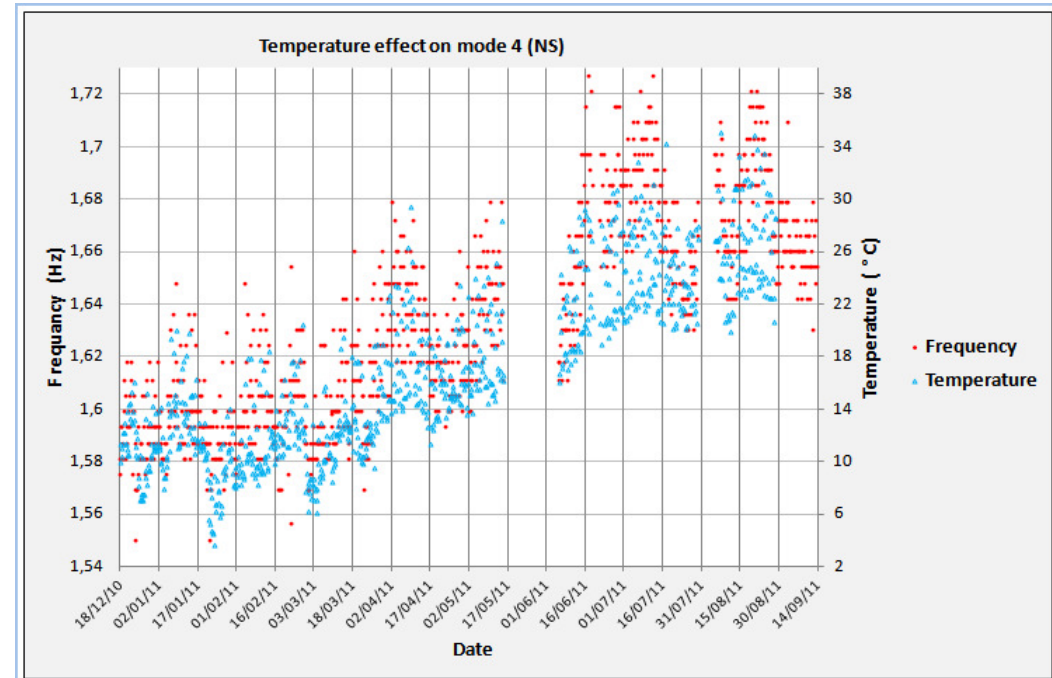
- The system worked properly from 17-12-2010 to 13-9-2011
Another monitoring period started in 18-5-2012 and is still working
- Good correlation between frequency and temperature.
- Temperature variation resulted in a measurable change in natural frequencies of at least 11%.

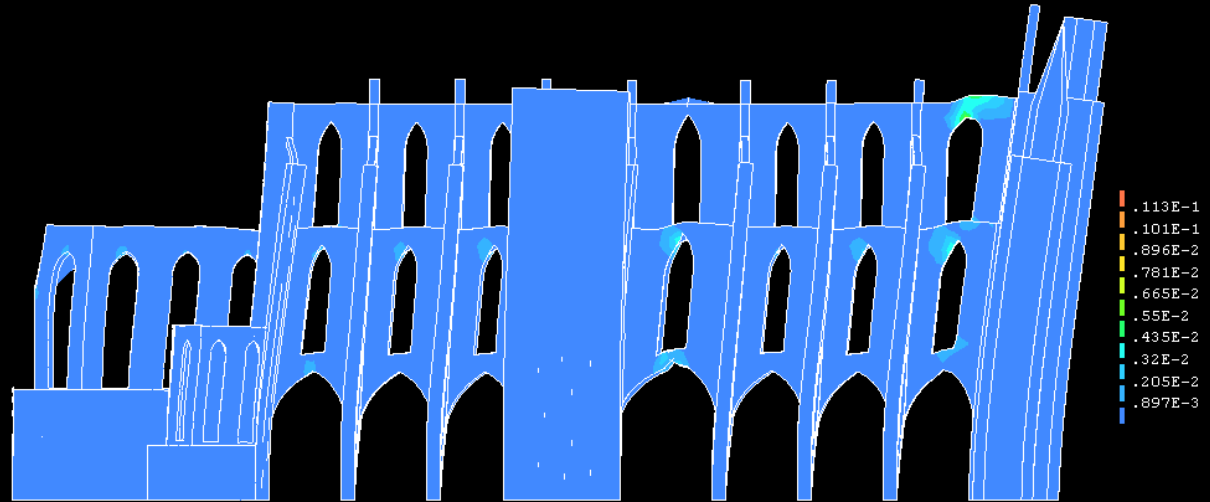
Longitudinal

Ultimate condition
