### Assessment and improvement of structural safety under seismic actions of existing constructions: Reinforced Concrete Structures and Historical buildings

### Lessons learned from the past earthquakes: damages catalogues and interpretation

Prof. Maria Rosa Valluzzi

University of Padova, Department of Cultural Heritage  
[mariarosa.valluzzi@unipd.it](mailto:mariarosa.valluzzi@unipd.it)

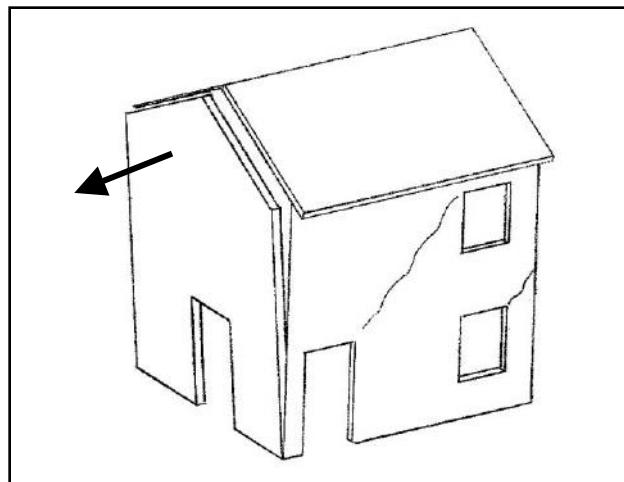
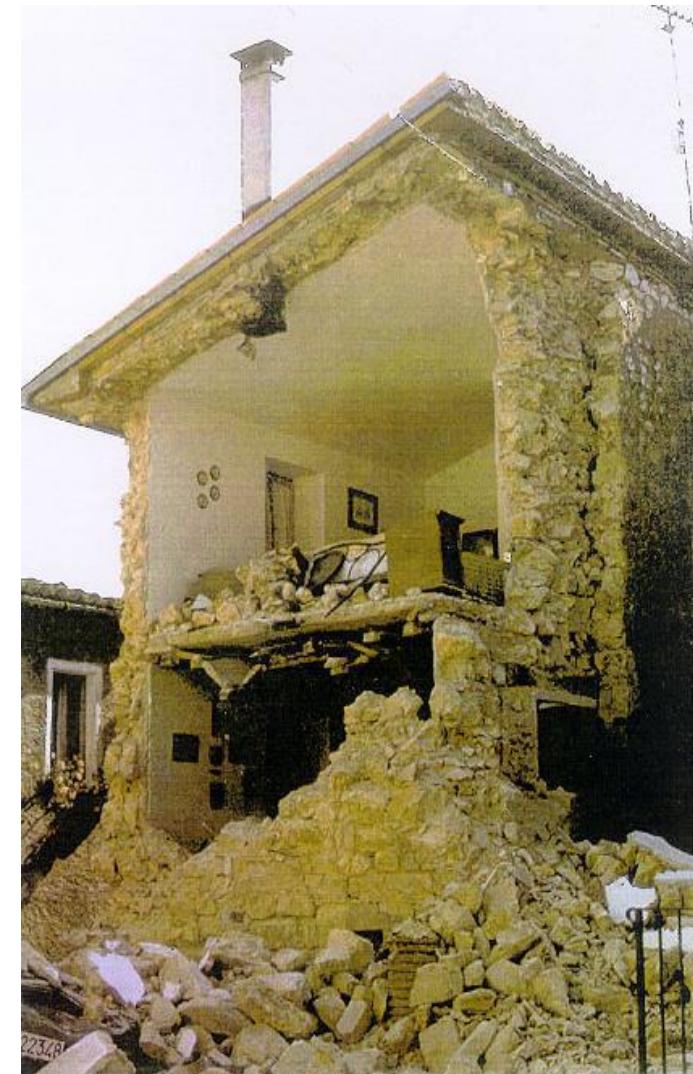
Total façade collapse

Out of plane rotation of the façade with formation of a cylindrical horizontal hinge at the base of the wall

Scarce connection between orthogonal walls

Absence of ties and tie beams

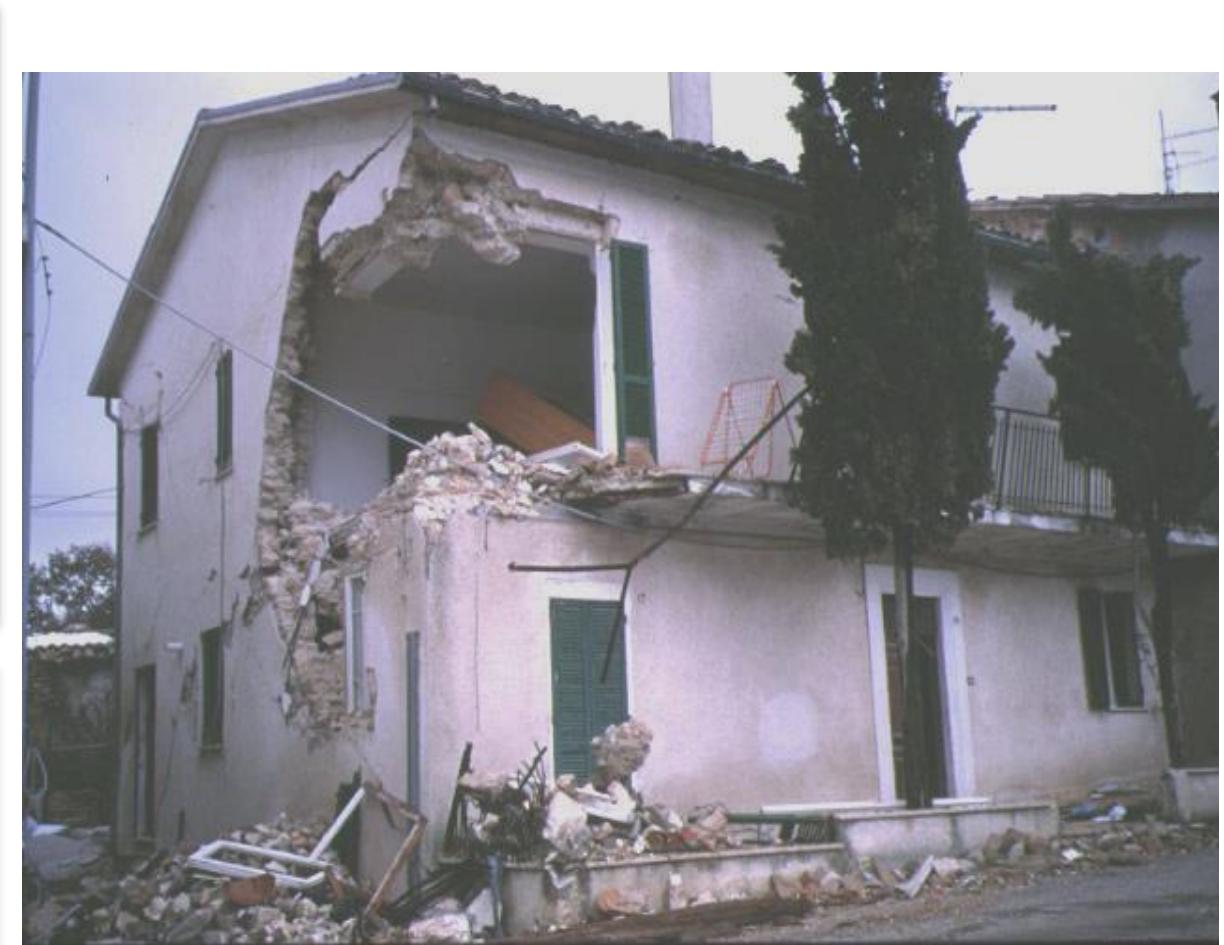
Collapse of the corner

Out of plane rotation of the masonry corner

Scarce connection between orthogonal walls

Scarce connection between floors and walls

Presence of openings close by the corner

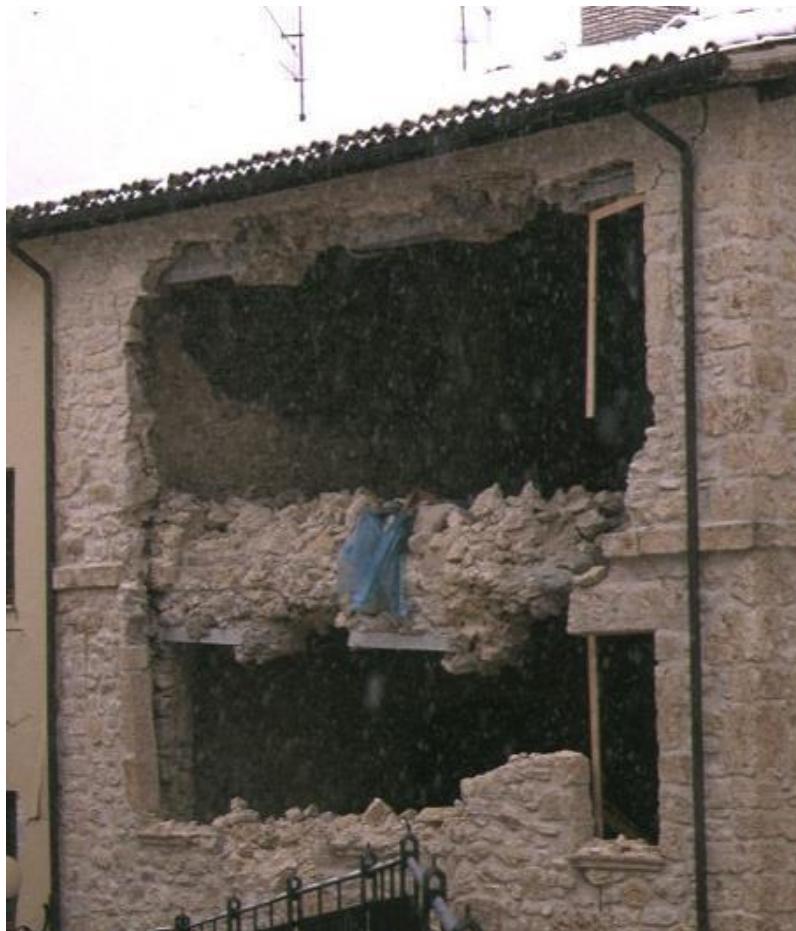
Expulsion of the façade

- Stiffening of horizontal diaphragms with non adequate strengthening of masonry walls

Rigid sliding of roof

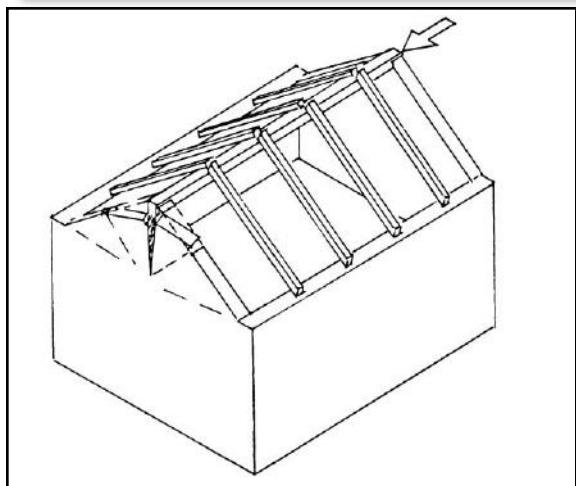
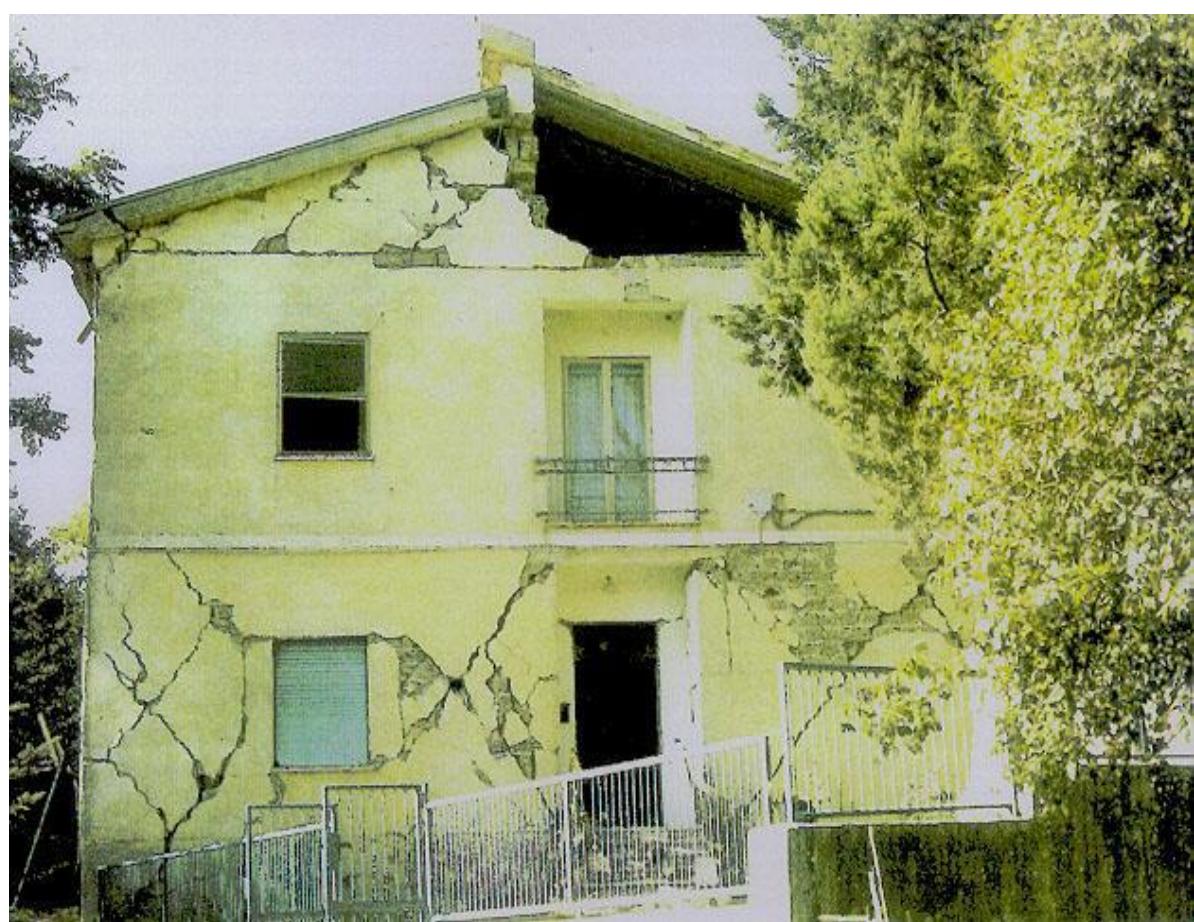
Local collapse of the tympanum

Local collapse of the cornice

Out of plane rotation of portion of the façade due to the pounding of the top roof beam

Scarce connection between roof and orthogonal walls

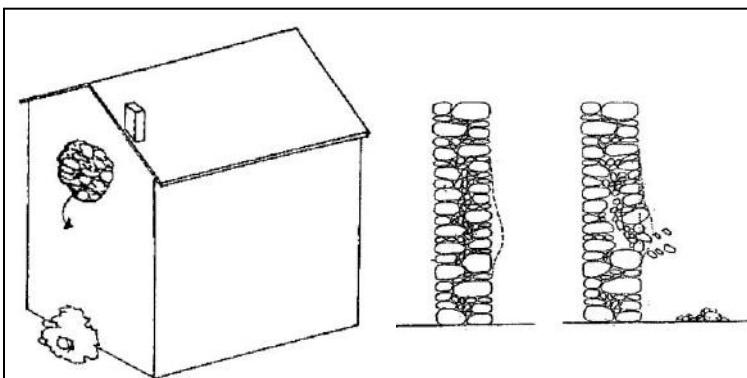
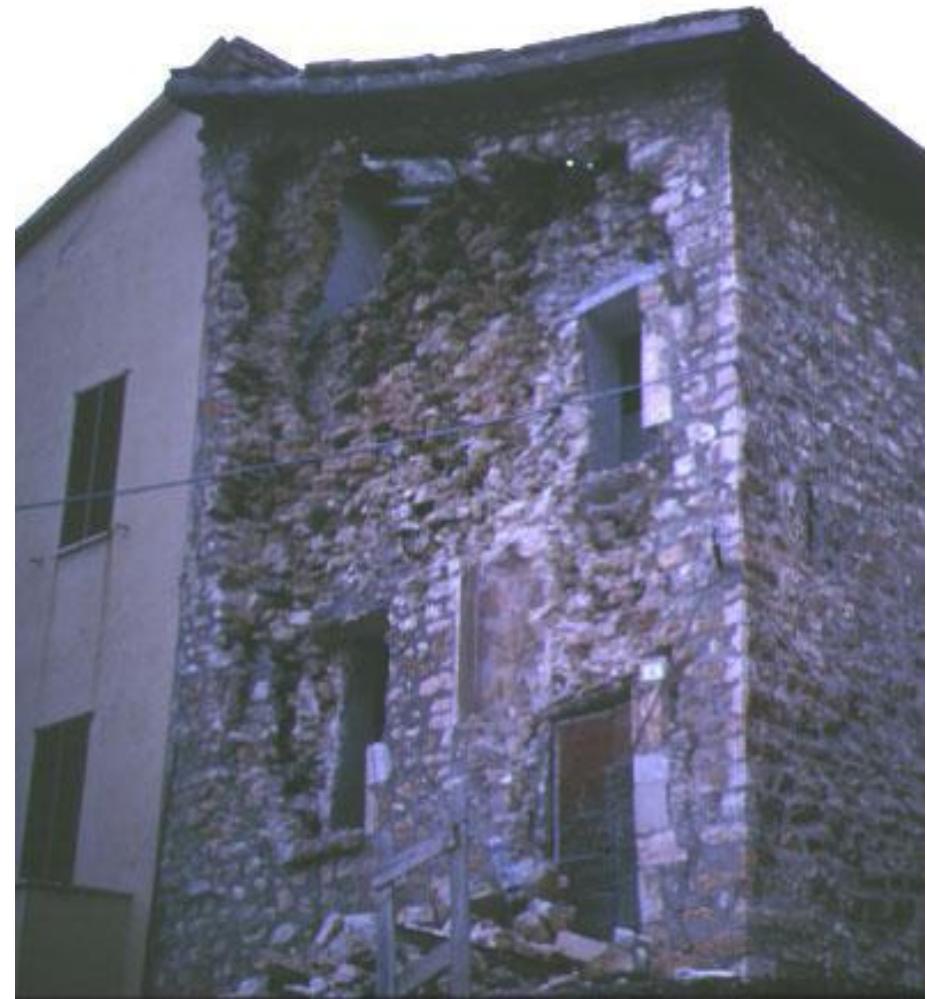
- Detachment of masonry leaves

- Local collapse and material expulsion

- Out of plane rotation of portion of the external masonry leaf

- Scarce quality of masonry walls

- Deterioration of masonry walls

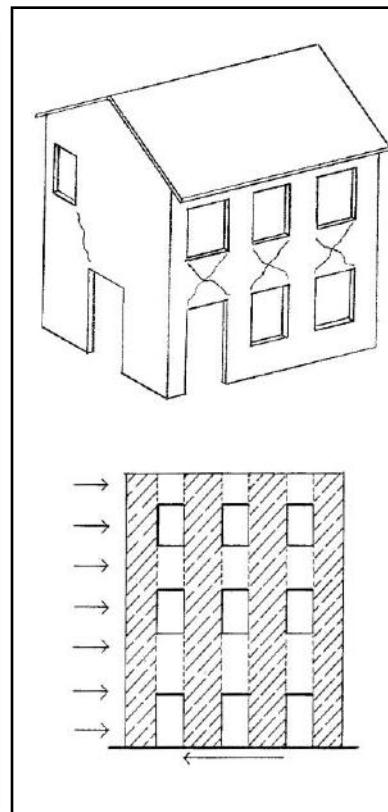
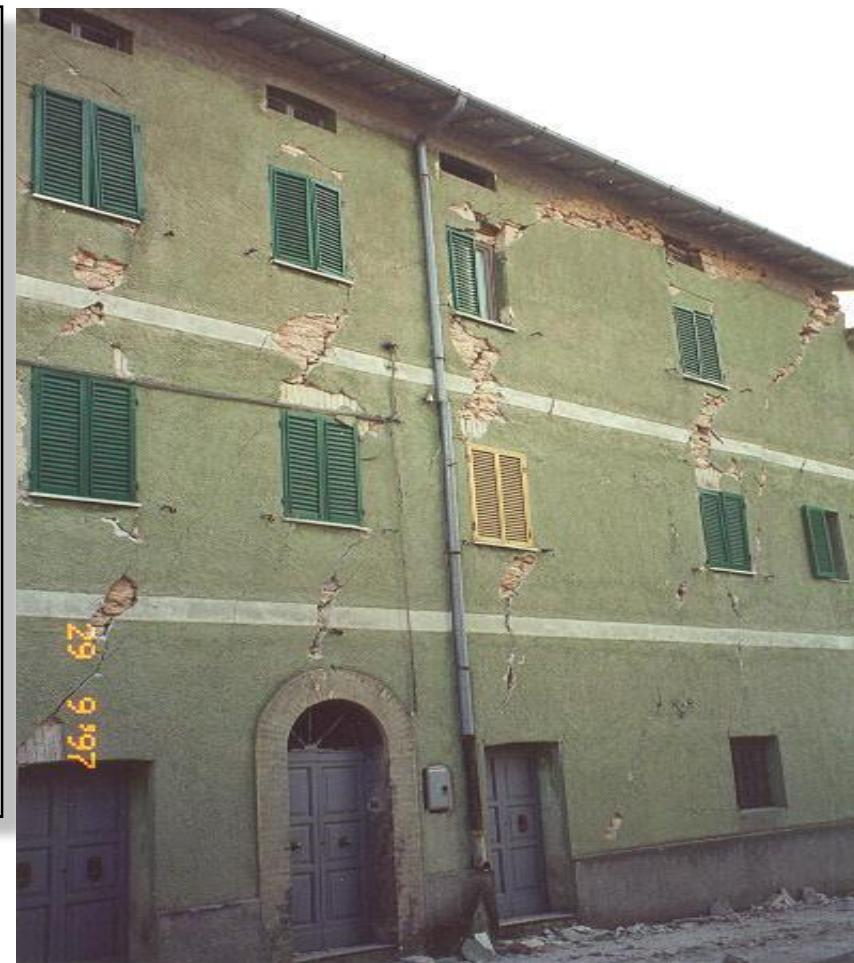
Crossed or diffused diagonal cracks above the lintels

Shear cracking of the spandrel walls due to in-plane flexural behaviour

Presence of weak lintels?? architravi?

Masonry piers between openings with small height and thickness

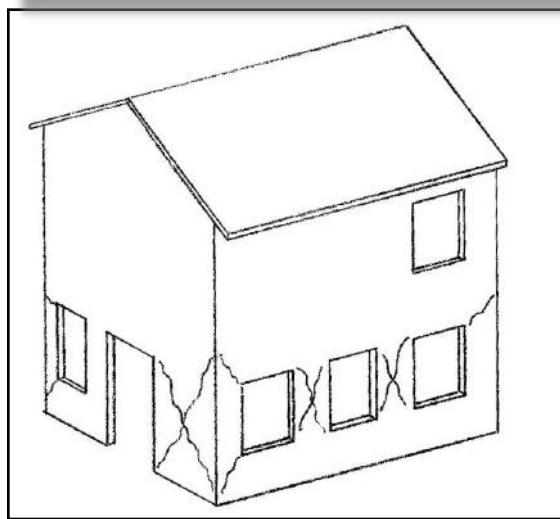
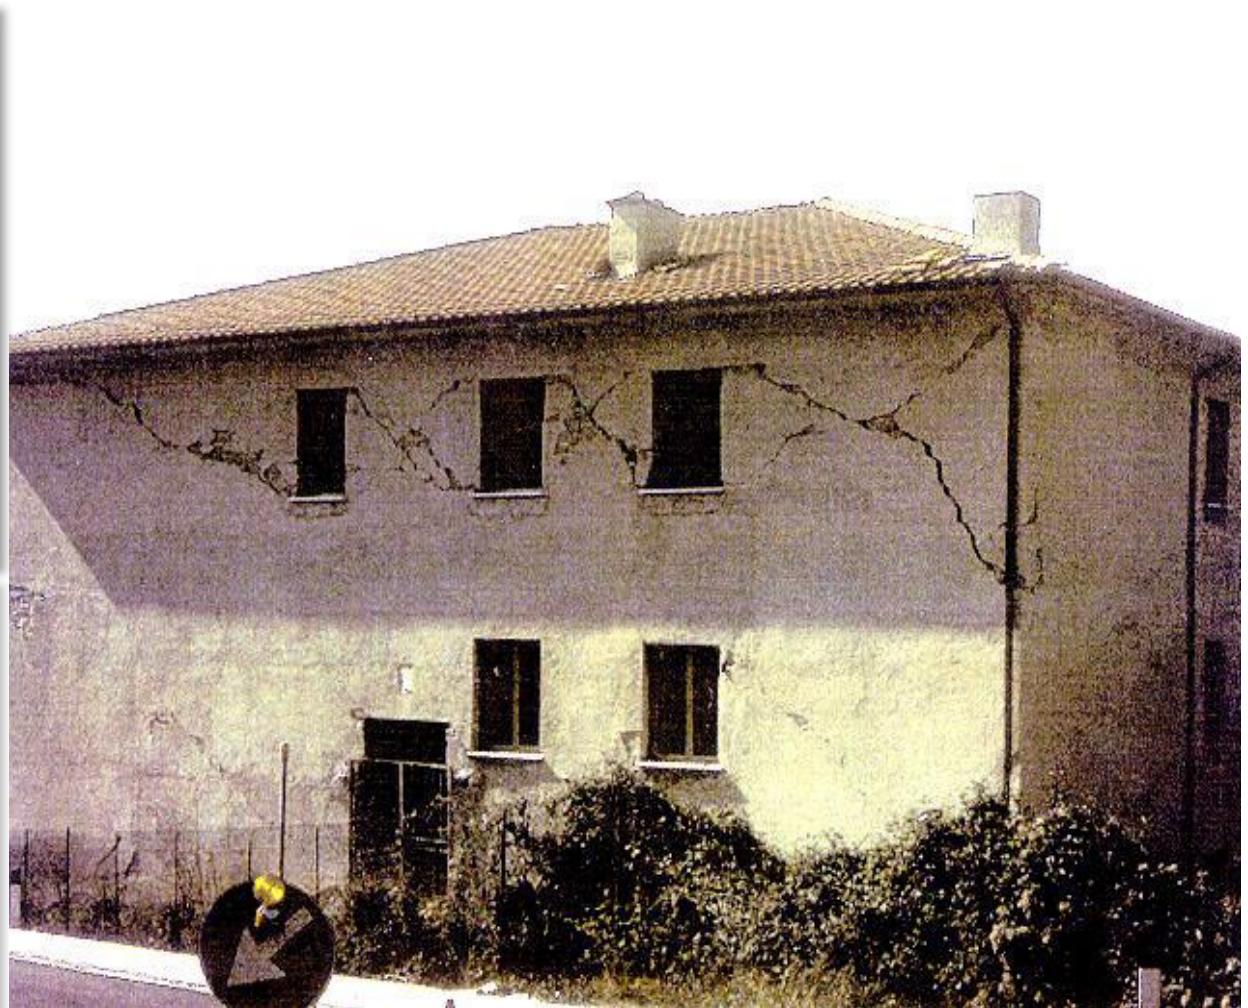
Crossed (in the central masonry piers) or inclined diagonal cracks in the squat masonry piers

Shear cracking of the wall under in-plane actions

Presence of many openings

Scarce quality of the masonry or presence of discontinuities

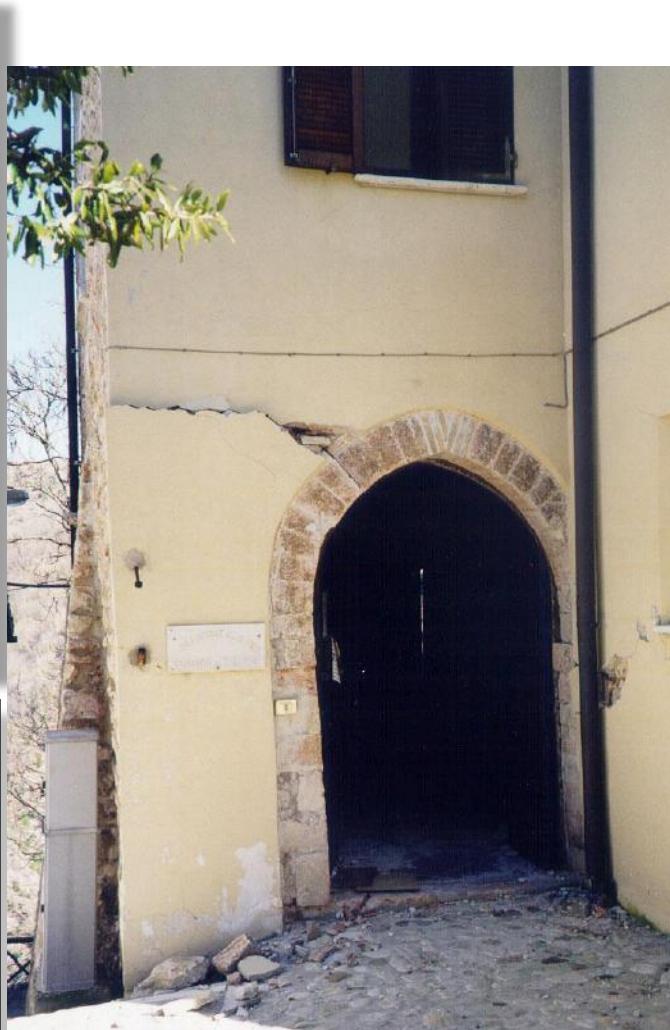
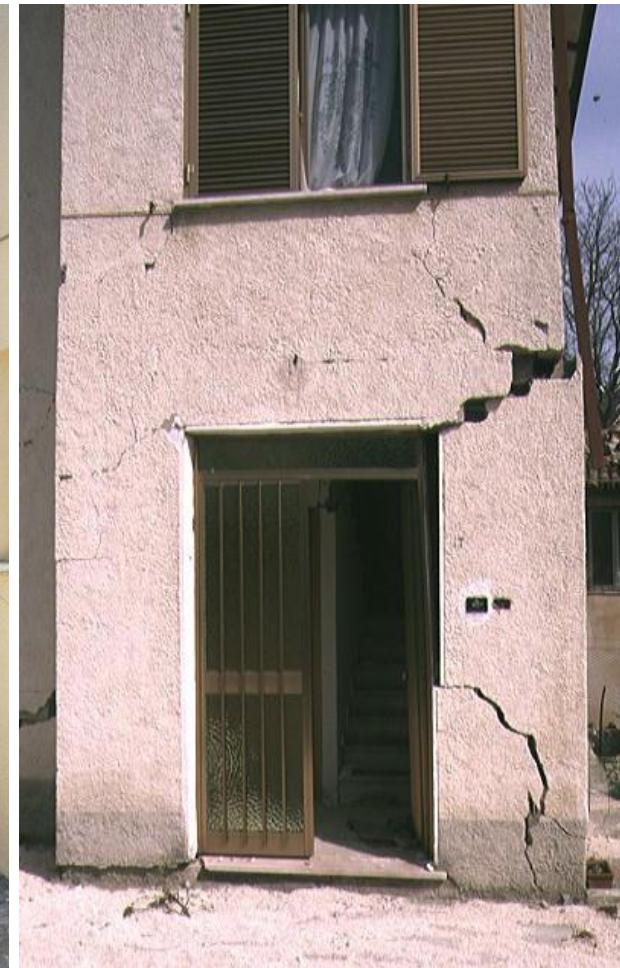
Horizontal cracks (tensioned corner)  
localized mainly at the base of the  
building

Eventual crushing of the compressed  
toe, due to attainment of maximum  
compressive strength

OVERTURNING of the masonry piers  
due to in-plane rotation

Excessive slenderness of the  
masonry piers due to the presence  
of many openings or large openings

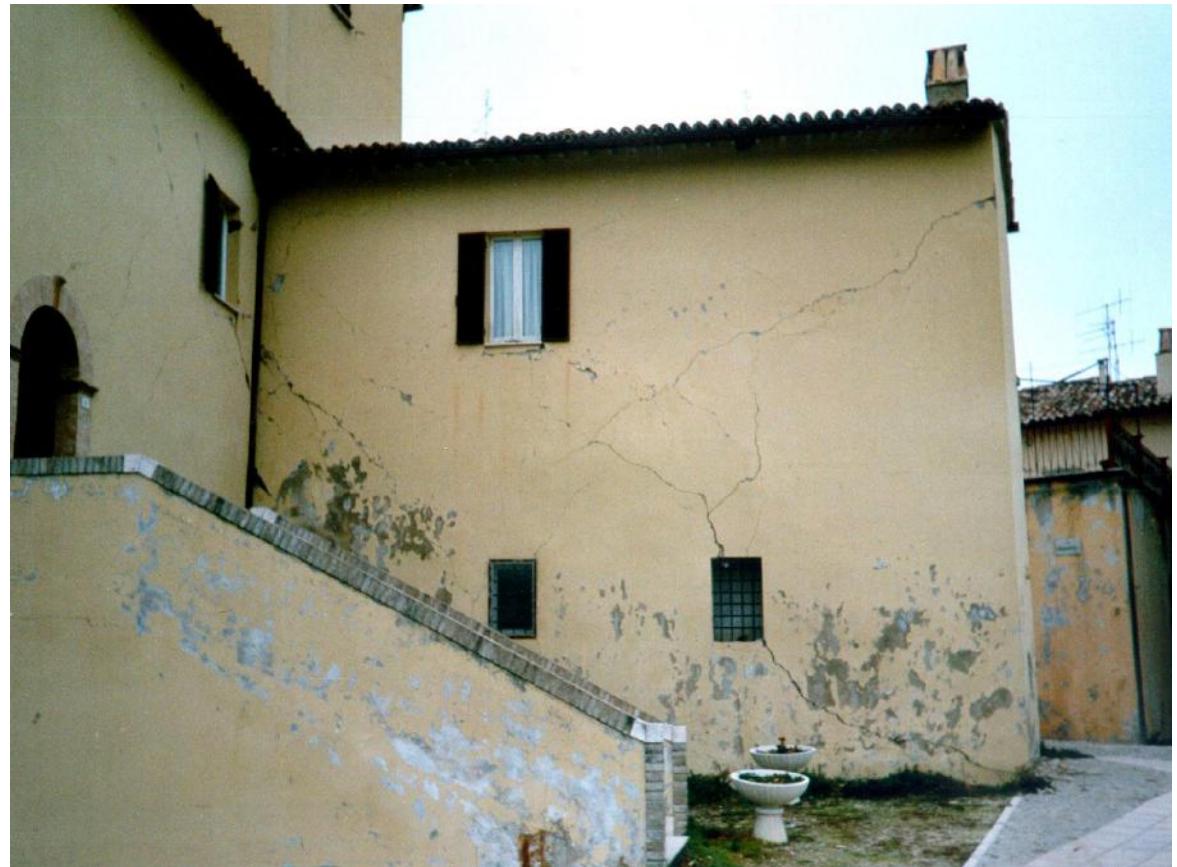
Shear cracking

Rotation of portions of the building

Irregular shape (plan) and  
consequent irregular distribution of  
horizontal forces

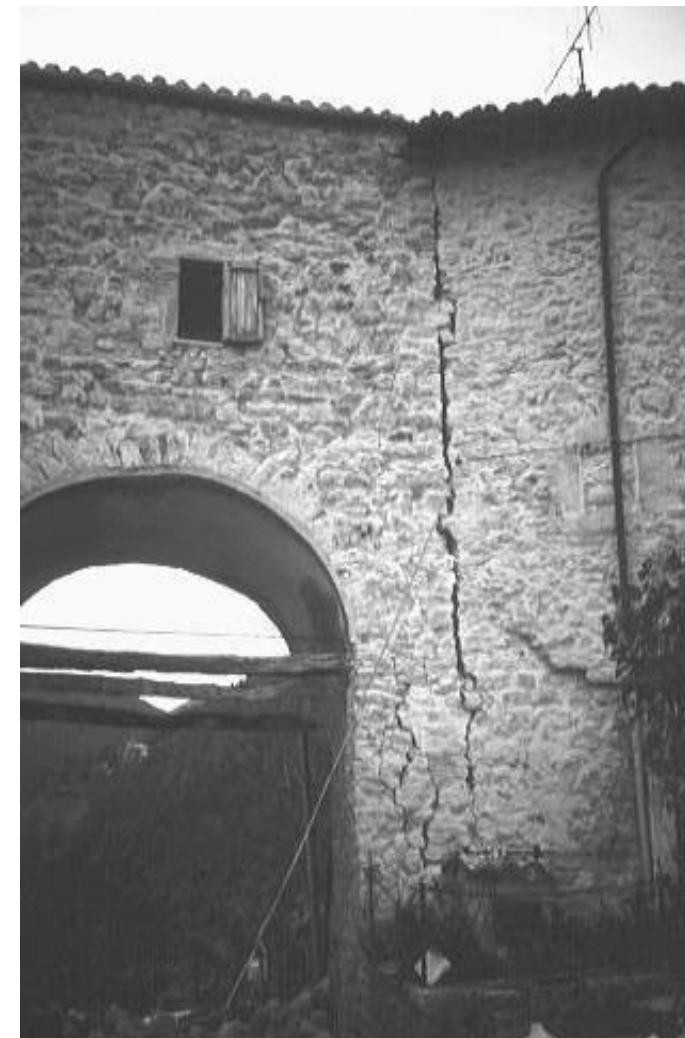
Vertical cracking at the joint between adjacent buildings

Different seismic response of adjacent buildings characterized by the presence of ineffective joint

Scarce connection between the buildings

Different stiffness of connecting structural bodies

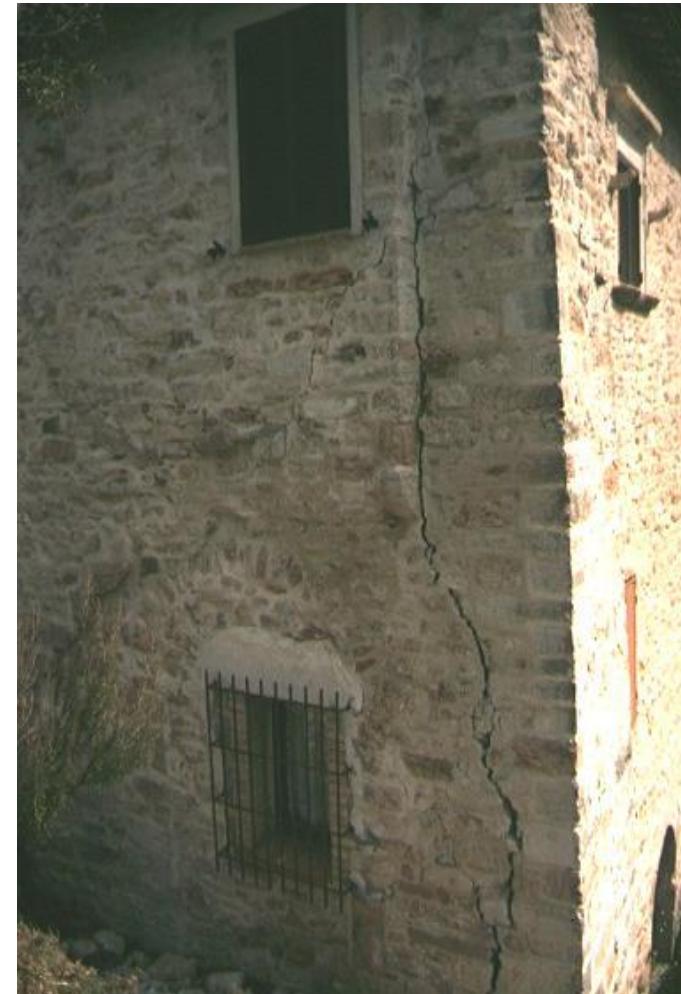
Large cracking (vertical ad sub-  
vertical)

Out-of-plane rotation and/or sliding  
of portions or the whole building

Uneven load capacity of the soil

Excessive soil sloping

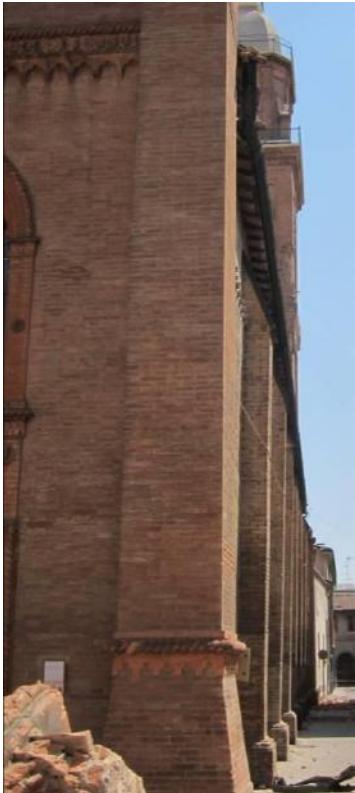
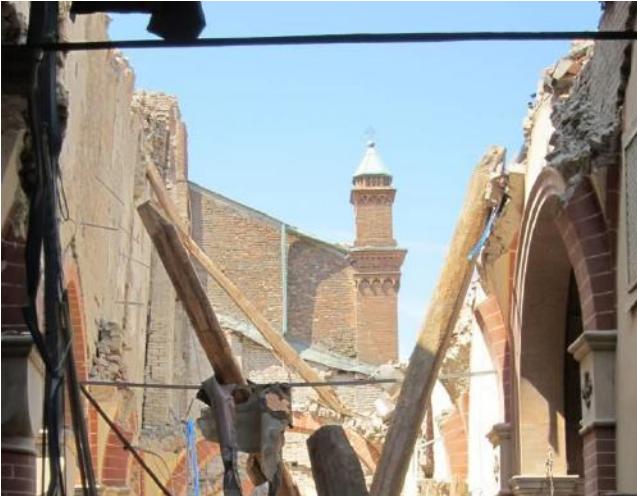
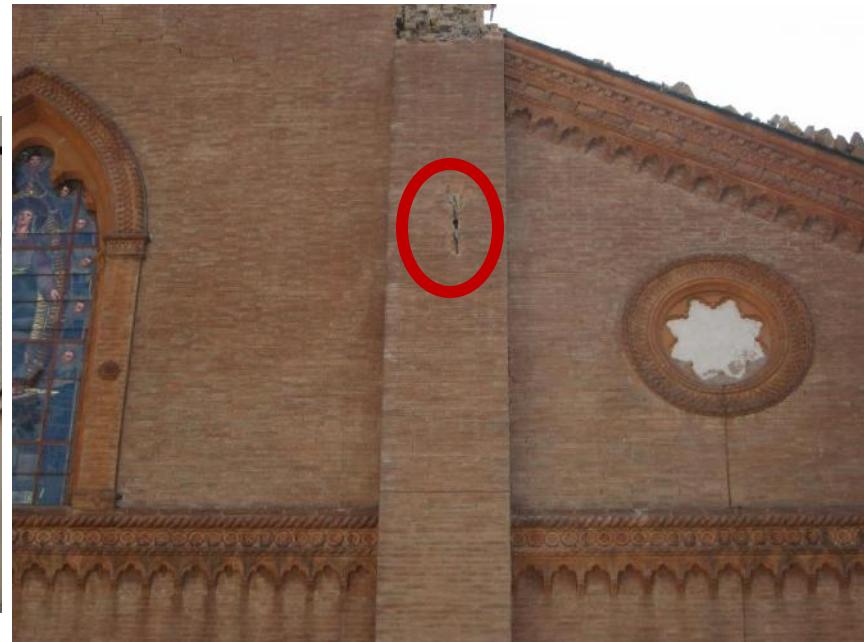
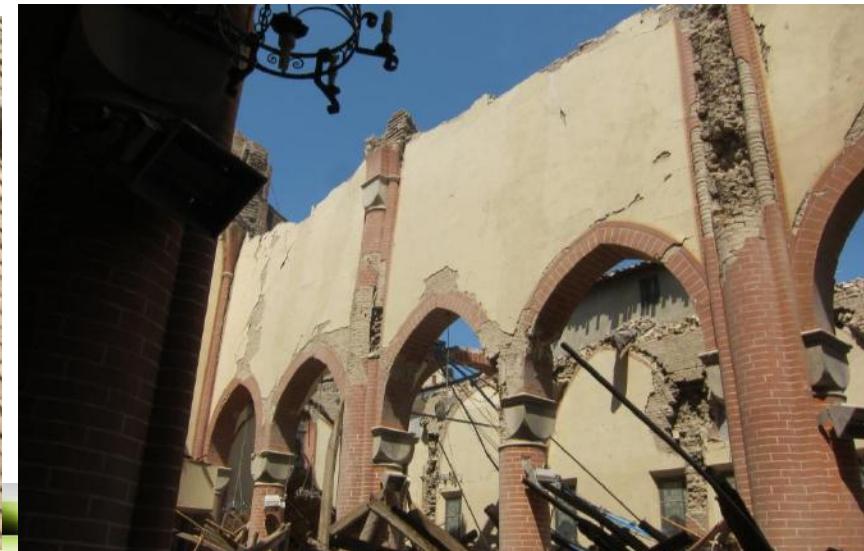
**2012** Collegiata Santa Maria Maggiore, Mirandola

- Presence of ties but not adequately evaluated
- Damage of fixing elements
