11-12 DECEMBER 2011, MIKVE ISRAEL, ISRAEL

MONITORING SYSTEMS & STRATEGIES

SPEAKER: PROF. CLAUDIO MODENA

DEPARTMENT OF STRUCTURAL & TRANSPORTATIONS ENGINEERING UNIVERSITY OF PADOVA, ITALY

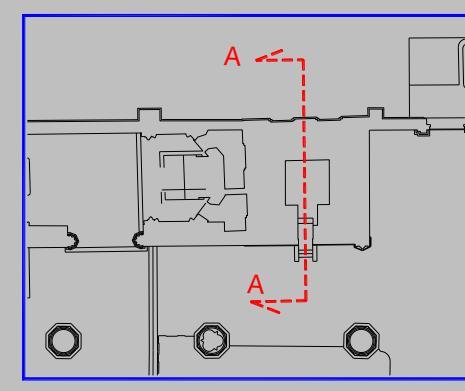
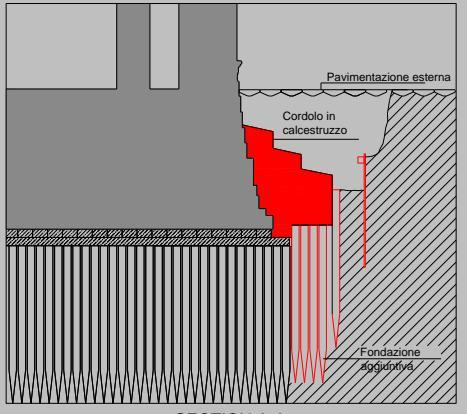
DIFFERENTIAL SETTLEMENT BETWEEN CHURCH AND TOWER: 30 cm
OUT-OF-PLUMB: 76cm ON A HEIGHT OF 42.5m

Reverse of tower's rotation toward the church

>The new structural configuration caused the formation of widespread cracks and extensive damages on structural elements of the church directly connected to the bell tower

1903: Intervention on tower's foundations

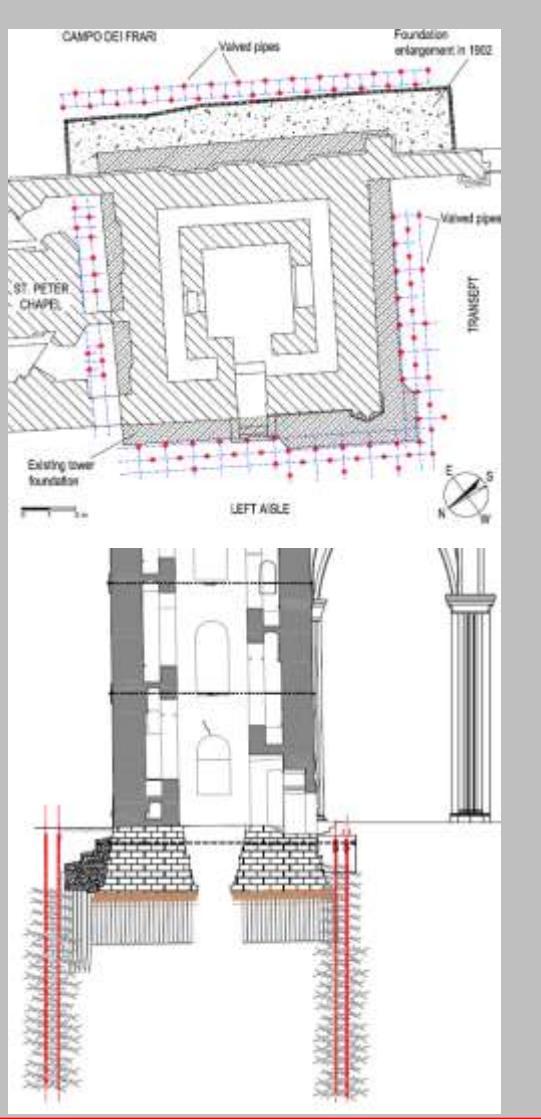
SOIL FRACTURING INTERVENTION (2005-2006)

From the above-mentioned surveys, tests and inspections it was possible to assess the structural behavior of the churchtower complex and state that the tower couldn't tolerate further differential settlements without serious consequences for the church' structures.

Thus it was necessary to intervene quickly, but also with great caution on tower's foundations, in order to reduce its settlement's speed and rotation.

It was decided to intervene directly on the clay soil around the stone basement of the tower in order to improve its the mechanical properties, through widespread and repeated injections of cementitious grout, under controlled conditions. Such injections produce expansions and/or fracturing of the soil around the injection pipes and for this reason the technique is called *soil-fracturing*.

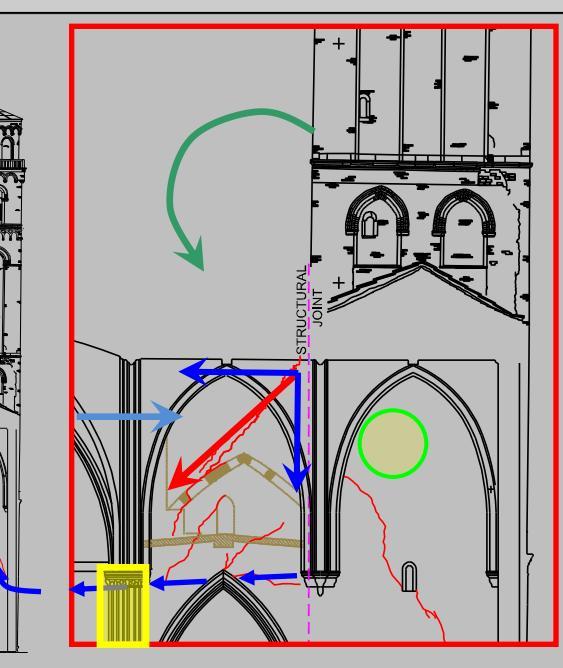
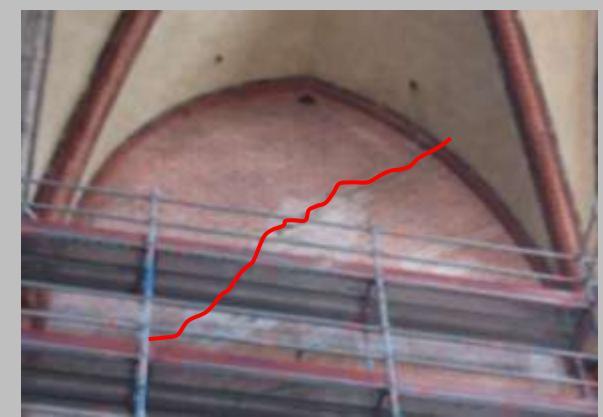
Out-of-plumb of the tower

A system of skewed cracks on the masonry panel over the stone arch that connects the tower to the column at the corner between nave and transept

Creation of a joint in order to separate the bell tower from the church and make them structurally more independent

Reduction of the compressive forces that transfer part of the tower's self weight to the column

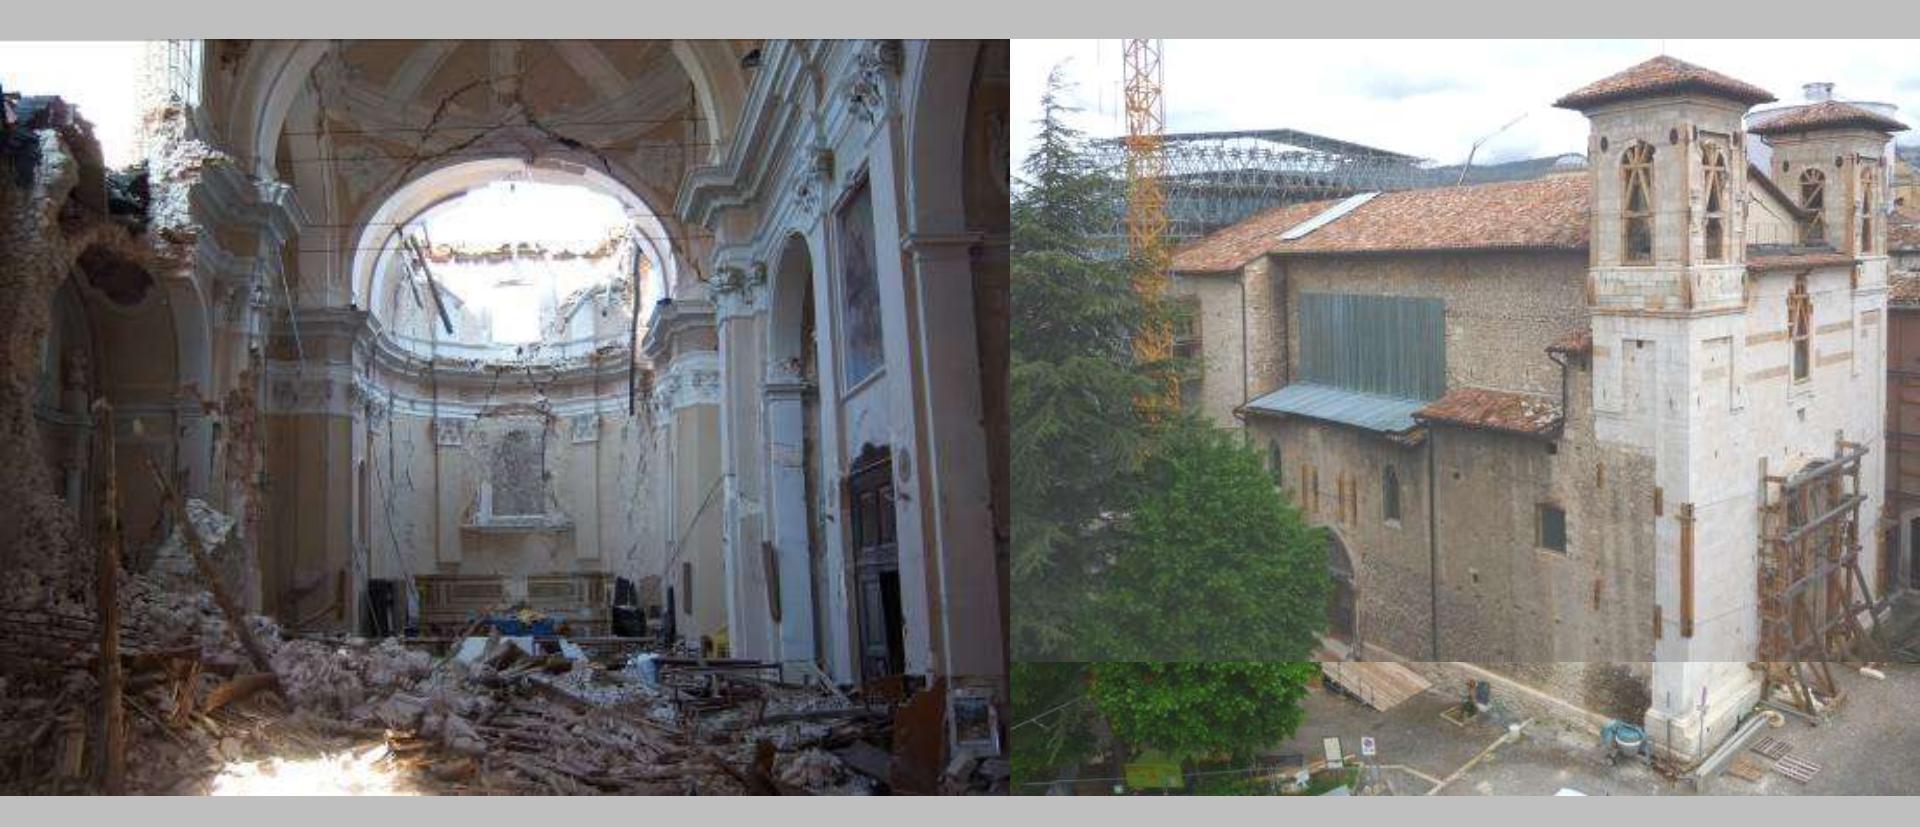
After the earthquake the church reported severe damage in the apsidal and transept area, where a critical crack pattern was noticed in the external walls, which manifested a visible outward overturning, involving the four pillars sustaining the dome. Also the transversal response of the church proved to be inadequate, since the most part of the vaults collapsed, such as a big portion of the external wall, at the clerestory level. Severe damage was finally reported in the vaults of the apse, of the presbytery, in the triumphal arch. The initial provisional strengthening intervention started the 4th of July and were completed in November 2009. This first intervention aimed at counteracting the most critical collapse mechanisms, such as the apsidal and transept walls overturning.

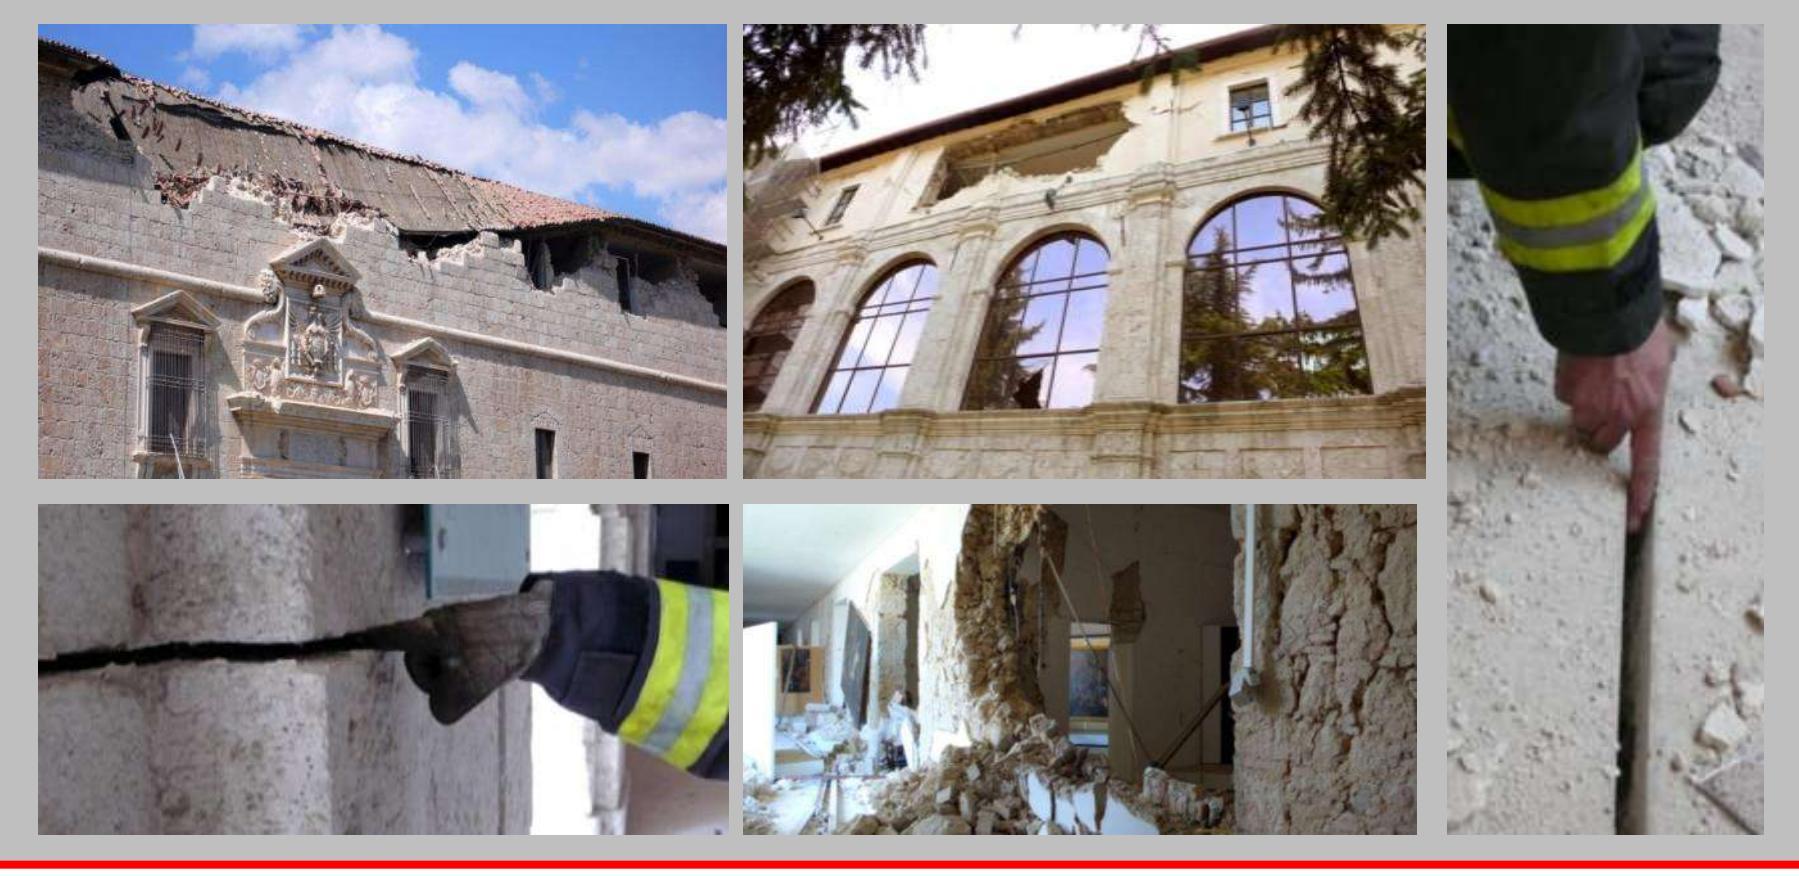
Following the 6th of April 2009 earthquake, the fortress was seriously damaged, especially in the upper floors, where several collapses were noticed. Between the recorded damage, overturning and flexural mechanisms on the external walls, shear damage in the external and internal walls, damage to vaults and arches, local collapses of floors and vaults, corresponded to the most worrying observations.

Damage manifested by the building were remarkable both for intensity and distribution, and were considered so serious to likely prejudice the overall stability of the building.
