POSSIBLE SOLUTIONS BEFORE AND IMMEDIATELY AFTER EARTHQUAKE.

SPEAKER: PROF. CLAUDIO MODENA

DEPARTMENT OF STRUCTURAL & TRANSPORTATIONS ENGINEERING UNIVERSITY OF PADOVA, ITALY

THE SPANISH FORTRESS

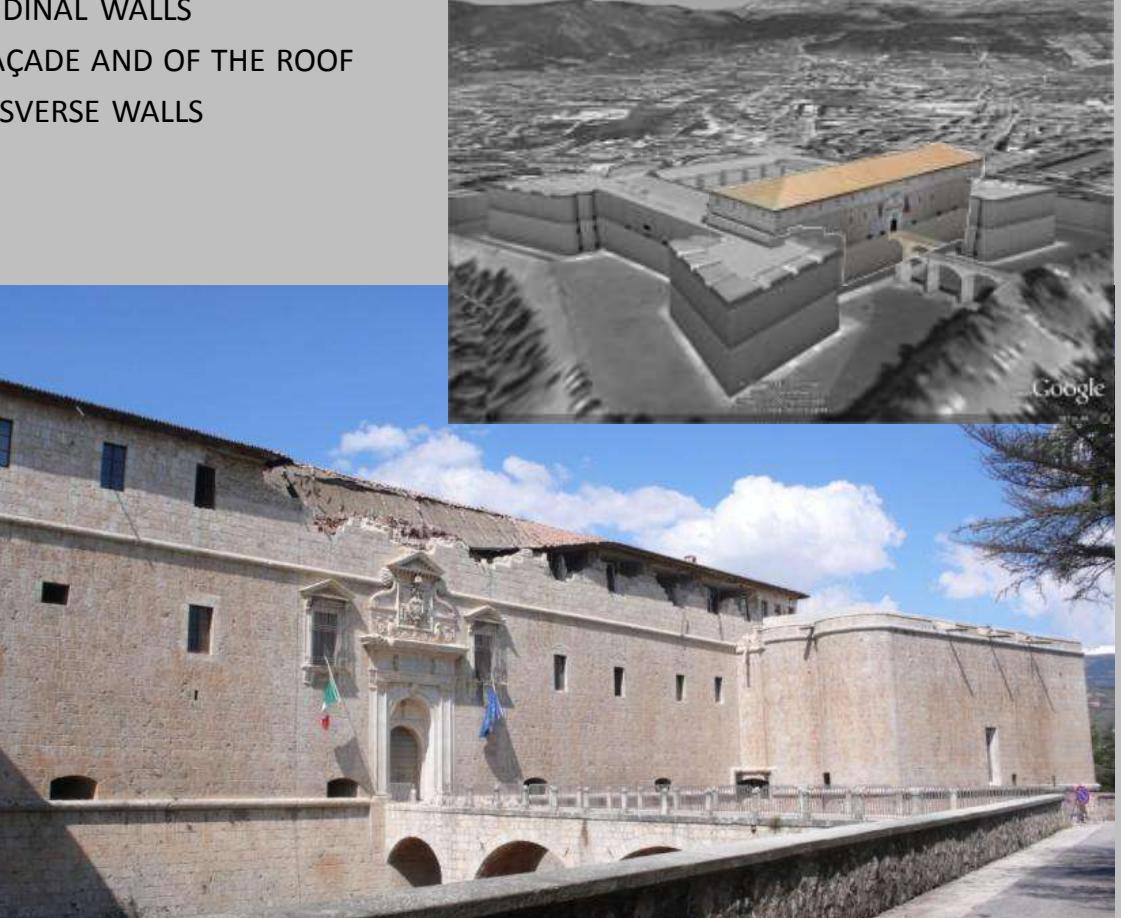
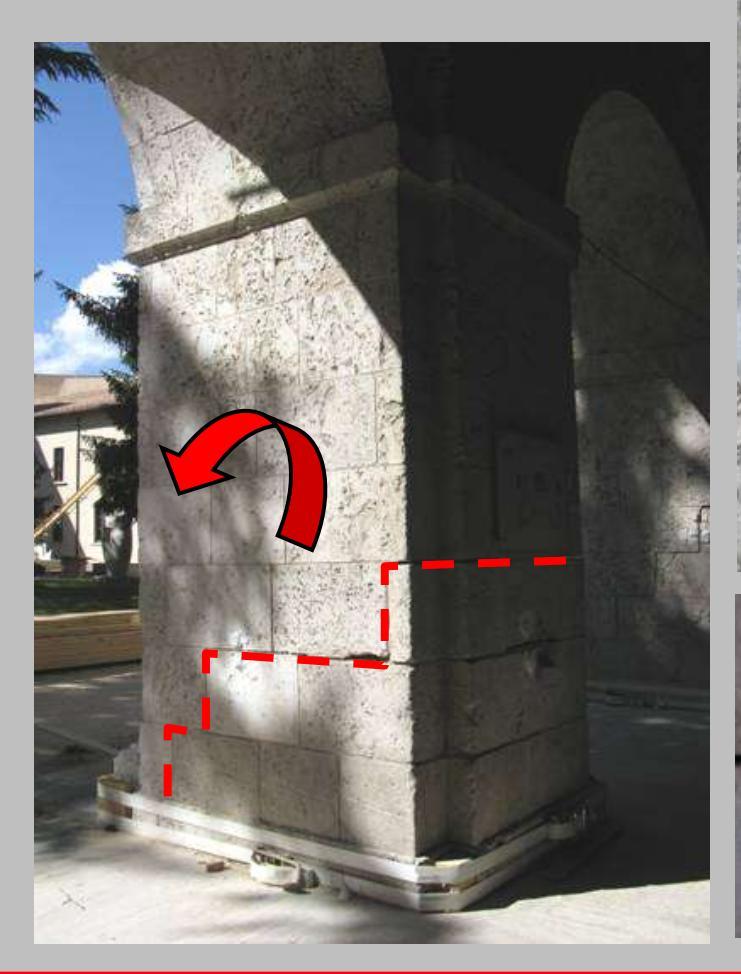
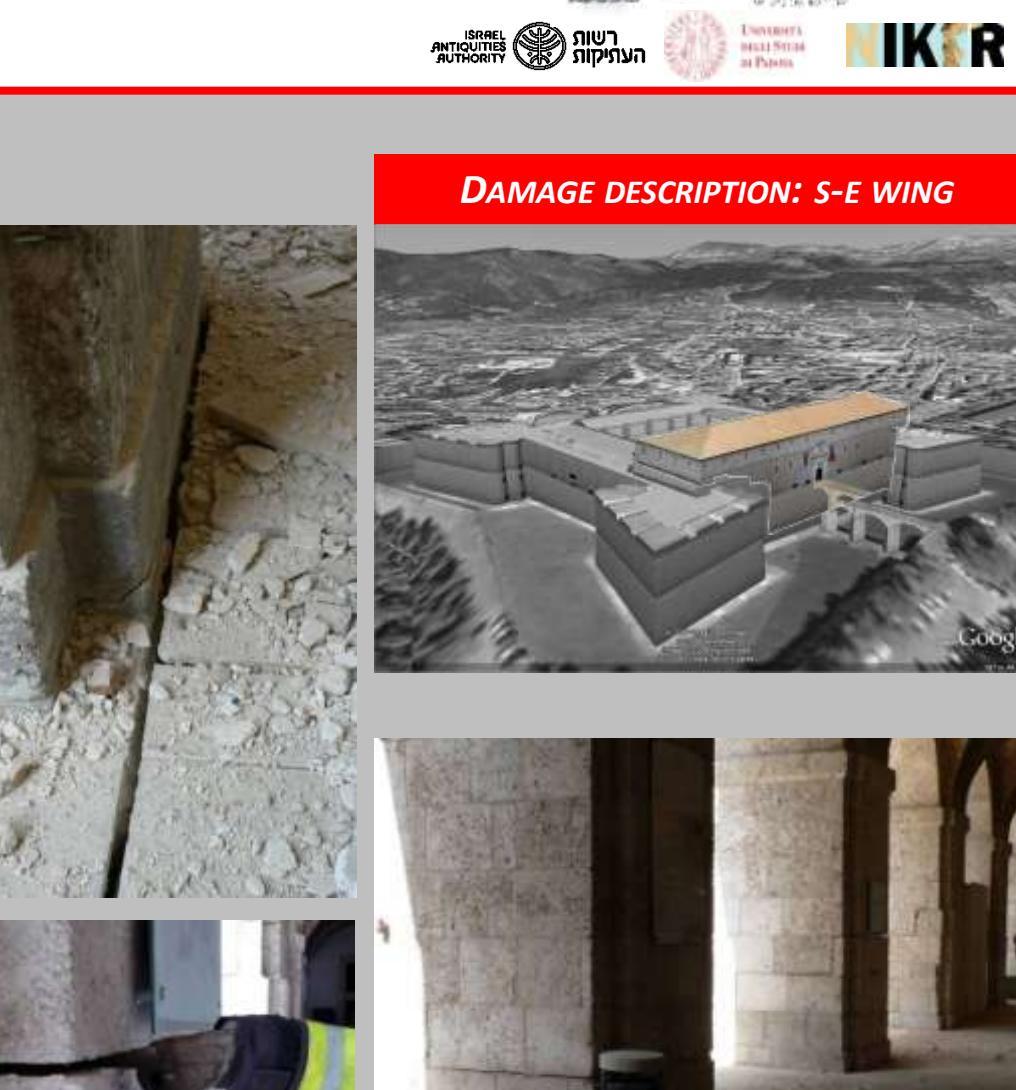
DAMAGE DESCRIPTION: S-E WING

MAIN OBSERVED DAMAGES:

- ➢ OVERTURNING MECHANISM OF PILLARS
- DAMAGES ON PILLARS DUE TO CRUSHING

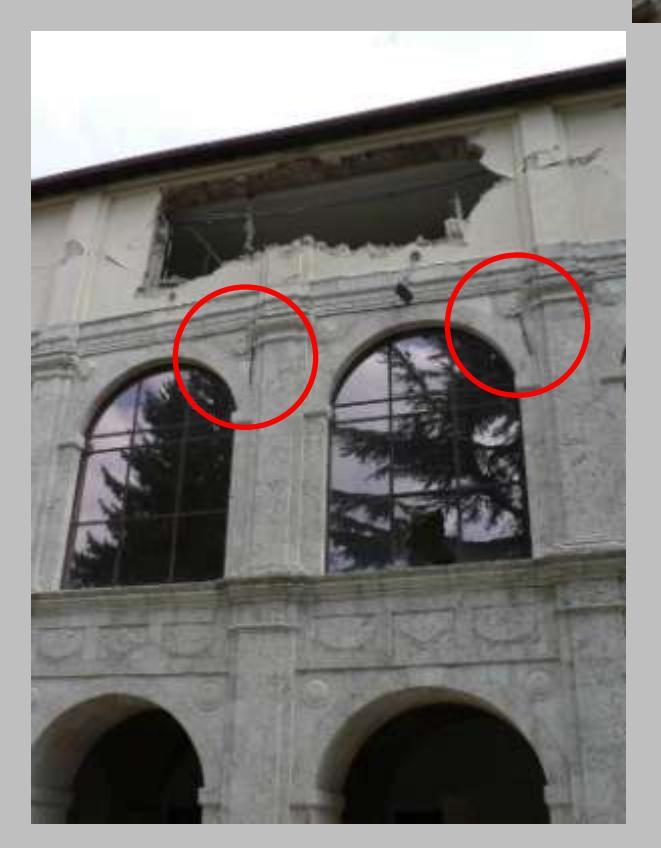
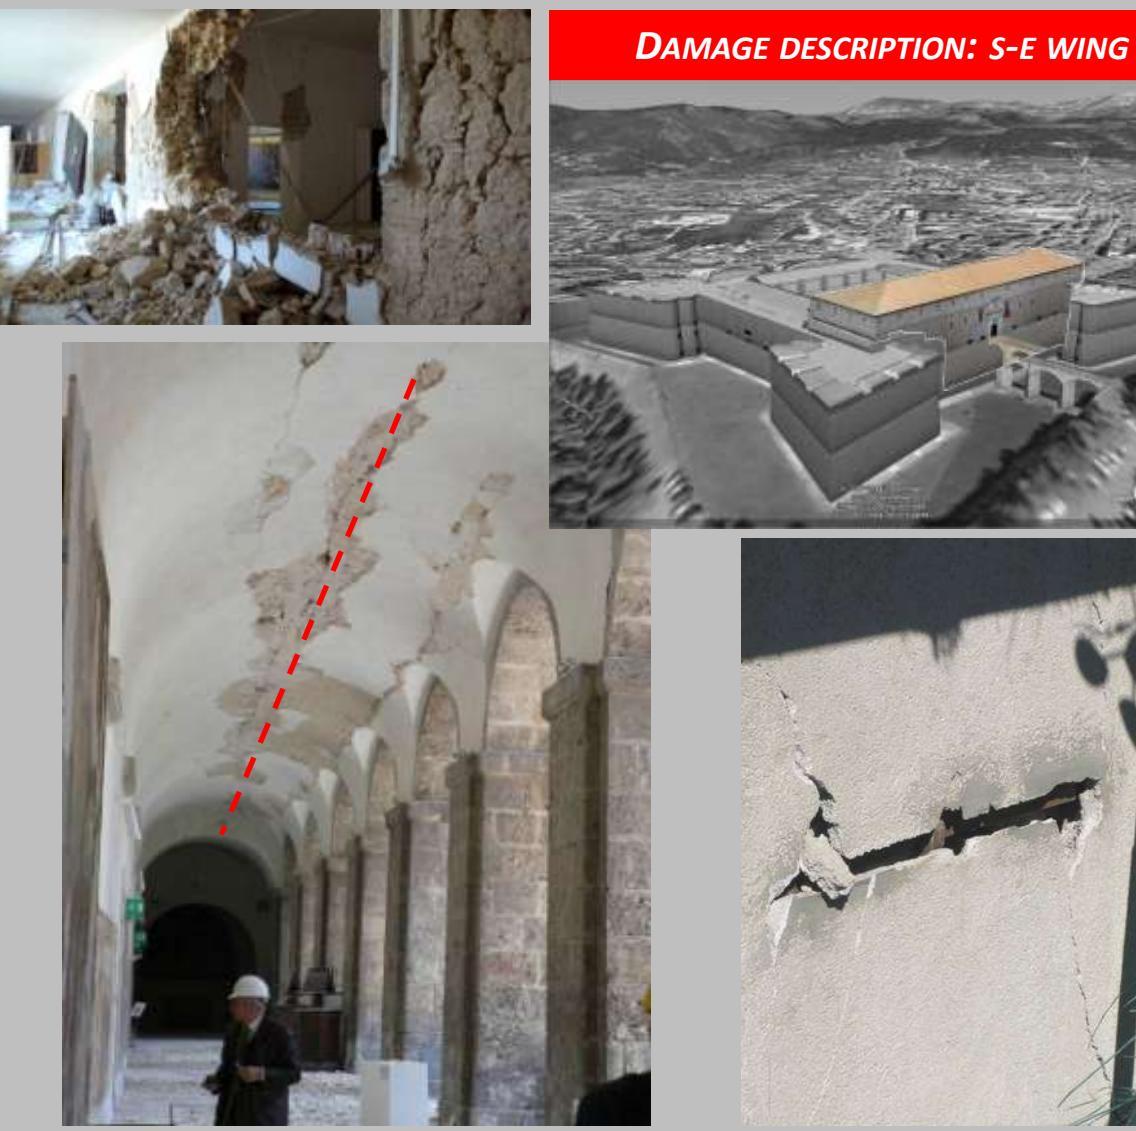
MAIN OBSERVED DAMAGES:

- LOCAL COLLAPSES OF THE LONGITUDINAL WALLS
- DAMAGE TO ARCHES AND VAULTS

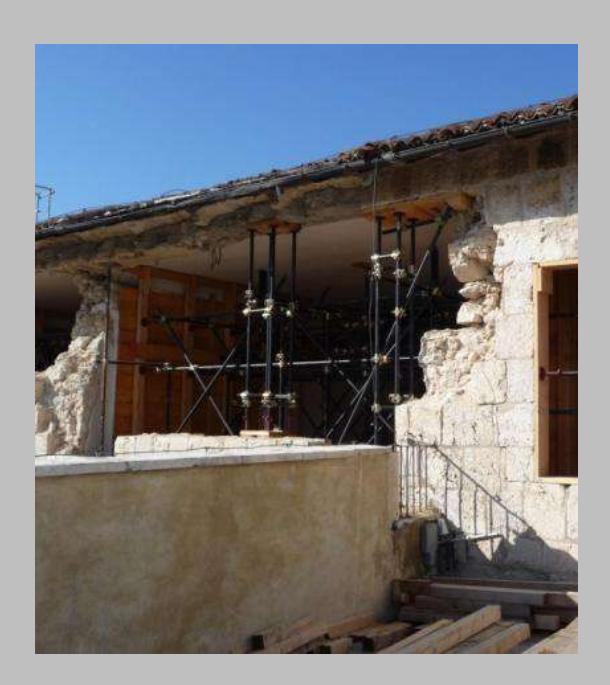
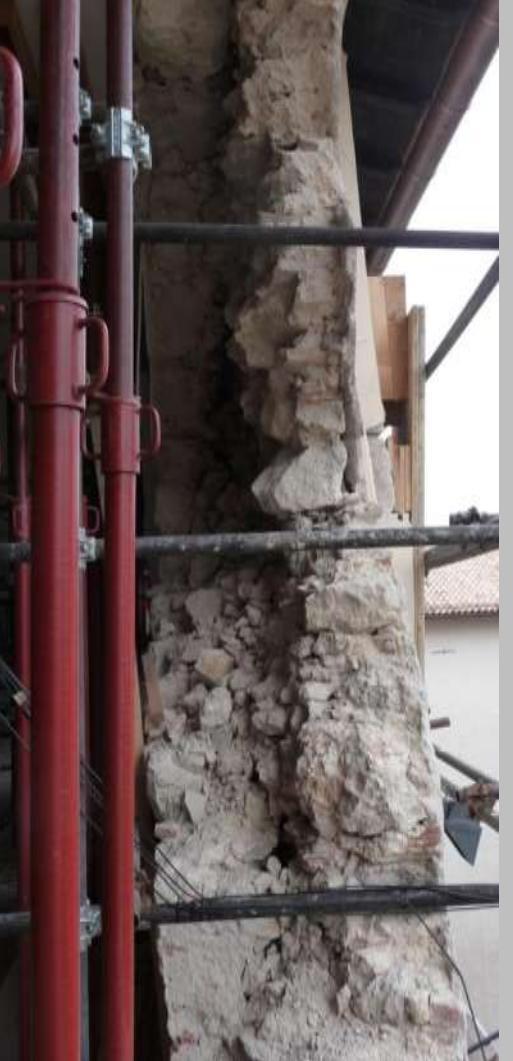
MAIN OBSERVED DAMAGES:

- OVERTURNING MECHANISM OF THE LONGITUDINAL WALLS
- DAMAGES ON VAULTS
- SHEAR CRACKS ON TRANSVERSE WALLS
- DETACHMENT OF FLOORS AND
 TRANSVERSE WALLS FROM THE
 LONGITUDINAL FACADES

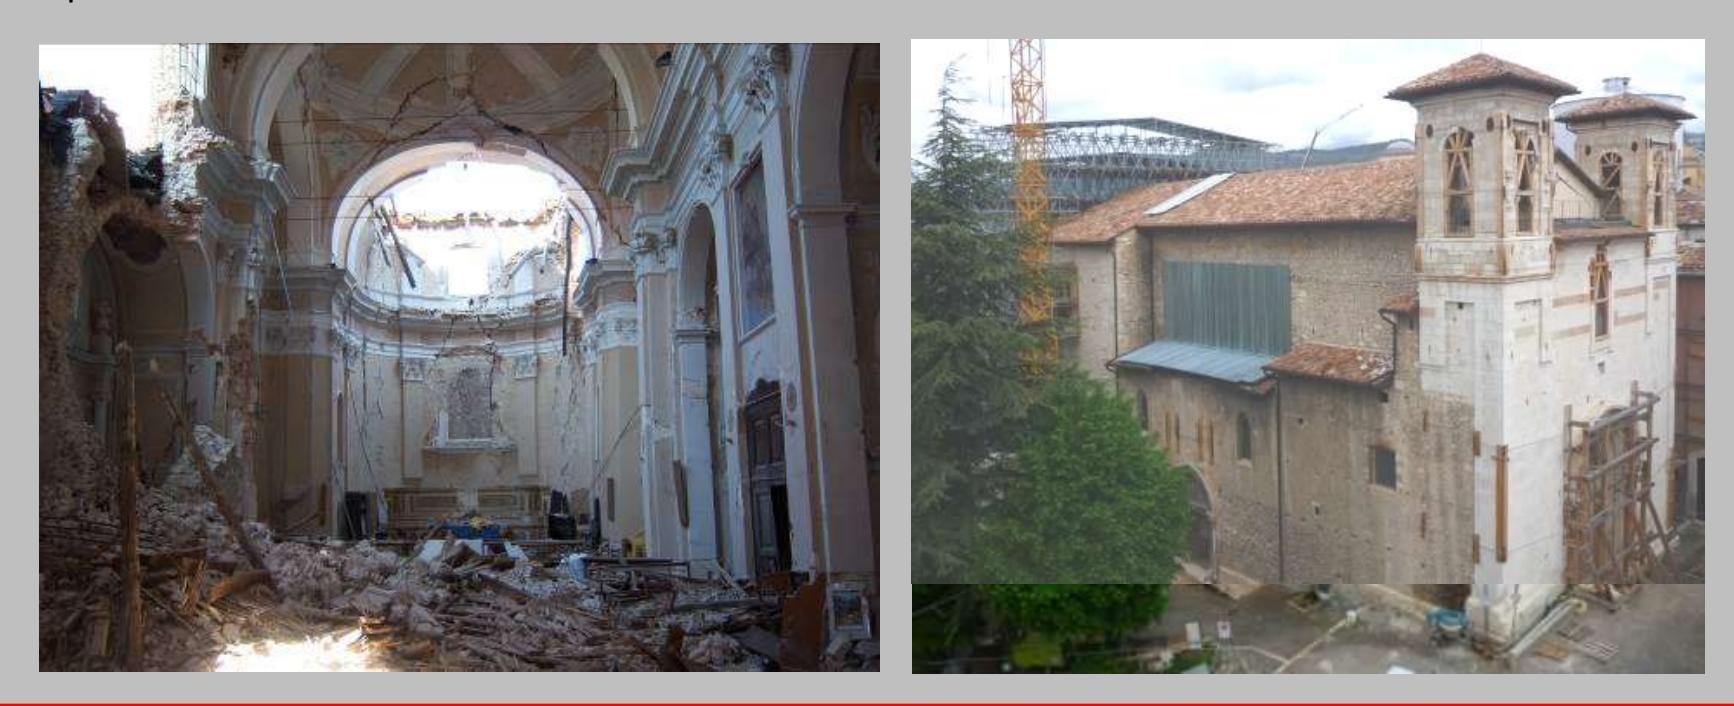
DAMAGE SURVEY

The church was severely damaged by the 6th of April 2009 earthquake.

After the earthquake the church reported severe damage in the apsidal and transept area, where a critical crack pattern was noticed in the external walls, which manifested a visible outward overturning, involving the four pillars sustaining the dome. Also the transversal response of the church proved to be inadequate, since the most part of the vaults collapsed, such as a big portion of the external wall, at the clerestory level. Severe damage was finally reported in the vaults of the apse, of the presbytery, in the triumphal arch.

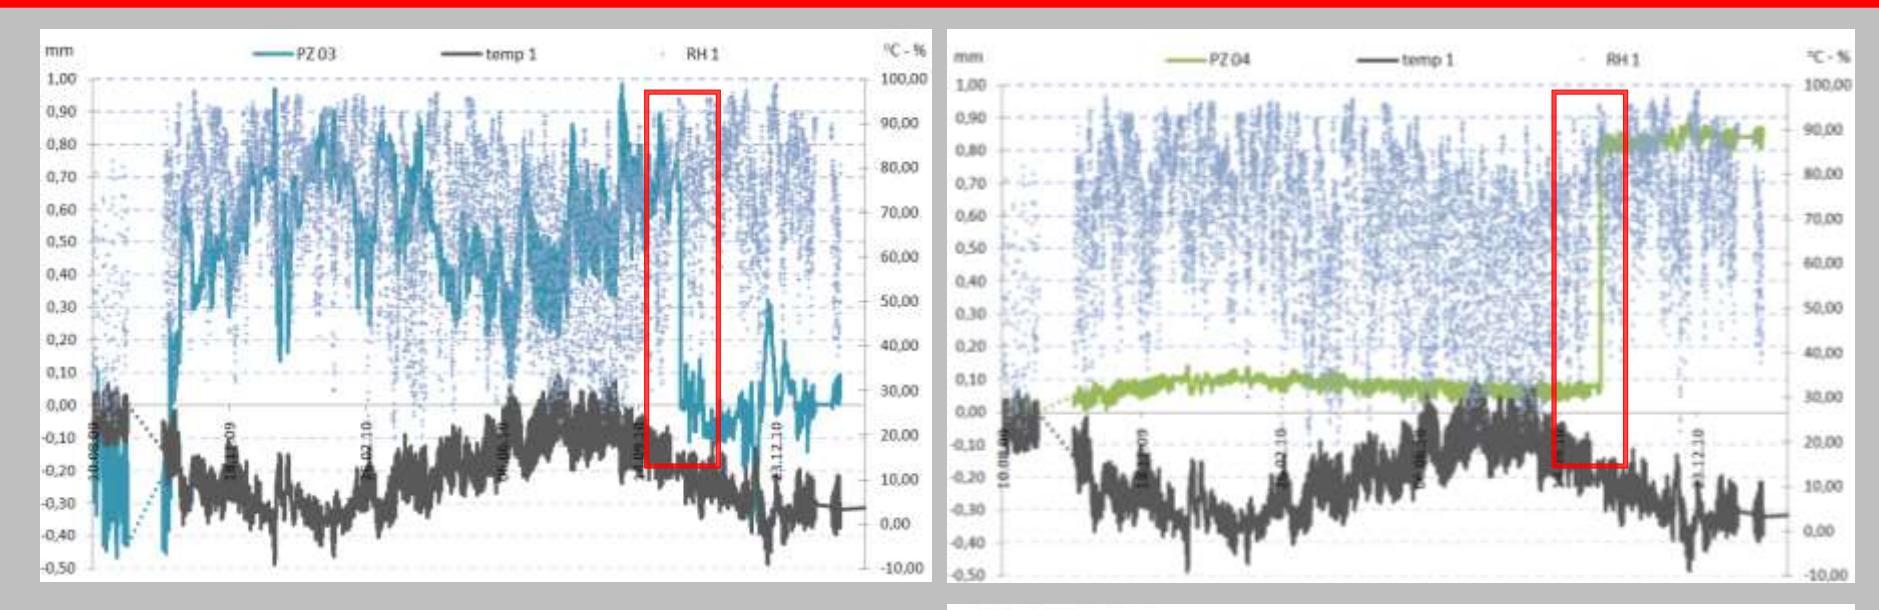
PZ 3 and PZ 4 (14.10.2010)

- same modulus ~ 0.80 mm
- opposite verse
- symmetric position in the apse
- no correlation with aftershocks

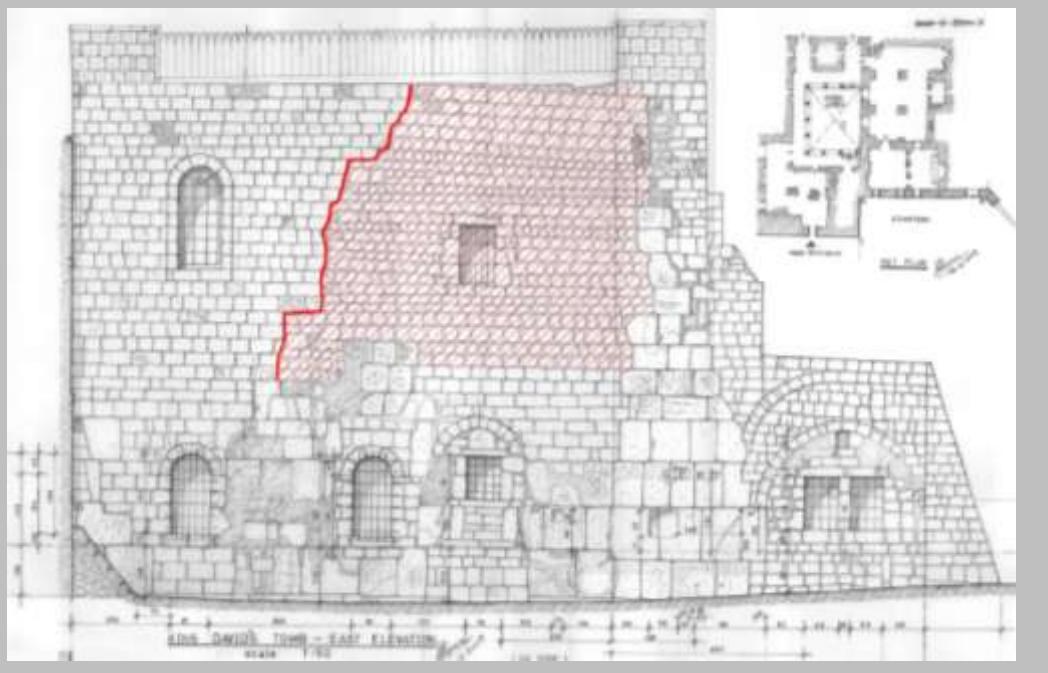
The limit analysis showed that the most vulnerable structural element in relation to the seismic risk is the eastern façade on the cemetery. The thrusts of the barrel vault on the ground floor and of the vault and cupola on the first floor are particularly high and induce to a precarious stability condition of the whole structural system. This is also testifies by the fact that most likely the façade has been reconstructed several times during centuries, since it is possible to recognize different kind of stone and different textures and arrangements of stones in the façade's elevation

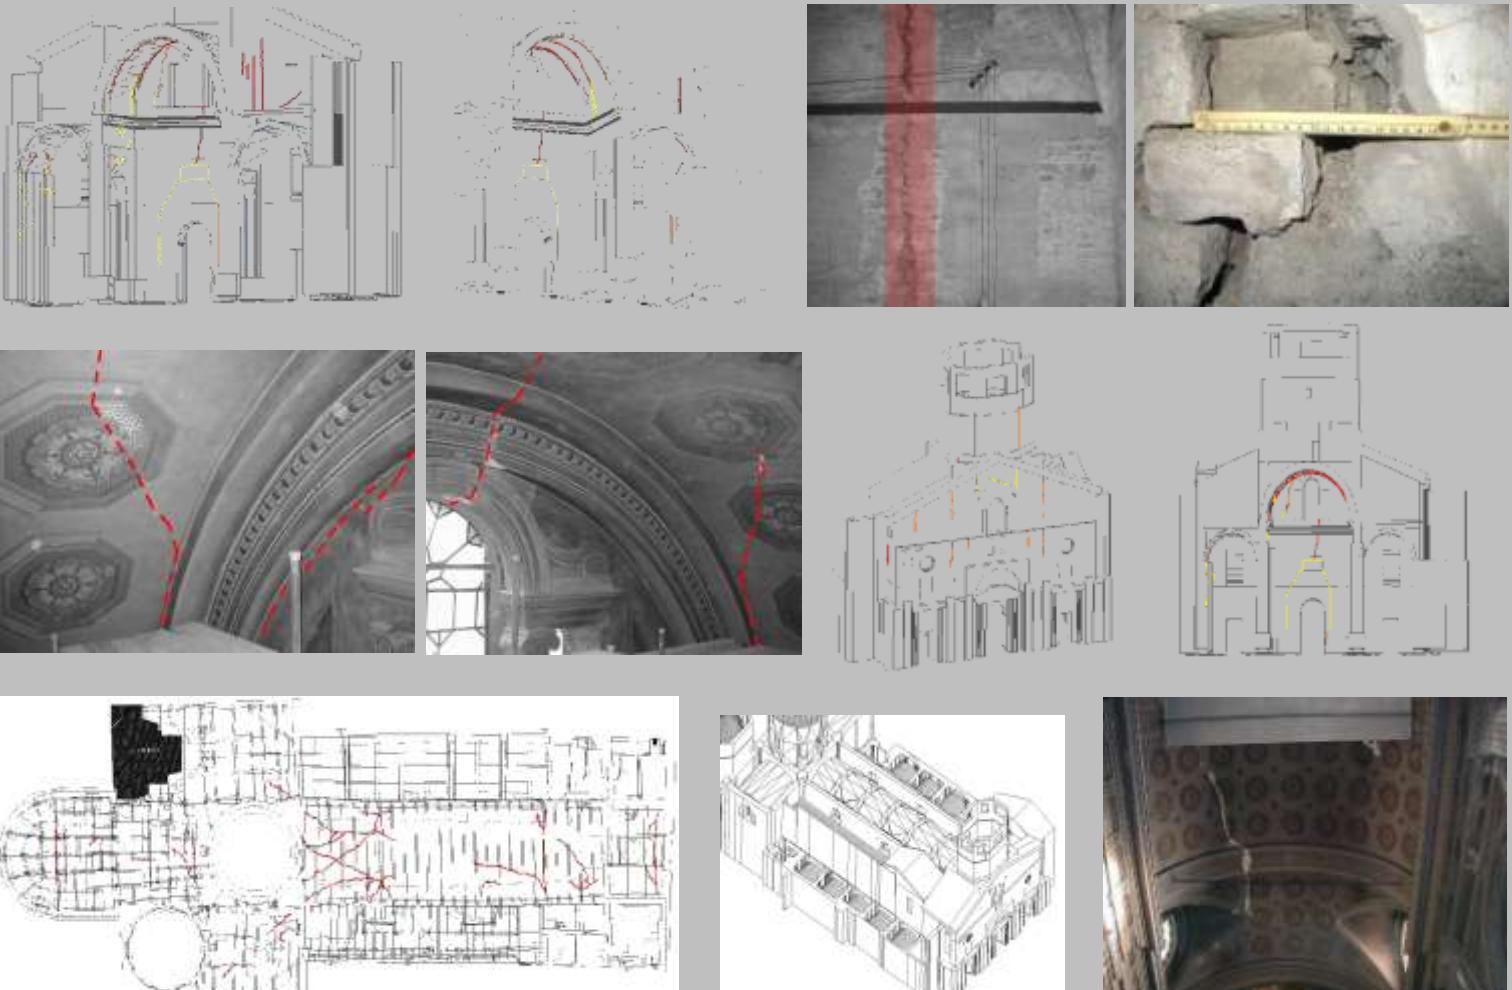
The **present damage pattern** shown by the Cathedral is highly indicative of the structural response of the building, and denounces the areas manifesting higher seismic vulnerability

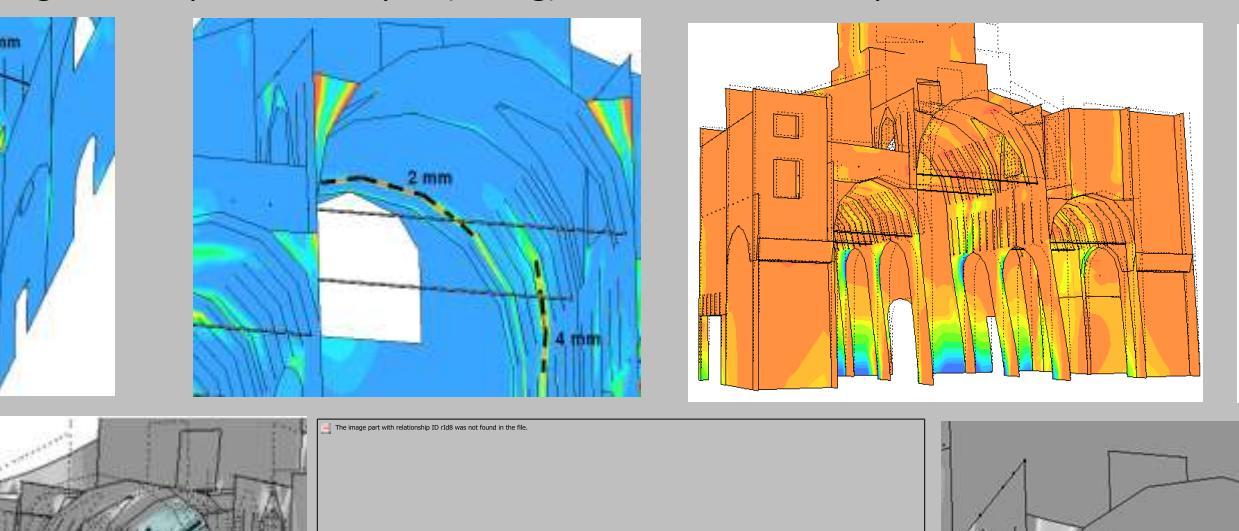
Cracks opening - last step of the analysis (0.26 g)

The **damage pattern predicted** by the analysis finds a remarkable correspondence with the **effective damage** denoted by the structures, in several positions:

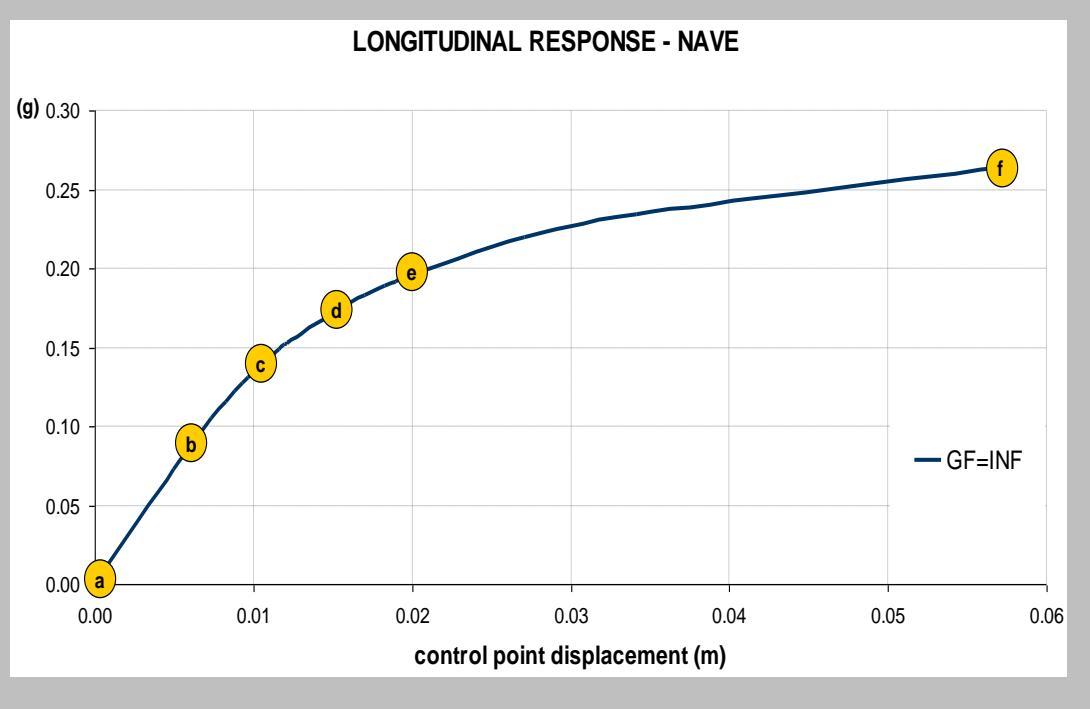
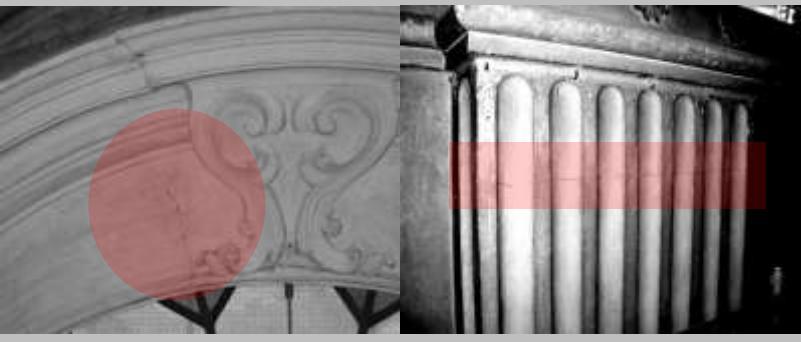
Model NL

The failure mode, following the application of growing horizontal loads, is determined by the overturning of the pillars

Damage identification – model prediction experimental verification
