PROTECTION AND PRESENTATION OF EXCAVATED STRUCTURES

John H. Stubbs World Monuments Fund, New York NY, USA

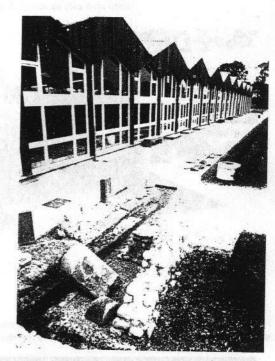
Plate 2b.
Clear span structure sheltering mosaic flooring and wall remains, Fishbourne.

The protective shelter at Fishbourne is a clear-span structure with window walls. Inside, an elevated walkway with carefully located footings allows visitor viewing from above (plate 2b). From the design and interpretation point of view, the complex is highly effective. Some problems, however, due to groundwater conditions are evident in parts of the sheltered remains. Rising damp is present in some of the most fragile archaeological fabric. The wooden thresholds and plasterwork were not re-set in impervious setting beds, as were the mosaics, leaving them vulnerable to rising damp. Moisture in these elements is evident from the tell-tale presence of biological growth. In this case, lowering the groundwater table through the installation of dry wells or similar means may not be the preferred solution because of the differential settlement potential for the foundations of the new structures. The present moisture problem at Fishbourne is relatively minor compared to the many successes, though it does underscore the issue that archaeological ruins, even if presented in carefully controlled interior environments, are not always exempt from deterioration problems.
