INVESTIGATION TECHNIQUES - MONITORING: THE CASE OF THE DAVID TOWER

Speaker: Dr. Eng. Filippo Lorenzoni

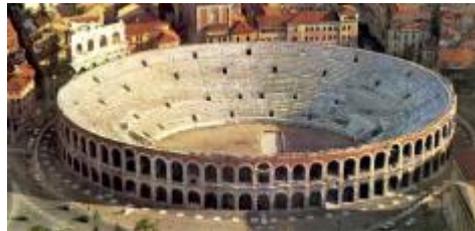
ARENA OF VERONA (VR)	
INSTALLATION PERIOD	December 2011
SHM TYPOLOGY	Static/Dynamic system
PURPOSE OF MONITORING	Alternative to the execution of interventions

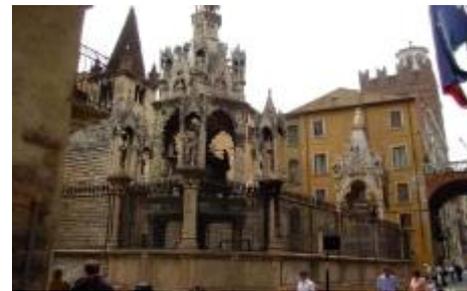
CANSIGNORIO STONE TOMB (VR)	
INSTALLATION PERIOD	December 2006
SHM TYPOLOGY	Static/Dynamic system
PURPOSE OF MONITORING	Structural controls before, during and after interventions

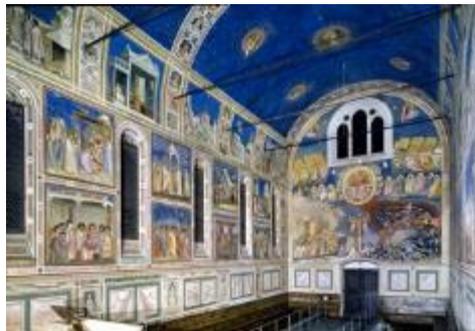
SCROVEGNI CHAPEL (PD)	
INSTALLATION PERIOD	October 2013
SHM TYPOLOGY	Static/Dynamic system
PURPOSE OF MONITORING	Vulnerability assessment/state of damage control

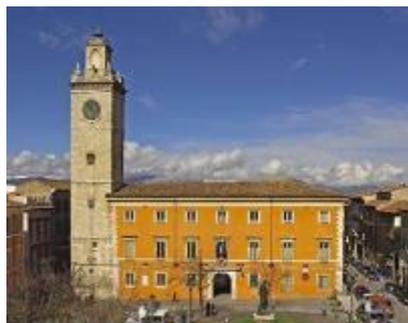
CIVIC TOWER (AQ)	
INSTALLATION PERIOD	July 2010
SHM TYPOLOGY	Static/Dynamic system
PURPOSE OF MONITORING	Post-earthquake controls

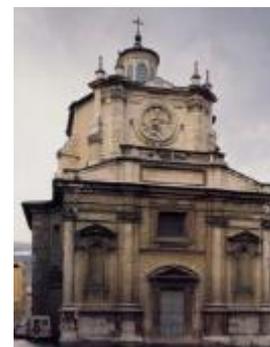
S. AGOSTINO CHURCH (AQ)	
INSTALLATION PERIOD	July 2010
SHM TYPOLOGY	Static/Dynamic system
PURPOSE OF MONITORING	Post-earthquake controls

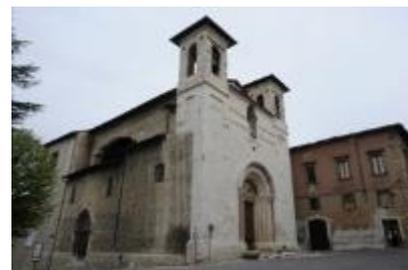
S. MARCO CHURCH (AQ)	
INSTALLATION PERIOD	August 2009
SHM TYPOLOGY	Static/Dynamic system
PURPOSE OF MONITORING	Post-earthquake controls

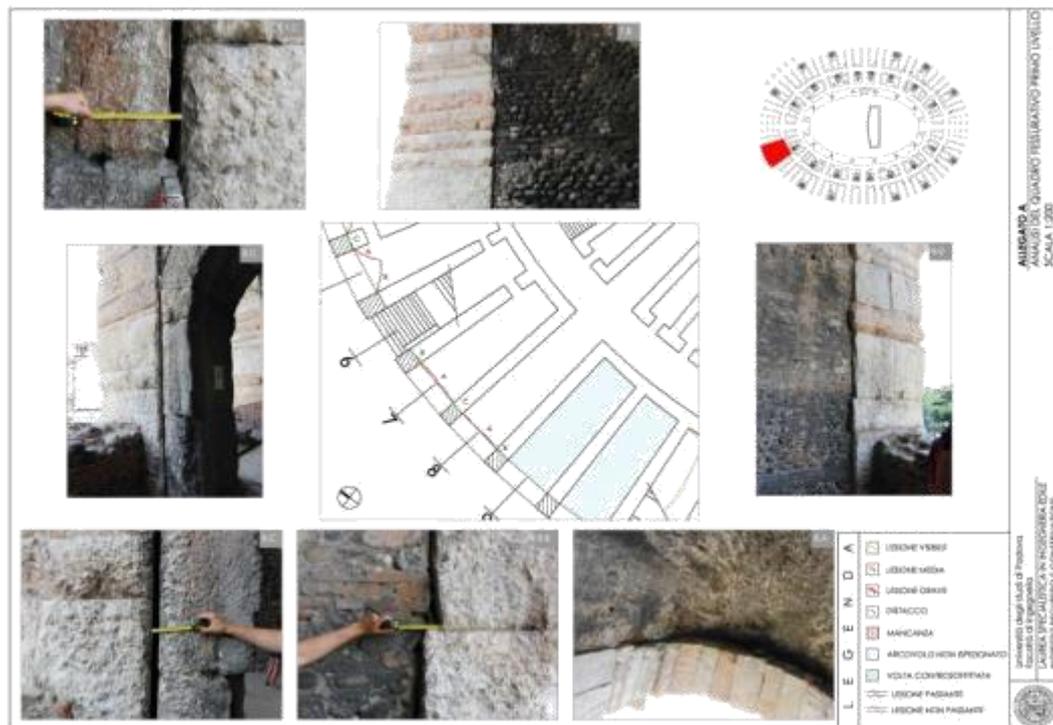
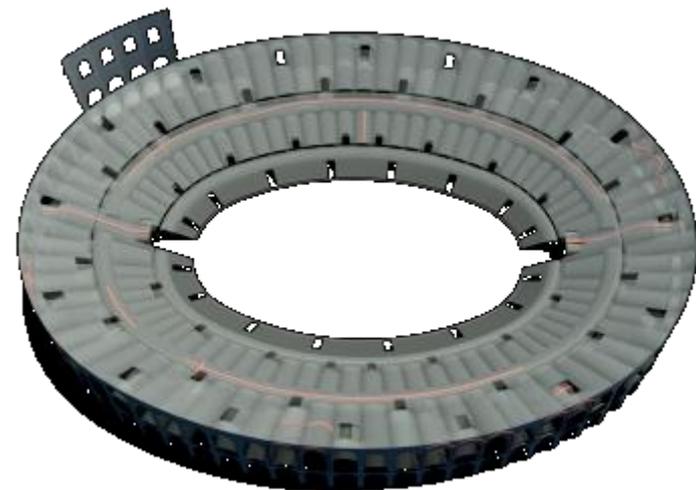
a. VISUAL INSPECTIONS - CRACK PATTERN SURVEY:

- Choose the optimal position of static sensors
- Identify principal damage and crack patterns
- Control local cracks or entire macroelements

MAIN STRUCTURAL PROBLEMS:

- Inner gallery's barrel vault
- Vaulted niches at the 1st level ('arcovoli')
- Outer leaf of the perimeter stone wall
- The 'wing': most vulnerable structural element

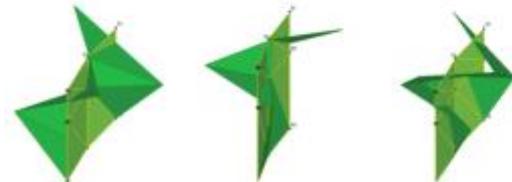
MODE 5 - 7,30 Hz MODE 6 - 9,30 Hz MODE 7 - 10,94 Hz

MO DE	AVT - Oct 2011			MAC	FVT - 1996		AVT vs. FVT	
	FDD	EFDD			f [Hz]	ξ [%]	Average error [%]	
	f [Hz]	f [Hz]	ξ [%]				f	ξ
1	1,93	1,92	1,36	1	1,92	1,4	0	2,94
2	2,64	2,65	1,12	0,99	2,61	1,3	1,51	16,07
3	5,08	5,08	1,07	0,99	4,83	1,8	4,92	68,22
4	5,88	5,98	3,86	0,99	5,87	6,9	1,84	78,76
5	7,30	7,29	2,07	0,99	7,10	2,3	2,61	11,11
6	9,30	9,30	0,43	0,99	8,62	1,1	7,31	155,81
7	10,94	10,92	1,06	0,99	10,65	2,6	2,47	145,28

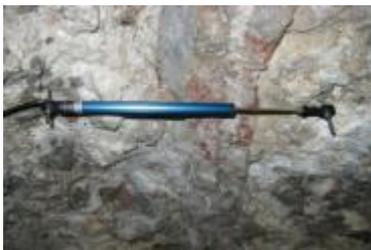
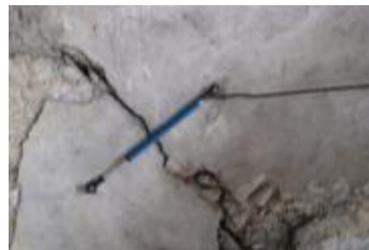
4 TEMPERATURE/RH

VOLTAGE: 0÷10 V
PRECISION: +/- 2 % RH
 +/- 0.2 °C
MEASUREMENT RANGE: 0÷100% RH
- 20/0÷50 °C

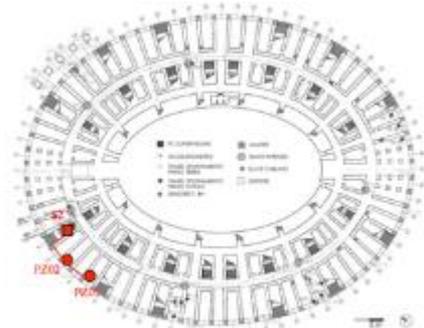
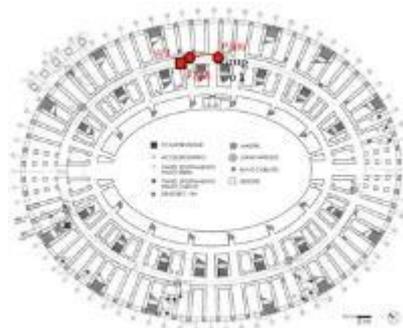
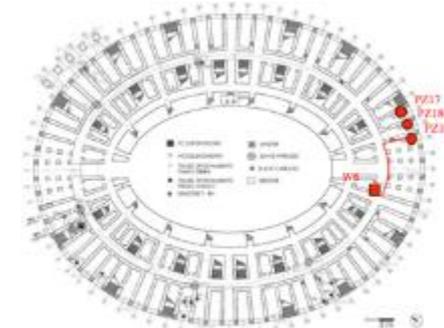
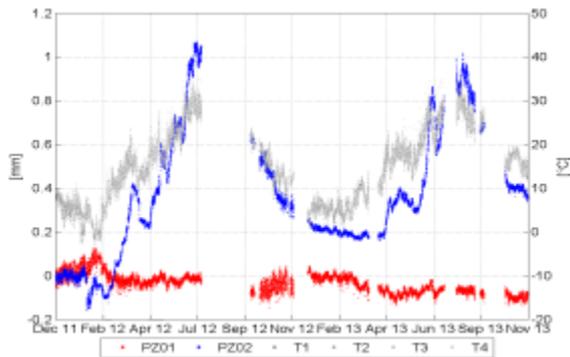
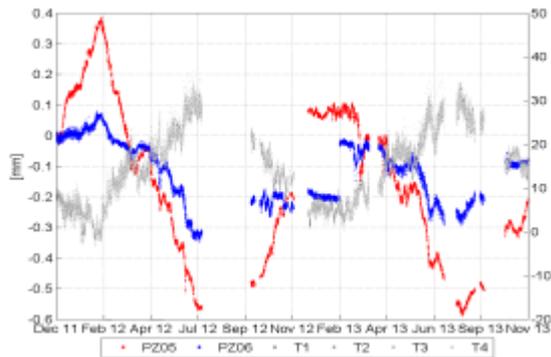
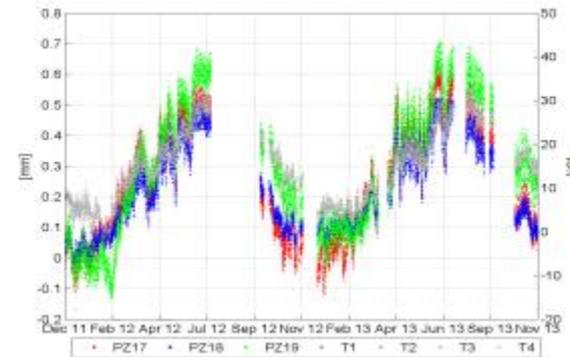
ARENA OF VERONA: STATIC MONITORING RESULTS (2 YEARS)

CRACK OPENING VS. TIME

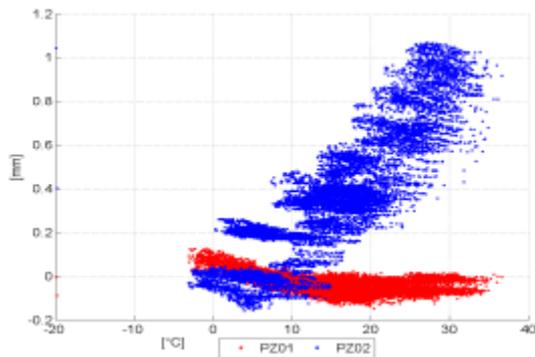
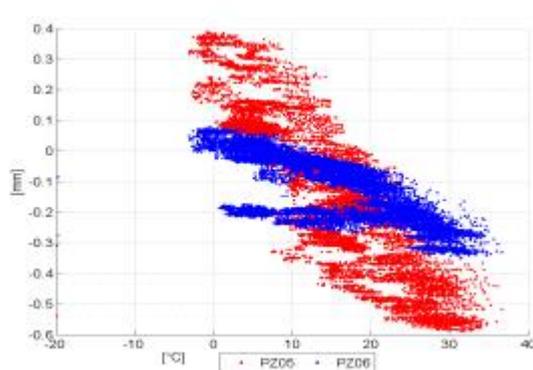
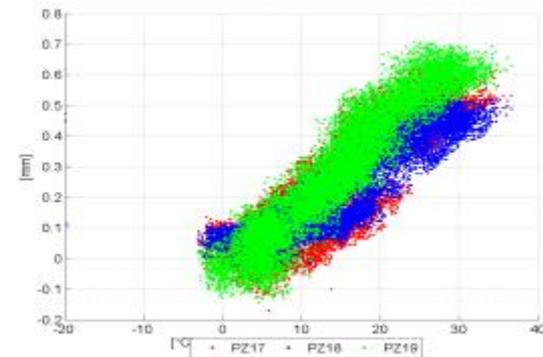
CRACK OPENING VS. TEMPERATURE

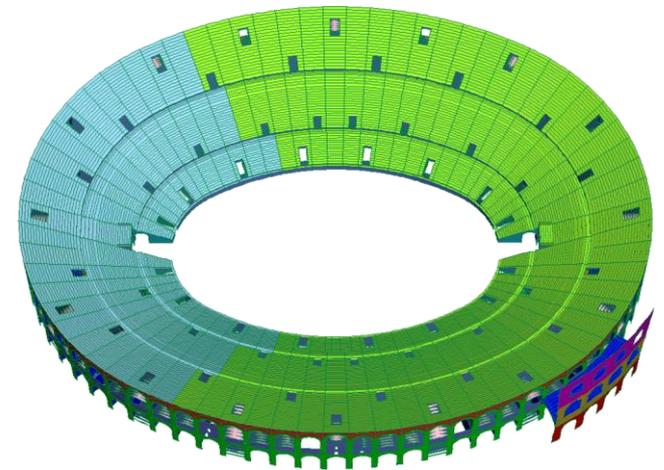
- Model driven approach → exploit SHM and dynamic identification results to calibrate and validate reference numerical models
- Implementation of modal matching procedures
- Model updating targets: material properties, geometry, morphology, connections, boundary conditions, soil-structure interaction, damage distribution, ect.

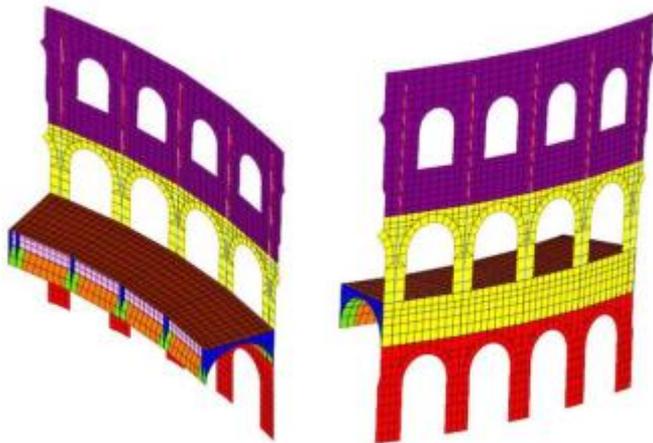
FE MODEL OF THE ARENA'S WING

CALIBRATION PROCEDURE

- Identification of morphology and materials
- Definition of initial values of elastic mechanical properties
- Iterative variation of mechanical properties/boundary conditions within a predefined range until reaching the final calibration

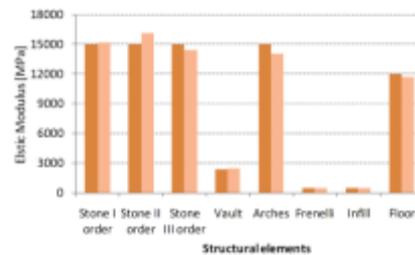
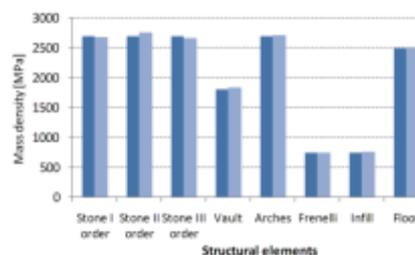
NUMERICAL MODE SHAPES

Structural element	ELASTIC MODULUS [MPa]			MASS DENSITY [kg/m ³]		
	Initial	Final	Diff. [%]	Initial	Final	Diff. [%]
Stone I order	15000	15223	1.49	2700	2687	-0.48
Stone II order	15000	16174	7.82	2700	2752	1.92
Stone III order	15000	14443	-3.71	2700	2658	-1.56
Vault	2400	2479	3.27	1800	1830	1.64
Arches	15000	14096	-6.03	2700	2703	0.12
Frenelli	500	477	-4.63	750	750	-0.04
Infill	500	483	-3.48	750	757	0.92
Stone floor	12000	11723	-2.31	2500	2509	0.36

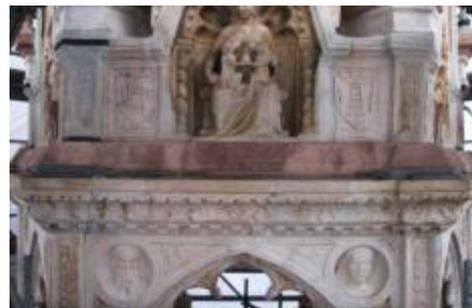
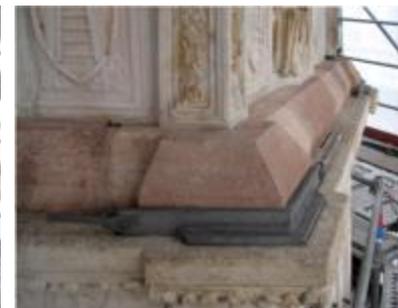
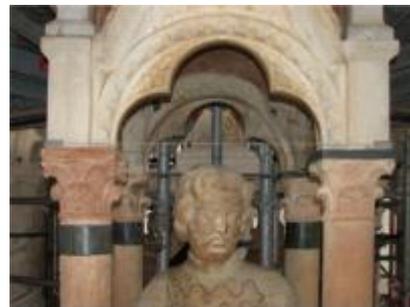
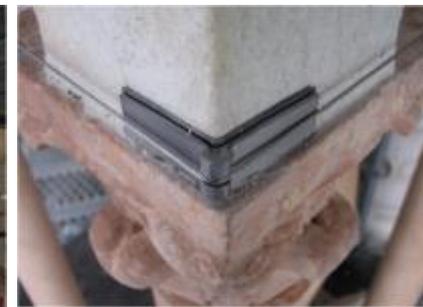
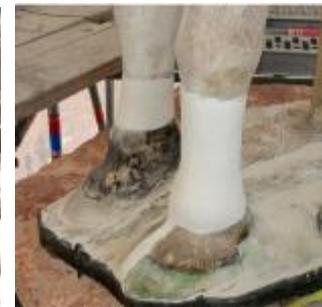
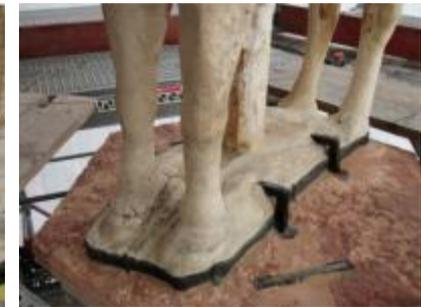
CANSIGNORIO STONE TOMB : STRENGTHENING INTERVENTION (2006-2008)

LOCAL AND GLOBAL INTERVENTIONS

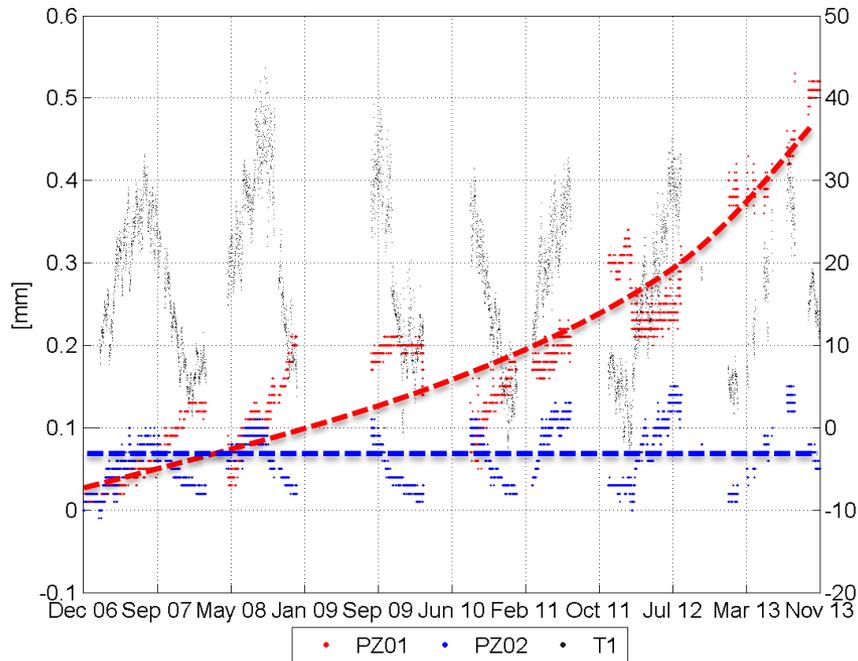
CRACK OPENING VS. TIME

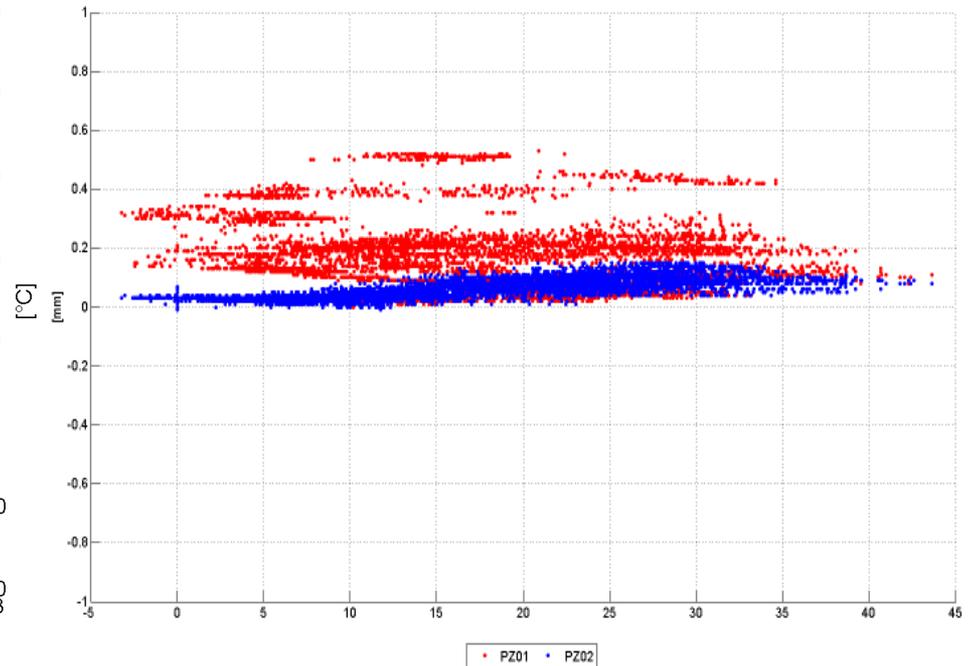
CRACK OPENING VS. TEMPERATURE

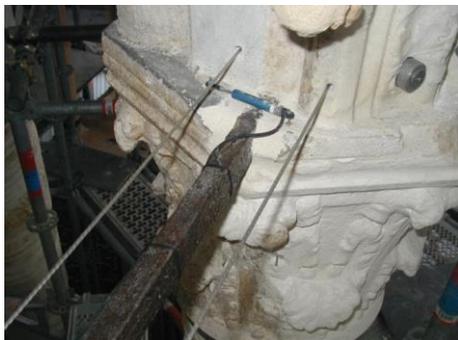
PZ 01

Presence of an active deterioration/damaging process

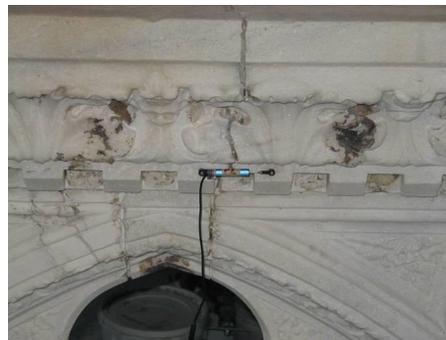
PZ 02

Reversible deformations of the crack strictly related to seasonal thermal cycles.
No active damage

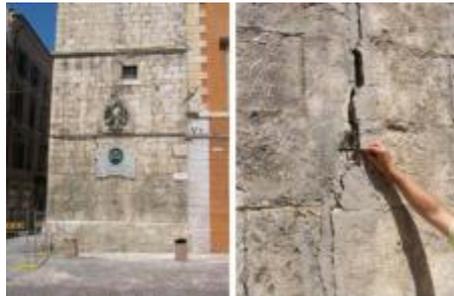
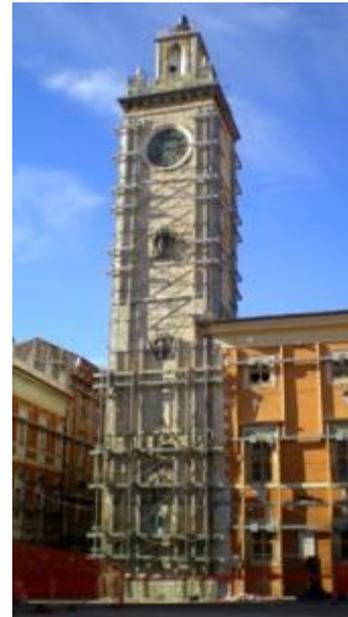
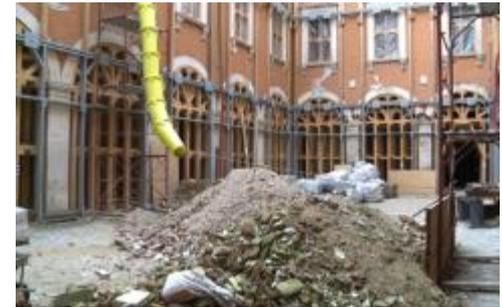
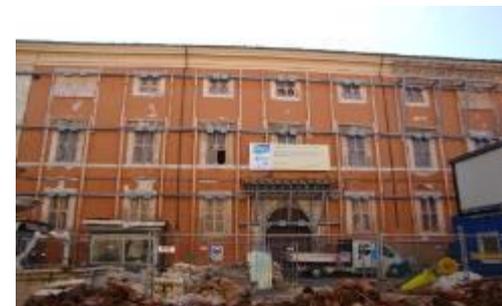
- West façade: vertical cracks
- East and South façades: cracks at the bottom of the tower due to stress concentrations
- South façade: failure of an existing tie
- Detachment of the tower from the Palace

- Confinement system of the tower (steel beams, ties and timber frames)
- Improvement of the tower-palace connection
- Propping system of the palace's perimeter walls to prevent out-of-plane overturning

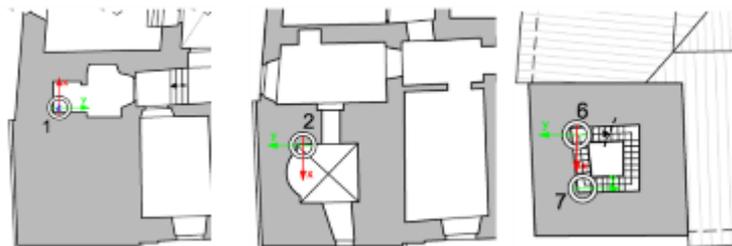
DYNAMIC SYSTEM

8 SINGLE-AXIS ACCELEROMETERS

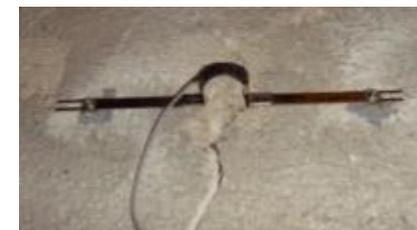
- 5 DISPLACEMENT TRANSDUCERS
- 6 STRAIN GAUGES
- 1 INCLINOMETER

- 6 THERMO COUPLES

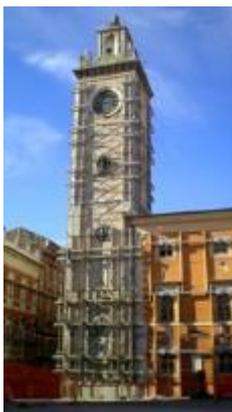
During the first 1,5 years of monitoring the crack pattern of the tower was kept rather stable

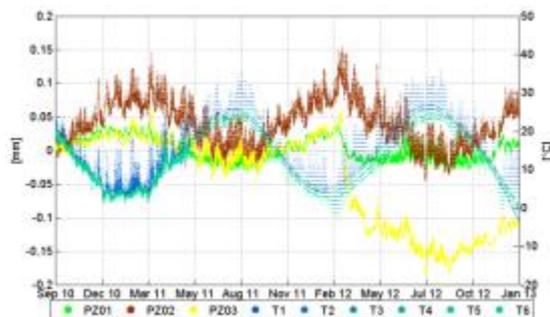
Starting from February 2012 the equilibrium conditions of the tower underwent a significant change due to a slight rotation/displacement of the tower toward the palace

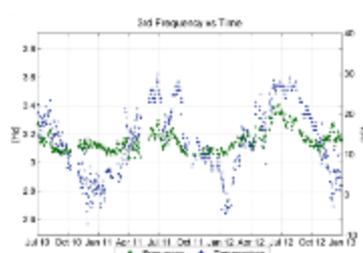
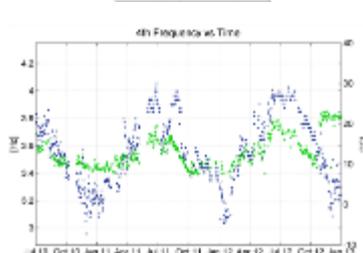
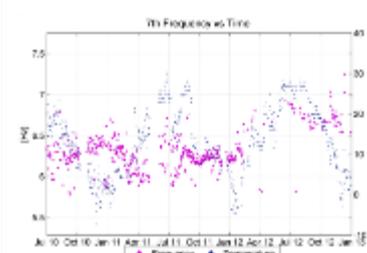
RESIDUAL ANALYSIS AND DAMAGE DETECTION

MODE 1: 1st bending E-W

- Until Feb 2012 → damage is stable since the residuals are always included within confidence intervals
- From Feb 2012 → the equilibrium condition of the tower changed due to a displacement of the tower
- It was possible to detect damage/modification of the structural layout demonstrated by an increment of frequencies

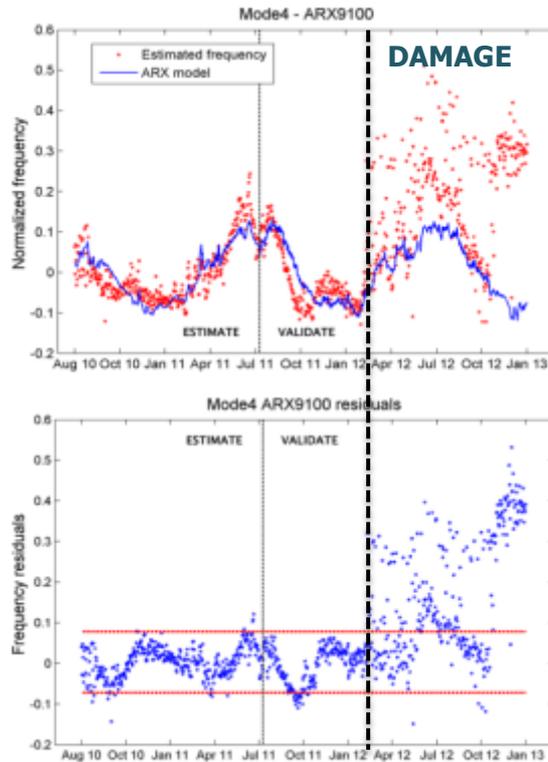
MODE 4: 2nd bending E-W

- Until Feb 2012 → damage is stable since the residuals are always included within confidence intervals
- From Feb 2012 → the equilibrium condition of the tower changed due to a displacement of the tower
- It was possible to detect damage/modification of the structural layout demonstrated by an increment of frequencies

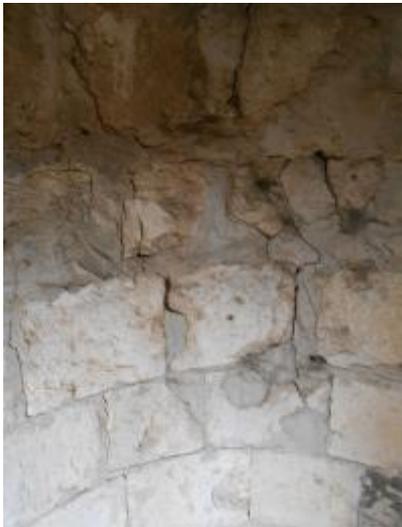
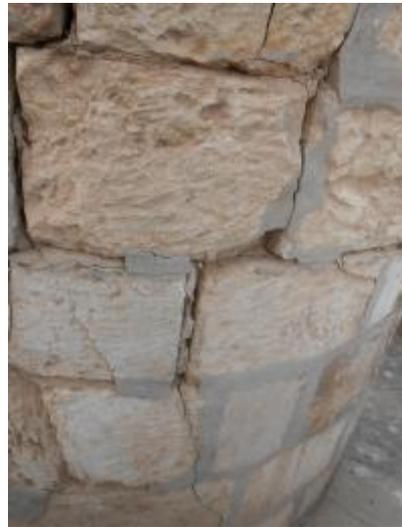
VISUAL INSPECTIONS - CRACK PATTERN SURVEY:

- Choose the optimal position of static sensors
- Identify principal damage and crack patterns
- Control local cracks or entire macroelements

MAIN STRUCTURAL PROBLEMS:

- Severe damages and cracks on the top of the minaret
- Cracks at the basement of the tower

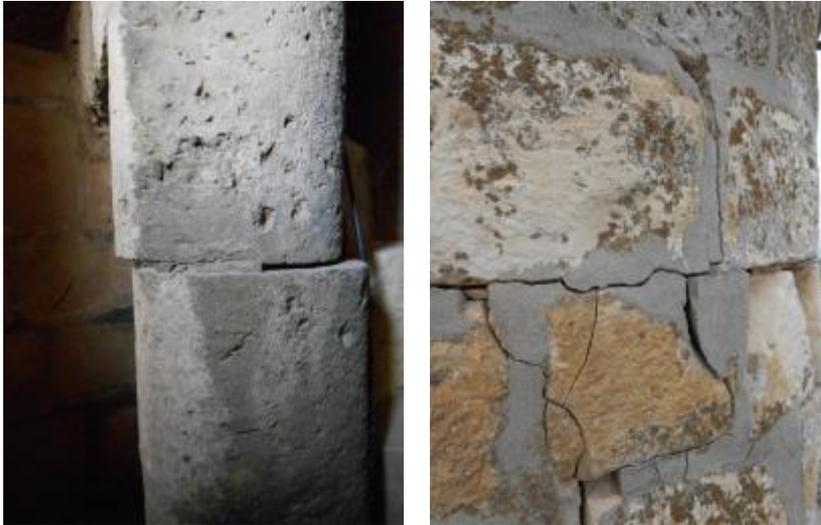
VISUAL INSPECTIONS - CRACK PATTERN SURVEY:

- Choose the optimal position of static sensors
- Identify principal damage and crack patterns
- Control local cracks or entire macroelements

MAIN STRUCTURAL PROBLEMS:

- Severe damages and cracks on the top of the minaret
- Cracks at the basement of the tower

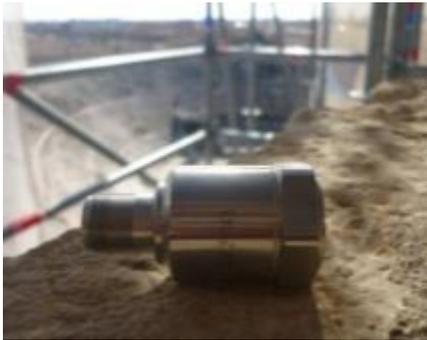
DYNAMIC

● 8 Single-axis piezoelectric accelerometers

Resolution (da 10,000 Hz): 0.00008 m/s²

Working temperature: -45÷82 °C

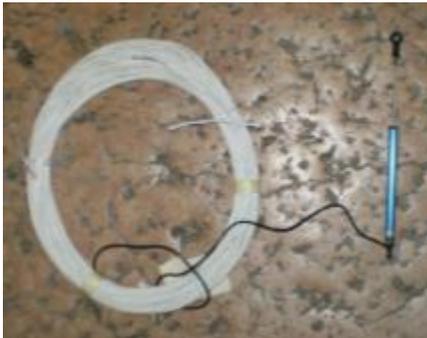
STATIC

● 6 Displacement transducers

Hysteresis: < 0.01 mm

Working temperature: -30÷100 °C

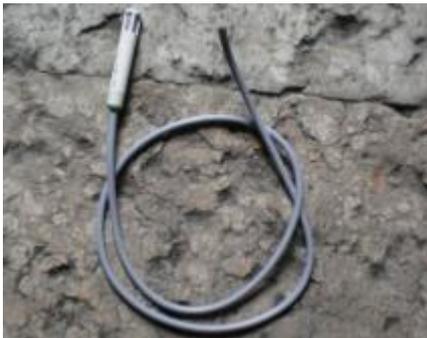
ENVIRONMENTAL

● 1 Integrated sensor temperature and relative humidity

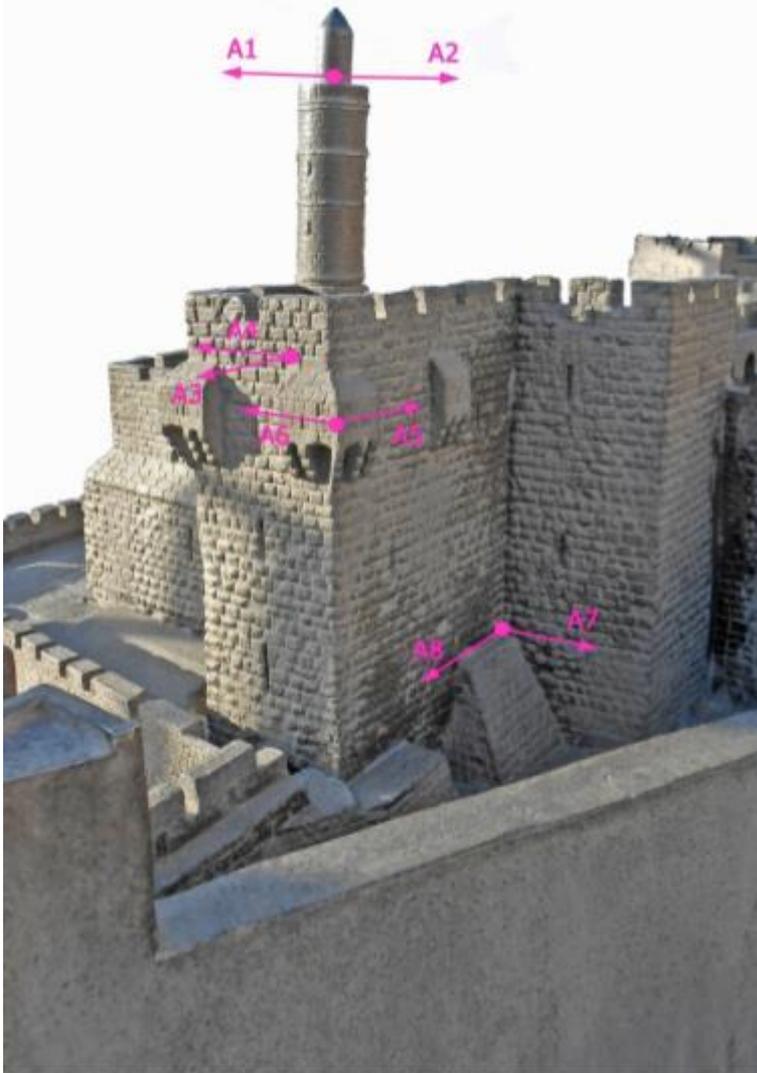
DYNAMIC SYSTEM

Dynamic data are being collected both at **fixed time intervals** (“long” acquisition, corresponding to 131’072 points, or to 21’51” of record at a sampling frequency of 100 SPS, each 12 hours) to allow successive dynamic identification of the structure with different environmental conditions, and on a **trigger basis** (shorter records, 3’35” at a sampling frequency of 100 SPS), when the signal, on one of the acceleration channels, gets over the predefined threshold

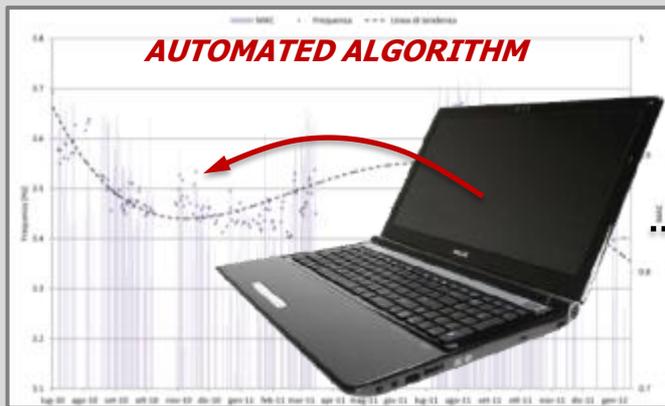
AUTOMATED ALGORITHM

AUTOMATED DATA PROCESSING

AUTOMATIC SUBROUTINE (NO USER-INTERACTION)

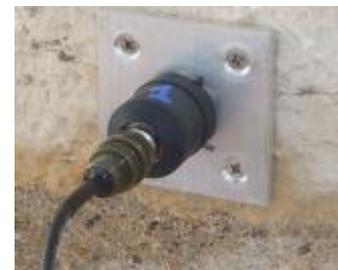
- Identification of the dynamic behaviour of the Tower
- Exploitation of the results for model updating
- Comparison of results using different OMA techniques
- SF 100 Hz; 131'072 points; record length: 21'51" sec
- System identification: decimation; segment length 2048 points, 66.67% overlap; selected methods: FDD and EFDD

Example of recorded time history
