## *Saving the Stones III*

### **The Work on Two Column Bases at the ICC Building, Old Akko**

## **Abstract**

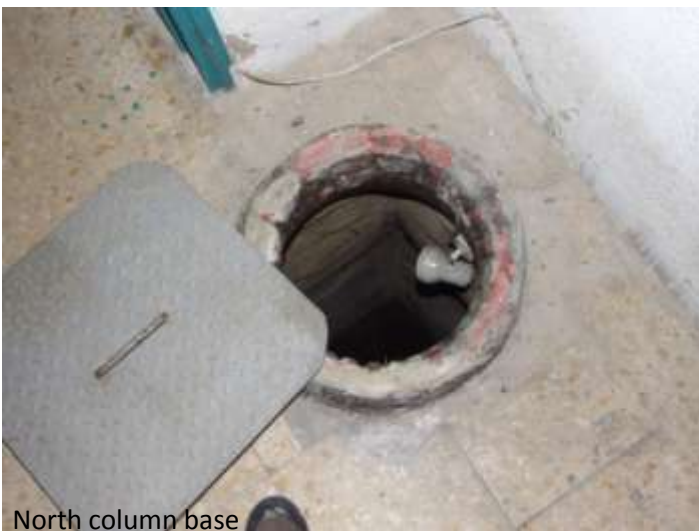
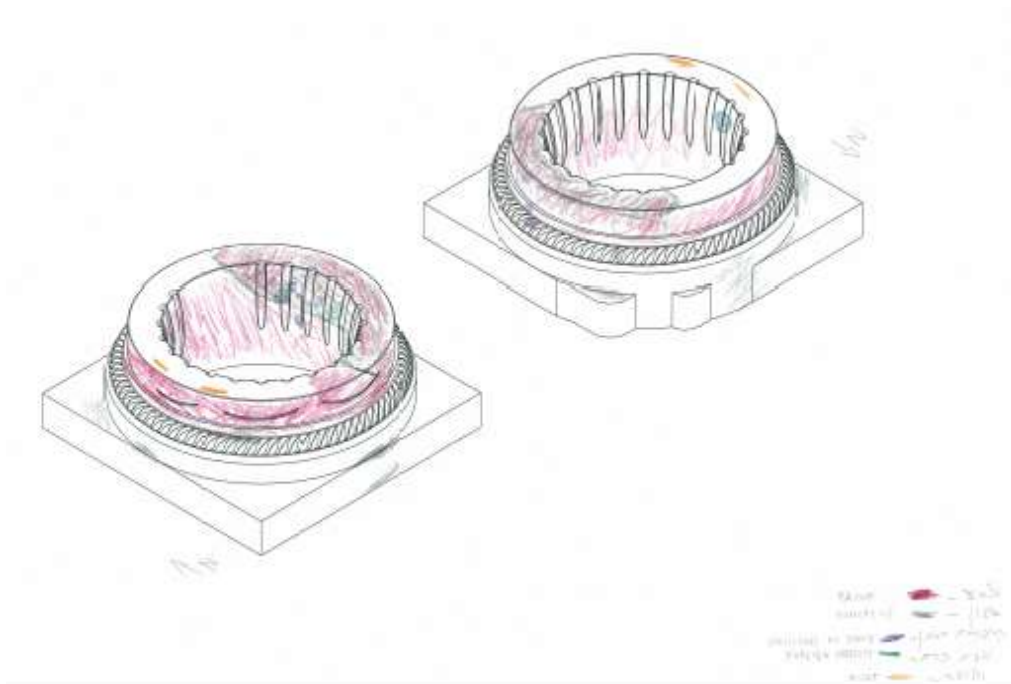
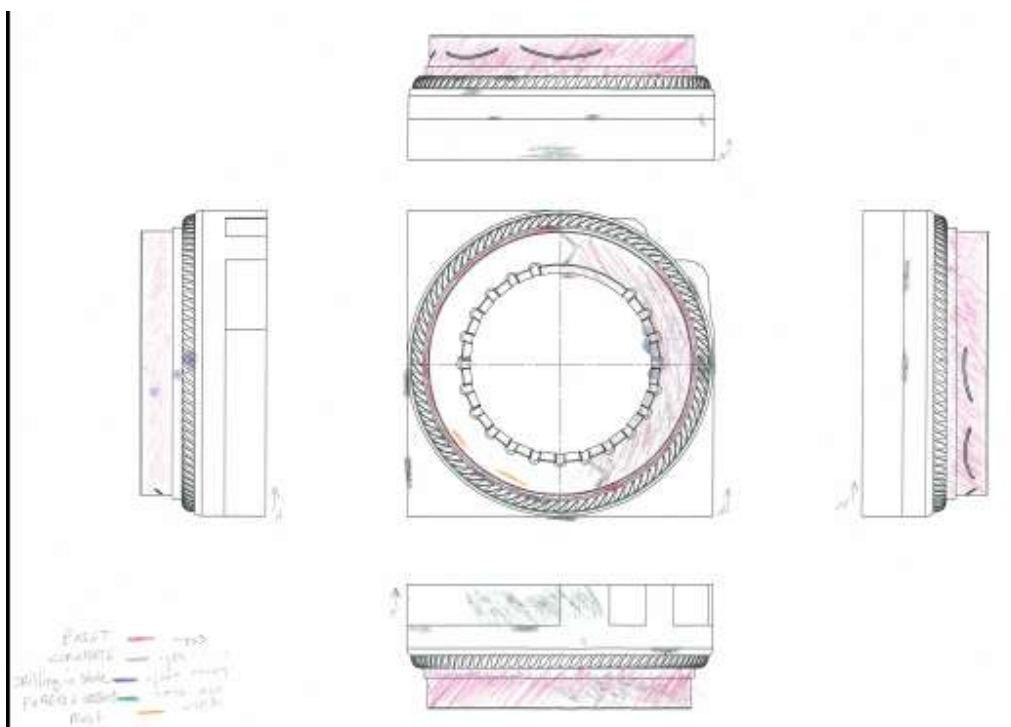
## North base pathology plans

The two column bases that were found at the ICC building had extensive sediments on them, which include pain, concrete, tar, rust and mortar. The north base was covered in brawn and red pain, had holes drill in to it and was covered up to half of its high with "Terrazzo" tile floors. The type of this column base is not Roman for sure, but the type isn't clear.

1. The concrete and mortar sediments will be removed by mechanical work. Use of hammer chisel and scalpel. The sediments will be hammered to the thinnest possible way and then a scalpel will be used to scrape the sediment so the stone won't be damaged.
2. Paint and tar will be removed by a compress of ethanol with the use of cellulose for dissolving it and then scraping it with scalpel.

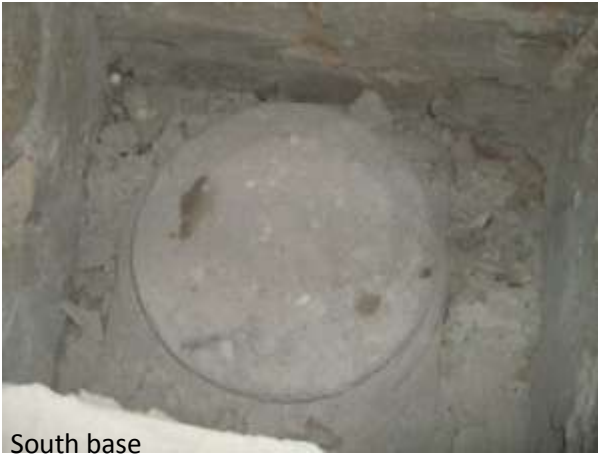
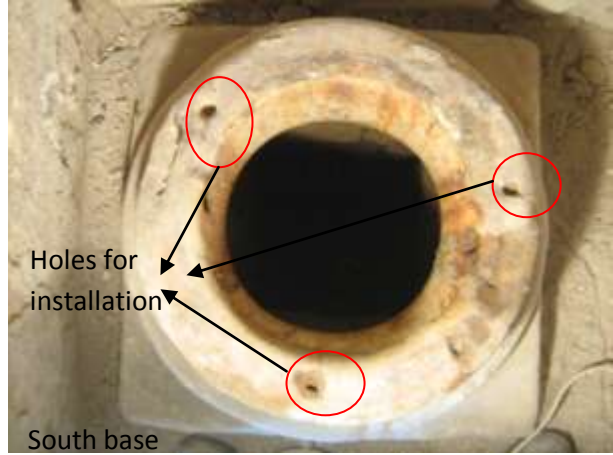
The south column base was found during the renovation work that was done in the building. The type of the column base is Byzantine. It was found when a wall in a niche was dismantled. On top of the base and around it parts of metal were found which hint for the mechanism that was

there for water extraction, holes on the base and extensive rust sediments support this.

South base

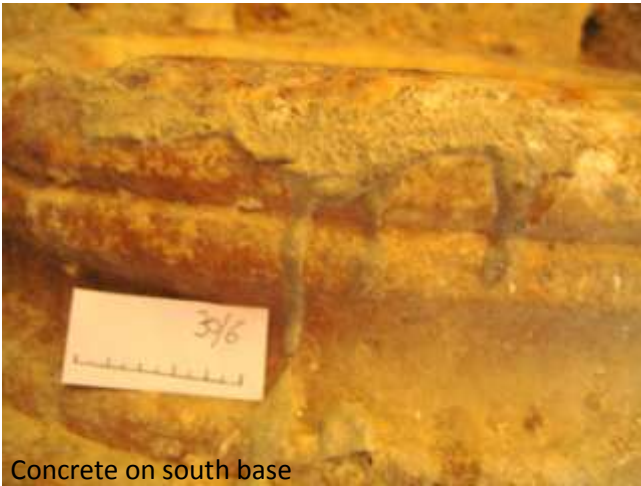
Concrete on south base

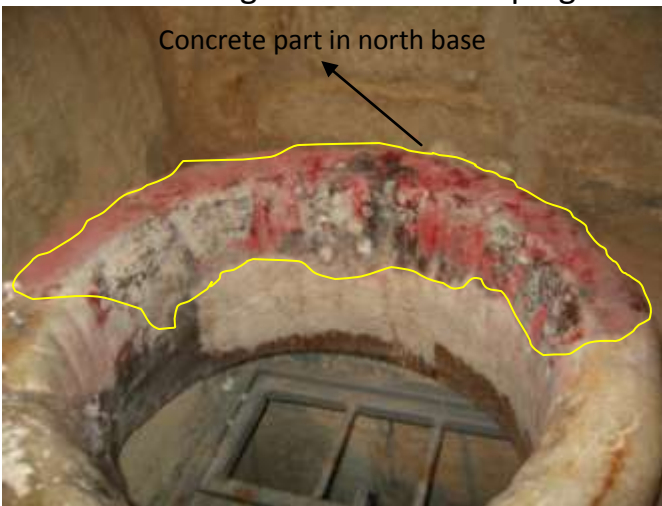
2. Addressing the question about the concrete adding in the radius of the adding, north base. keeping it or removing it and molding a marble like

3. The concrete addition was made after the breakage of the marble base during its use. The question is should it be removed, and if so how and what will be the solution for the molding of the replacing piece with binder and stone powder. The problem with that we don't know the date of the concrete addition and that it has rope marks that connects it to the use of the column base as part of water installation give it a connection to the function use of the base, and so is a part of it. In some places the rope marks on the marble are not correlate to those in the concrete, and by that showing that the base was used on top of a water opening before it was broken and fixed be concrete. The rope marks are at the entire radius of the base which shows that the polling of the rope

took place from all around the base, although there are walls that don't allow this kind of action on the east and north side of the base. This indicates that the column base was used as a "unit" in another place before arriving the ICC building.

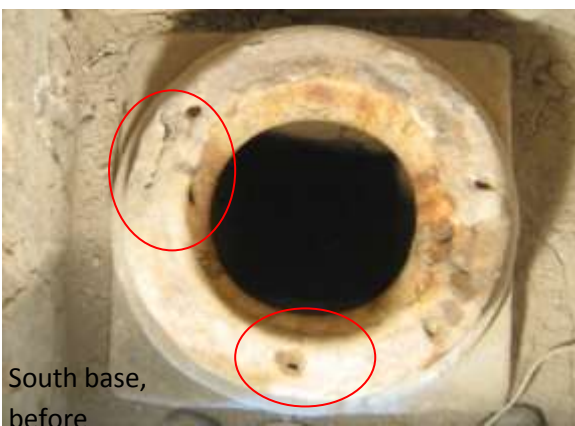
3. Restoring the original position of the south column base, that was repositioned wrong.

South base,  
before

4. Returning the lime base to its original position in the niche. It was moved for installation of metal bars, but was replaced wrong.
5. Leaving the rust sediments *in situ* for they are remnants of the use of the bases as part of water installations. Hence the sediments have authentic value.

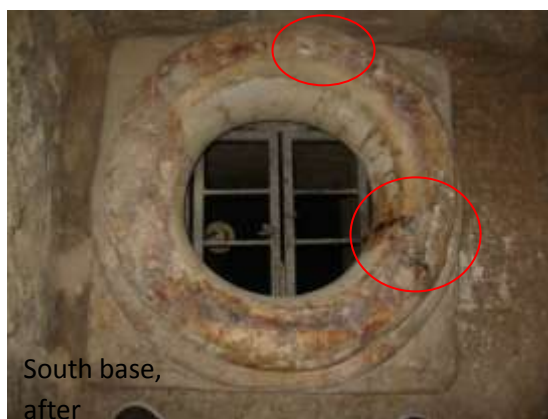
South base,  
after

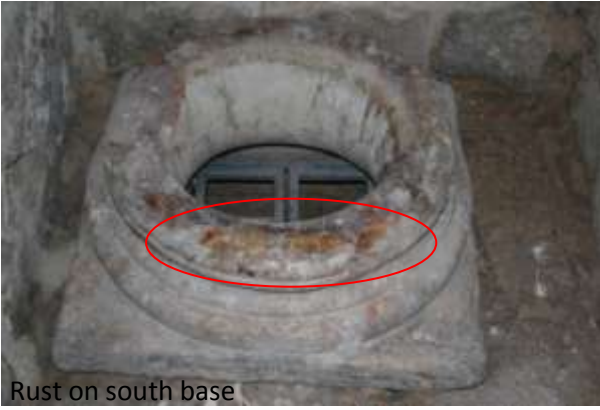
4. Addressing the question of the rust sediments on the bases which was made by the metal installation on it.

Rust on south base

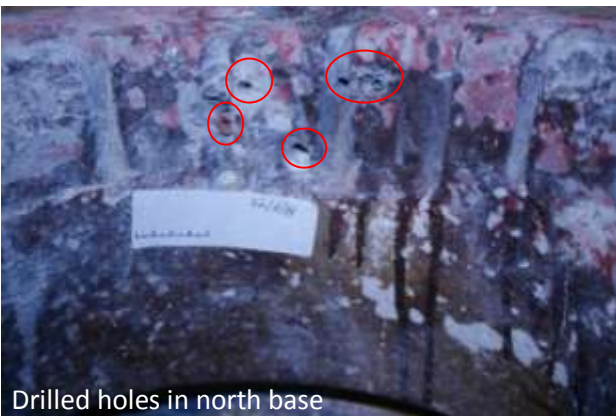
5. Filling the holes that were drilled in the north base.

Drilled holes in north base
