REPAIR AND STRENGTHENING INTERVENTIONS ON VERTICAL AND HORIZONTAL ELEMENTS

SPEAKER: PROF. CLAUDIO MODENA

**DEPARTMENT OF STRUCTURAL & TRANSPORTATIONS
ENGINEERING
UNIVERSITY OF PADOVA, ITALY**

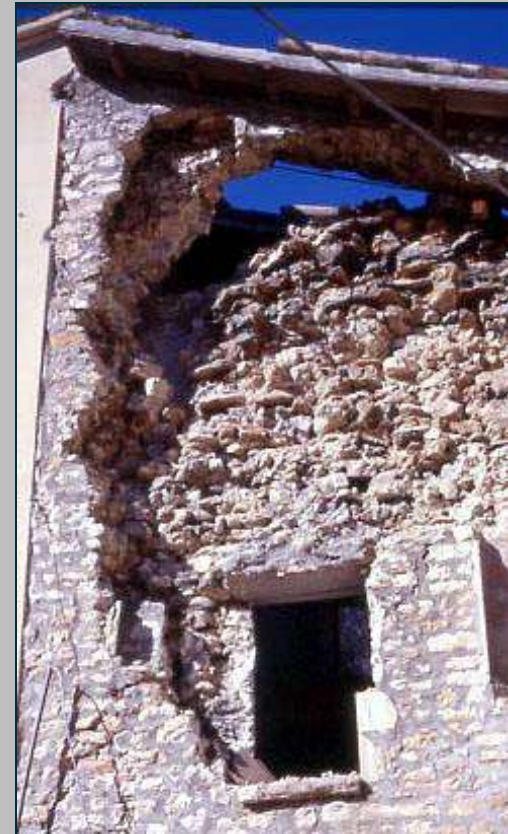
Separation of leaves in a repaired stone masonry

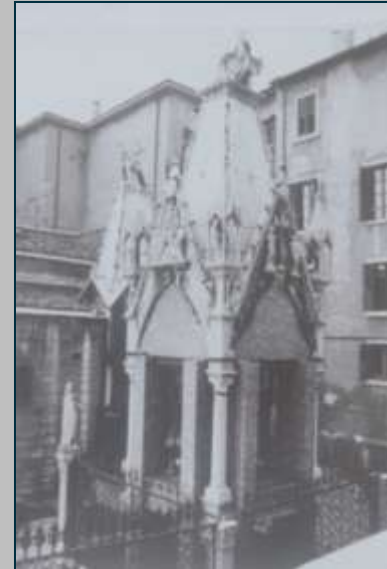
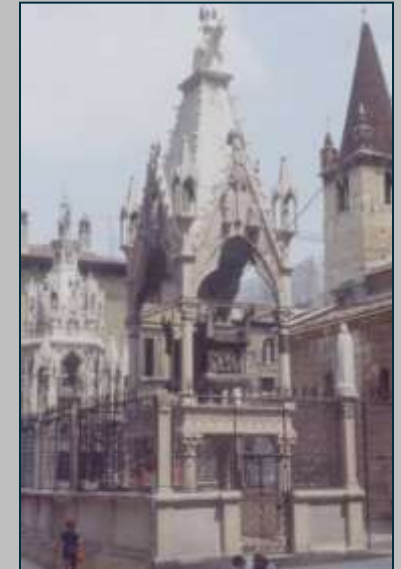
Arche Scaligere, Verona, Italy Before and after intervention

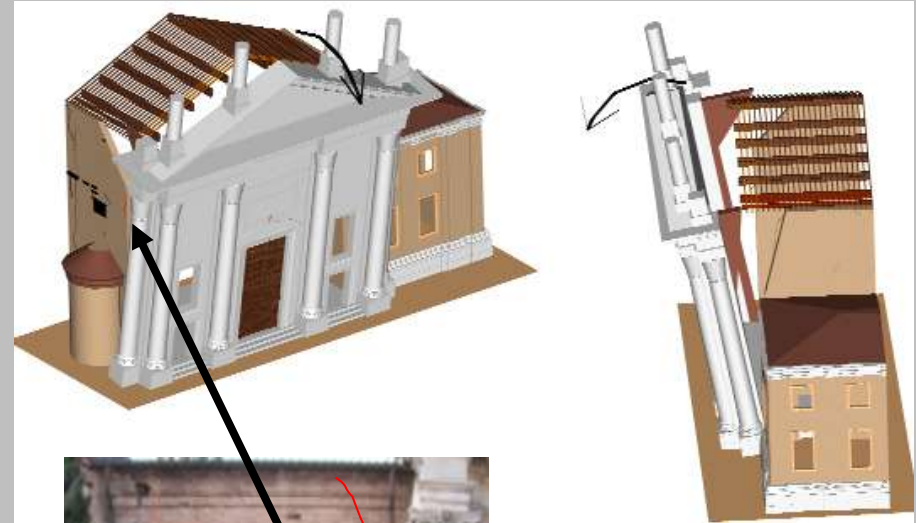
From the analyses carried out, it was pointed out that the most vulnerable element is the **façade**, in case of **overturning with partial involvement of the lateral walls**.

This is also a possible mechanism, due to the presence of corresponding **crack pattern** close by the façade.

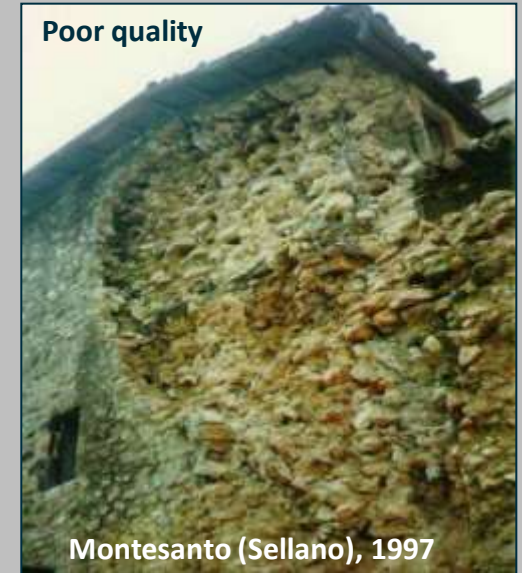
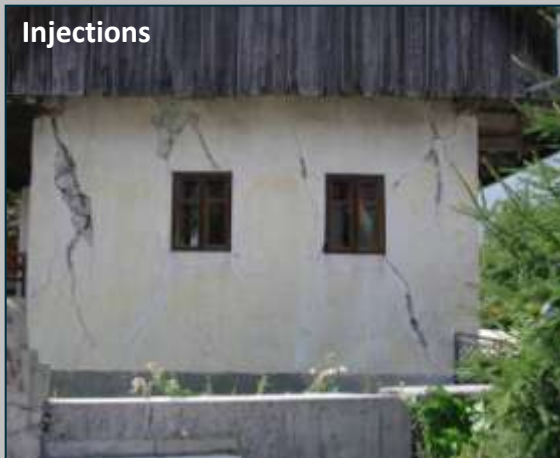
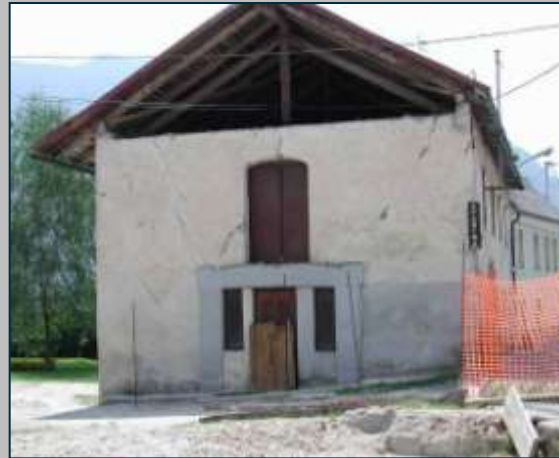
Building strengthened after the Bovec earthquake (Slovenia) in 1998, damaged again during the 12/07/2004 earthquake

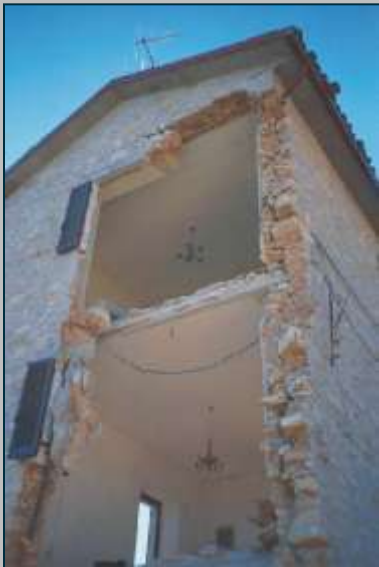
The orthogonal walls are not adequately connected each other and to the new R.C. slabs

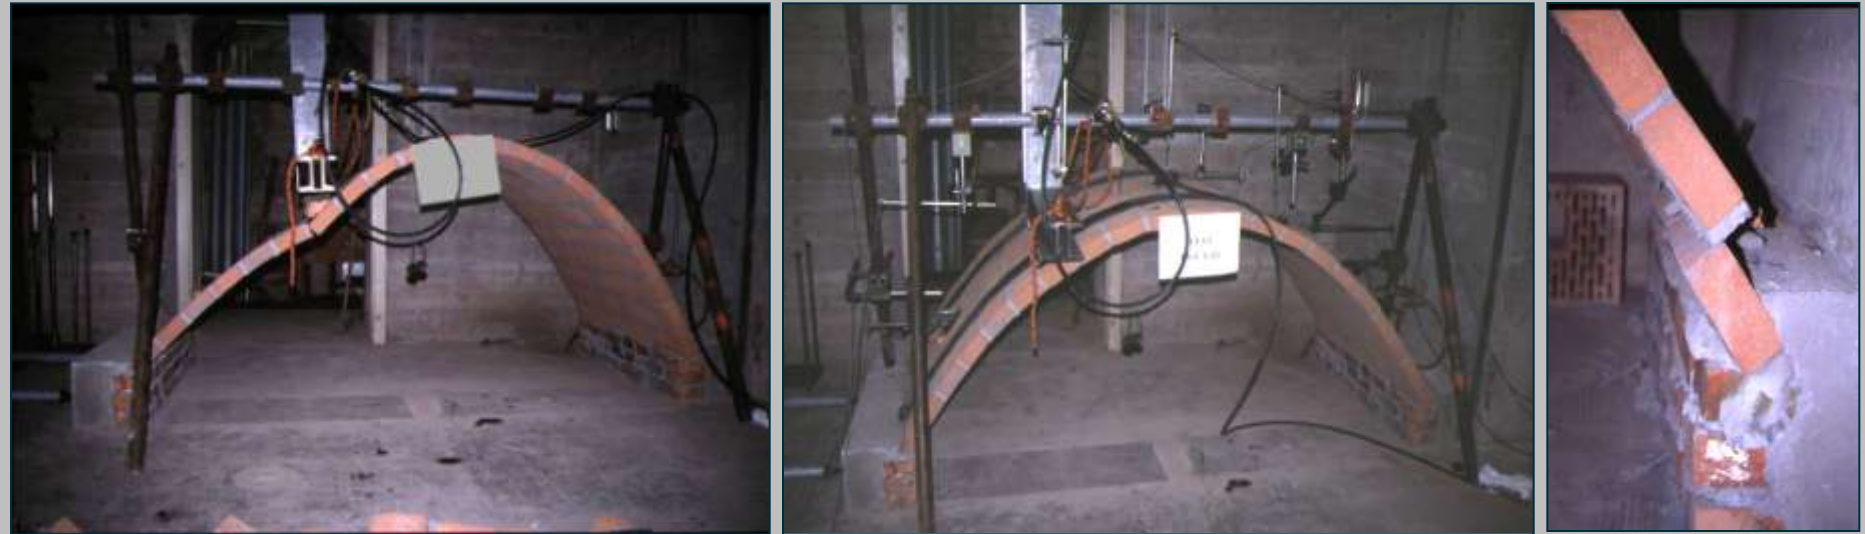
FRP strengthening of brick masonry vault specimens

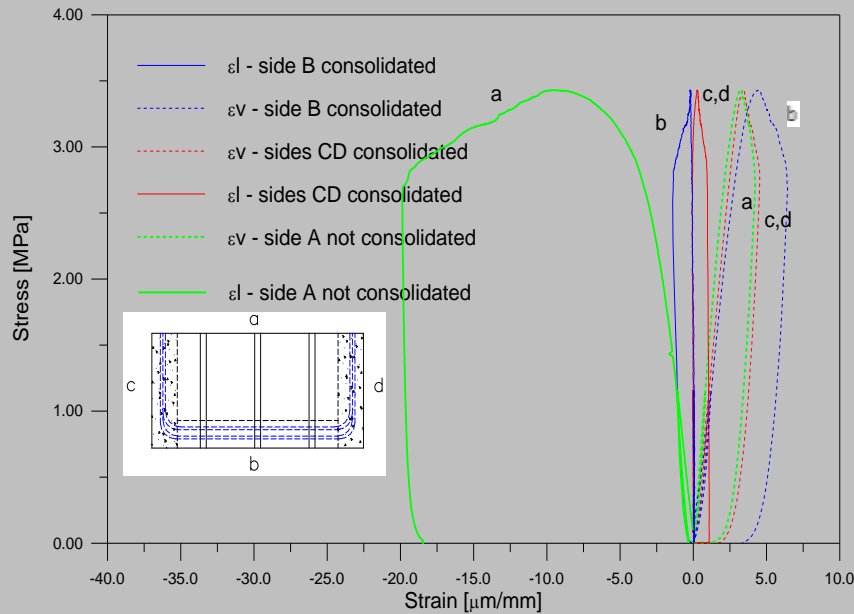
Experimental results:
comparison among the faces after repair

- **no improvement in the strength** of the wall
- **reduced dilation** of the repaired panels against the not consolidated ones
- reduced dilation of the consolidated faces of the repaired panels
- **reduced cracking pattern** on the repaired faces against the not repaired one
- **reduction of the tensile stresses** in the bricks (40%) and absorption by the bars

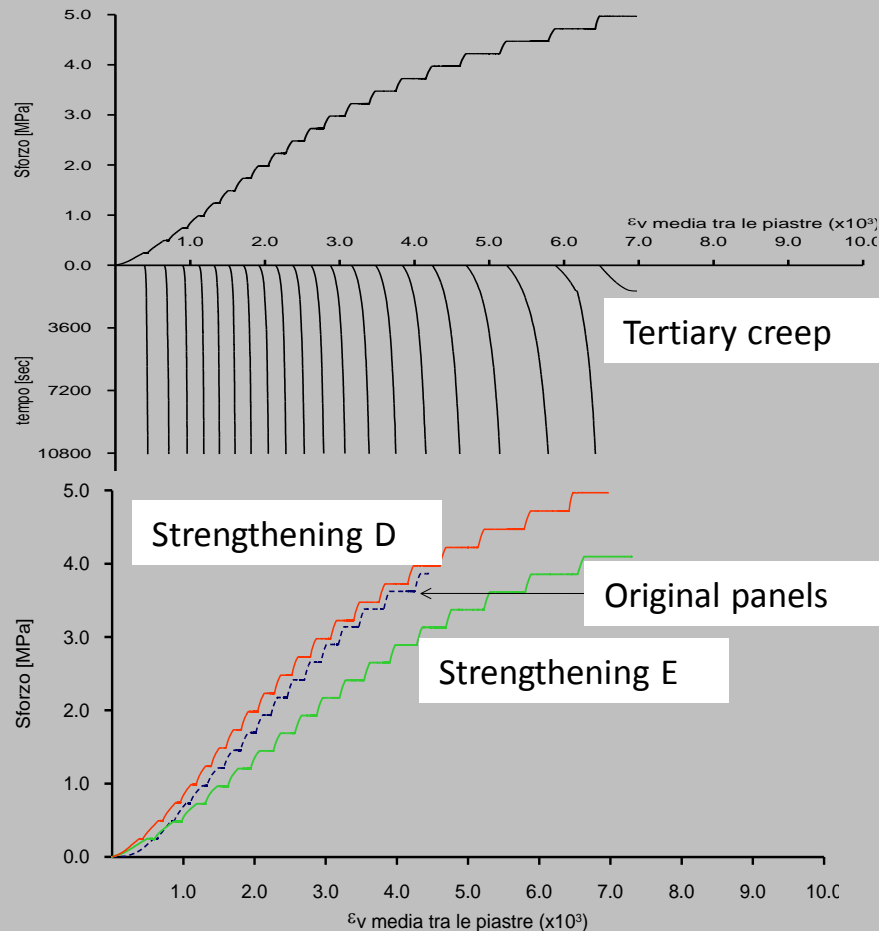
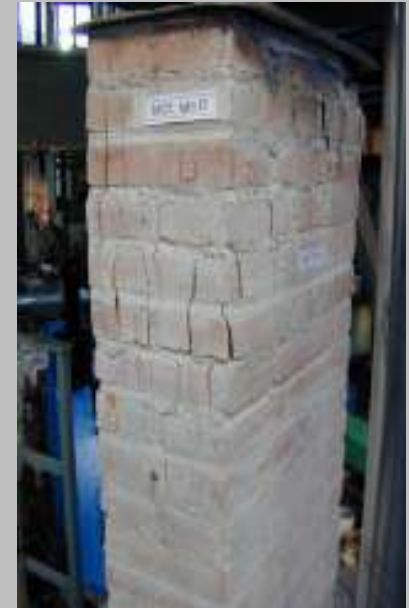
Experimental results:

constant single compression load steps (3^h)

- Diffused cracking pattern
- Reduction of the dilatancy of the walls
- Tertiary creep condition in the strengthened panels achieved for deformations over 70% higher than the original ones

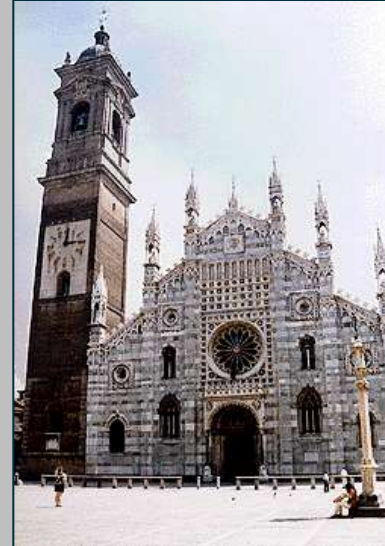
The bell tower of the Cathedral of Monza (XVI c.):

- 70 m tall
- **passing-through large vertical cracks** on some weak portions of the West and East sides (slowly but continuously opening since 1927)
- **wide cracks in the corners** of the tower up top 30m
- damaged zone at a height of 11 to 25 m with a multitude of **very thin and diffused vertical cracks**
- in the heaviest portions of the wall the current state of stress is close to the 70% of the masonry compression strength

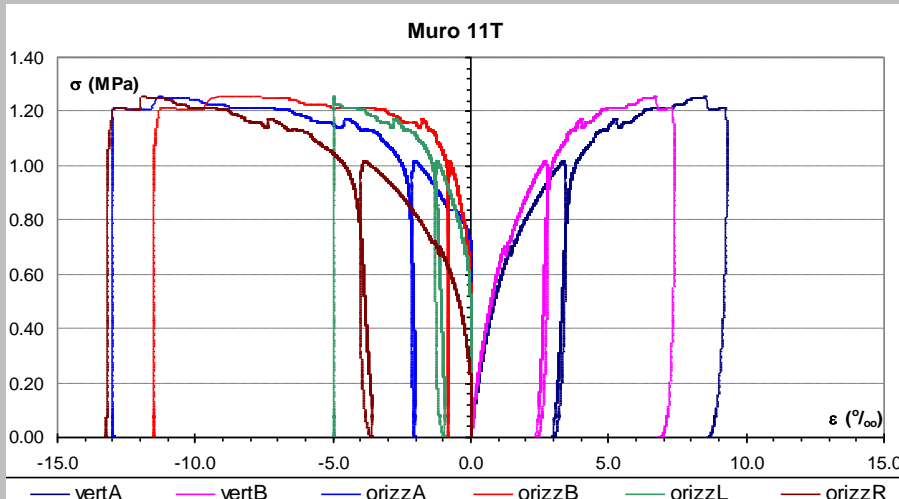
- Improvement in the strength of the wall
- Reduction of the dilatancy of the walls

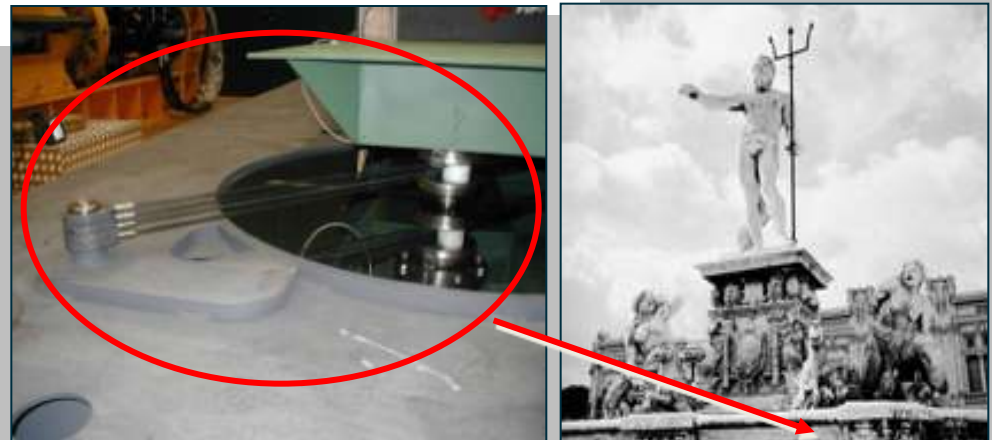
Seismic isolation of the Statue of Nettuno & Scilla in Messina (Sicily): particular of the support with isolator and SMAD device.
