# Case Study

## Monastery of Jerónimos, Lisbon, Portugal

**Paulo B. Lourenço**  
**Universidade do Minho**  
**Department of Civil Engineering**  
**Guimarães, Portugal**

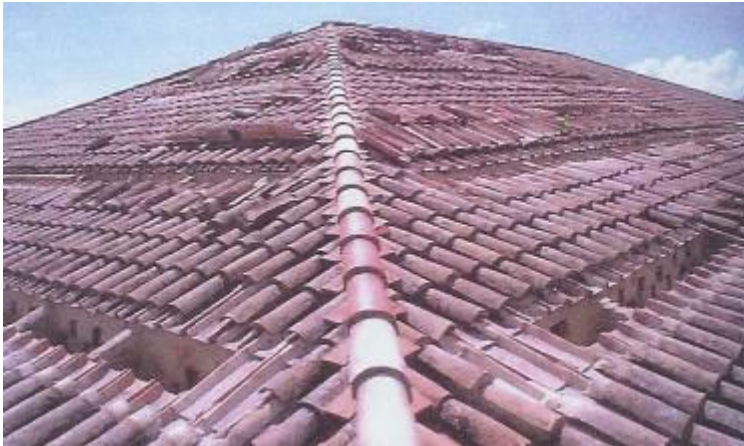
**Tiles removal for visual inspection**

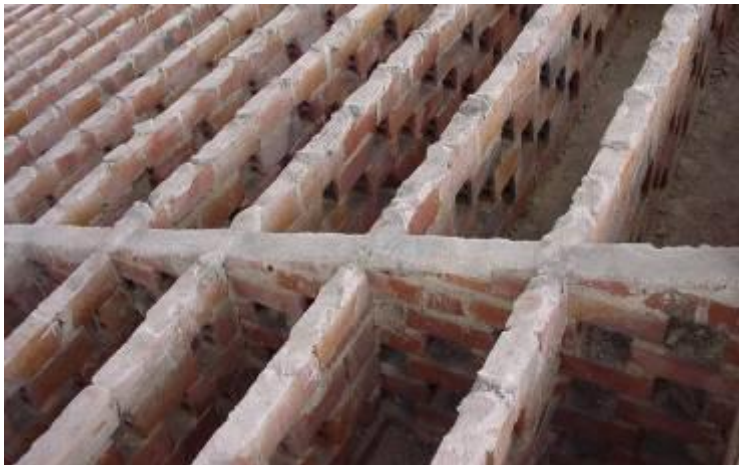
**Walleys for supporting tiles (20<sup>th</sup> century)**

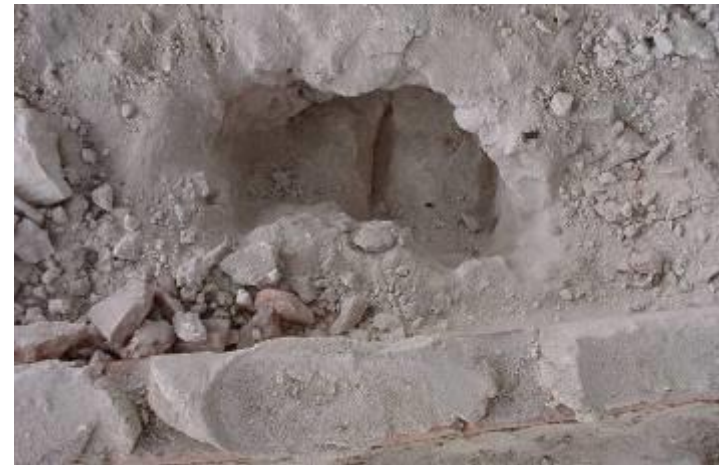
**Ribs visual inspection**

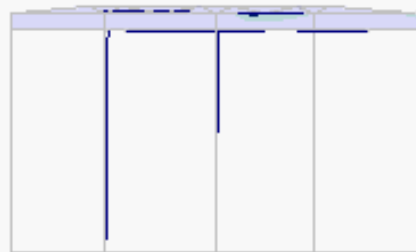
# Mode I

f = 3.685 Hz

z = 2.337 %

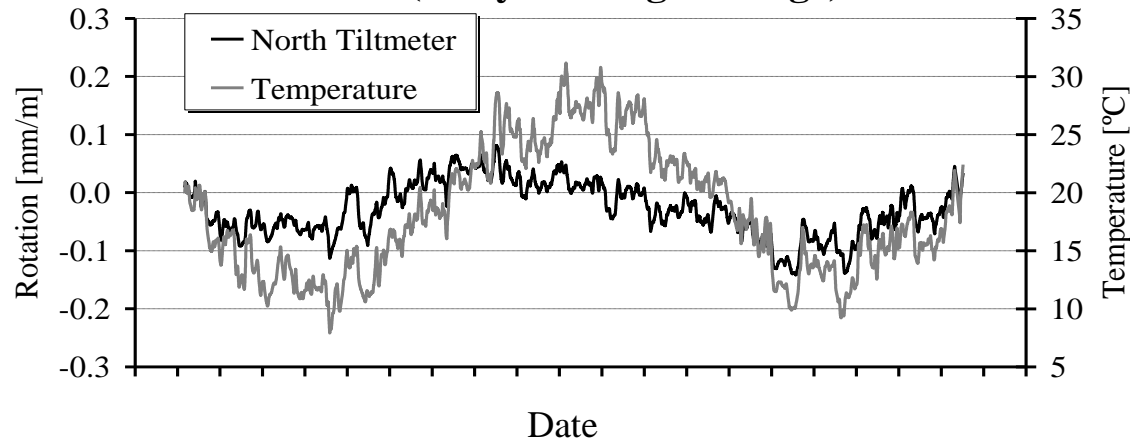
## North Tiltmeter (Daily Moving Average)

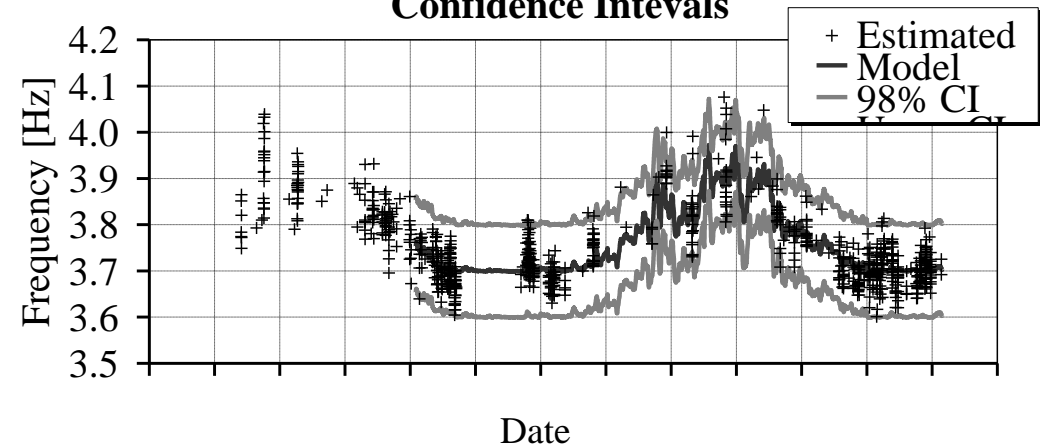
### Confidence Intervals

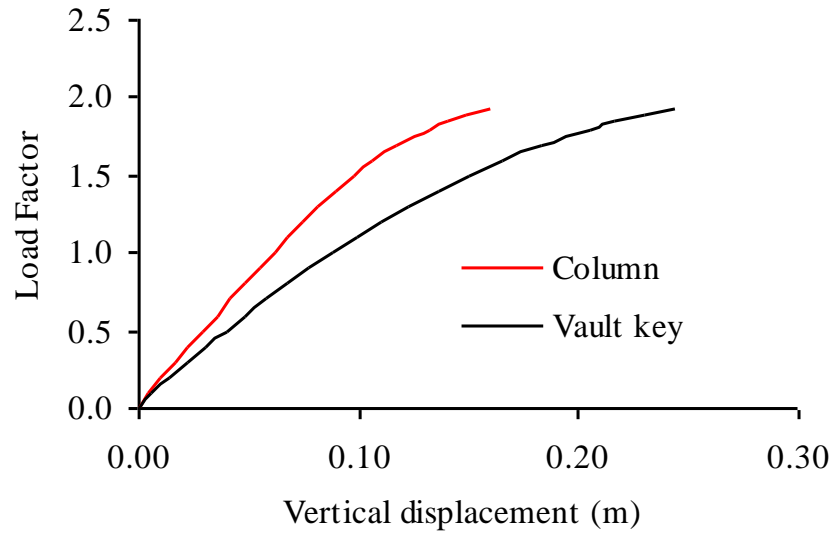
**Non-linear Analysis:  
Loading = Self-weight**

$$f_t = 0$$

$$f_{c, \text{masonry}} = 6 \text{ N/mm}^2$$

$$f_{c, \text{infill}} = 1 \text{ N/mm}^2$$

**Load displacement diagram**

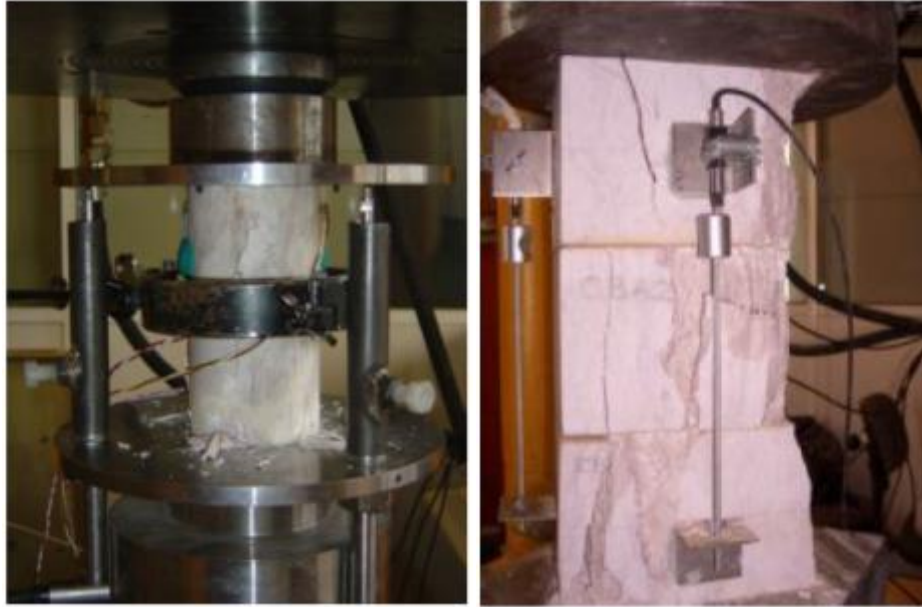
**Stone and masonry testing**

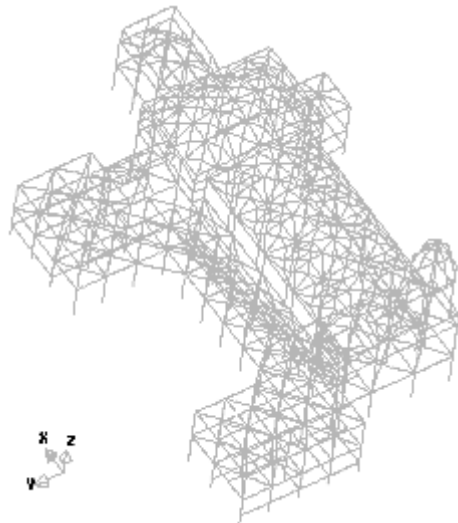
**3D beam element model**

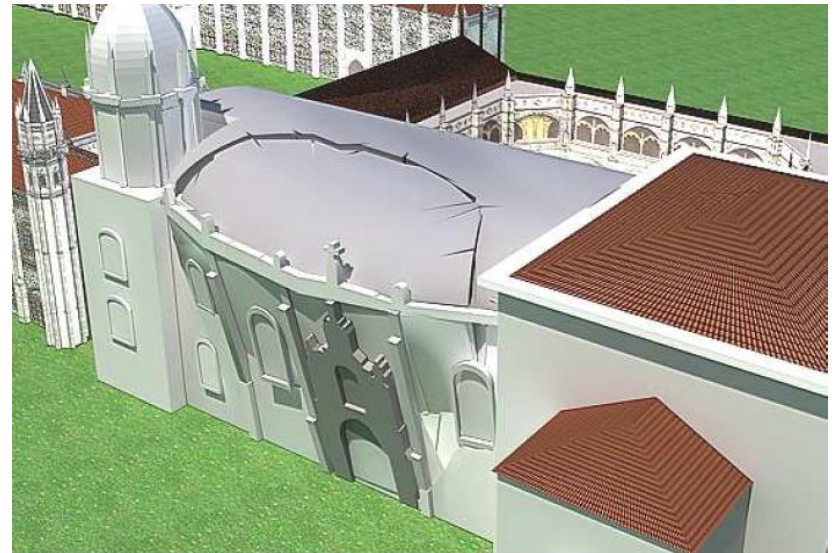
**South façade**
