ŞADIRVAN AL-JAZZAR

Architectural Documentation and Conservation Report
of the Ablutions Fountain of al-Jazzar Mosque

Alison Hortig
July 2010

International Conservation Center

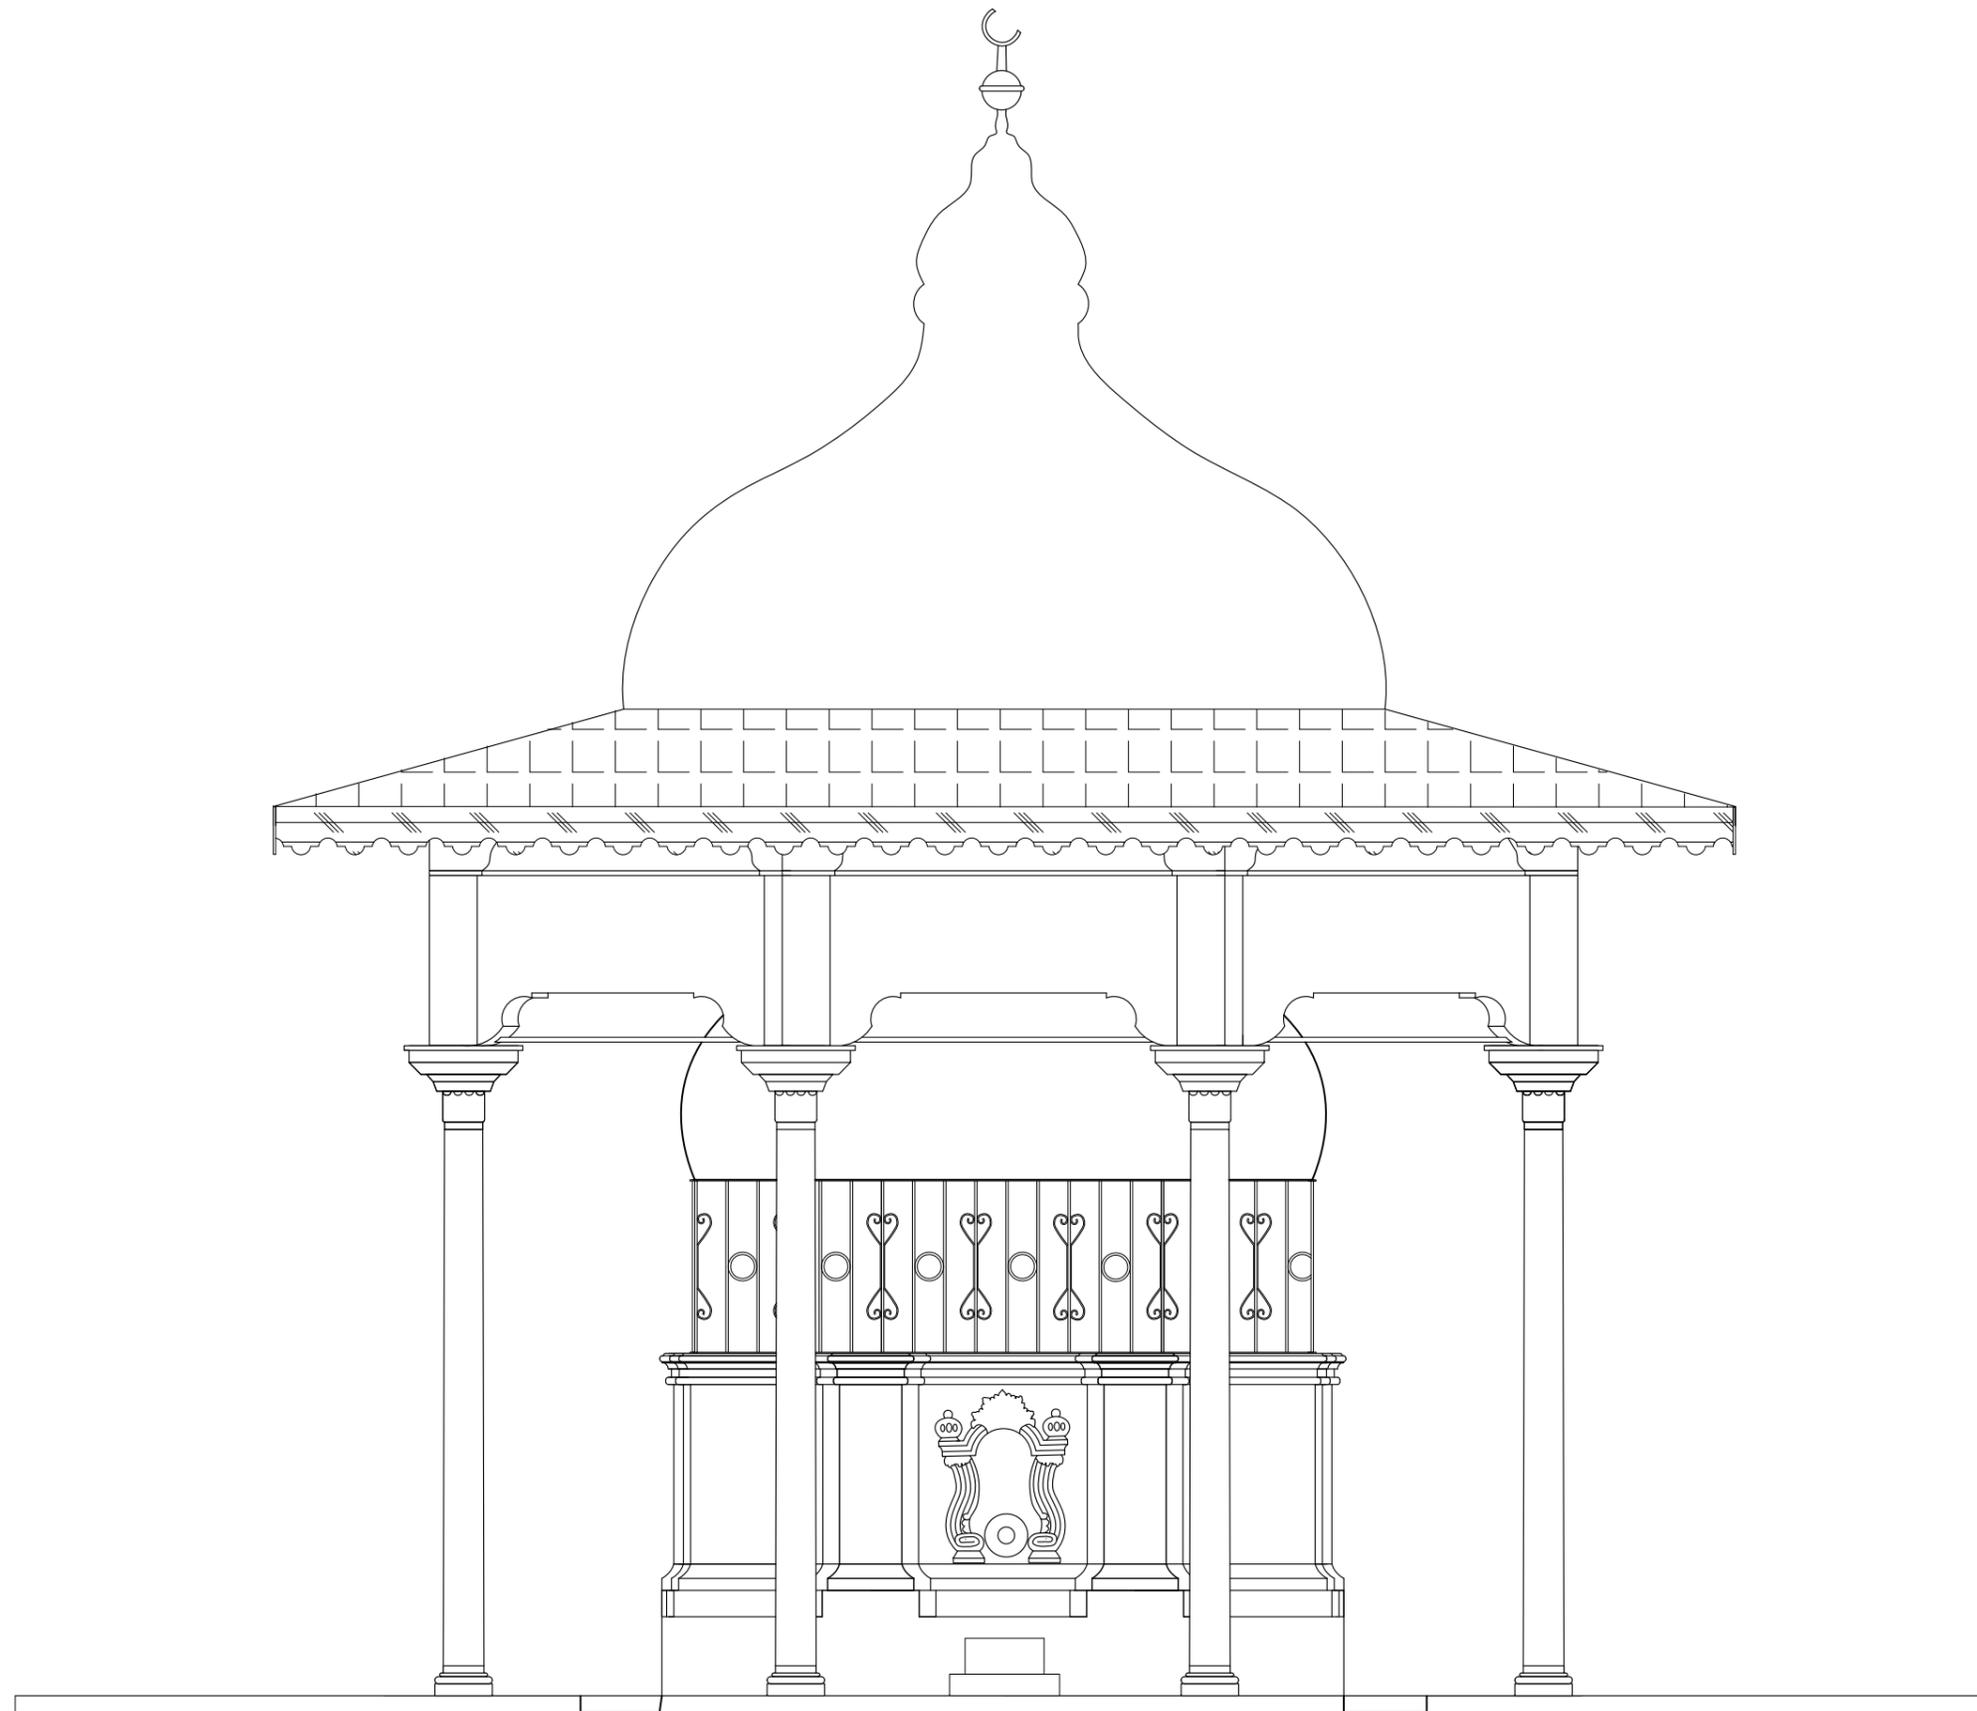
PATHOLOGIES

#	Damage	Cause	Sum	Treatment
1	Unstable wood elements	Degradation	5%	Stabilized and replace as needed
2	Damaged wood frame	Missing panels	70%	Explore interior of frame to determine extent of damage, treatment TBD
3	Missing wood panels	Degradation	2%	Replace panels
4	Disintegrated joints	Modern interventions, degradation	5%	Remove existing pointing, replace with lime mortar
5	Rust	Environmental	5%	Clean rusted areas
6	Metal disintegration	Rust, degradation	2%	Disassemble affected pieces (interior cupola), intervention TBD based on damage
7	Cracks	Varies	3%	Clean areas. Fill utilizing lime mortar injection, or dutchwork.
8	Biological	Dark damp conditions	1%	Clean localized areas and regular preventative maintenance
9	Modern additions	Necessity of lighting, plumbing	5	Remove modern additions; assemble alternative solutions as noted in recommendations.
10	Missing stone	Varies	1%	Clean areas of foreign materials (concrete etc), repair using dutchwork. Certain areas require dismantling.

11	Coloring	Rust staining	1%	Clean localized areas
12	Coloring	Paint overspray	2%	Clean localized areas
13	Coloring	Biological staining	1%	Clean localized areas
14	Warping of metal roof material	Under frame disintegration/ varies	30%	Relative to needs of wood frame

The şadırvan holds significance to both the Muslim communities of Israel as well as the tourism industry in Akko. It is recommended that pathologies be addressed by priority as stated in the previous chart.
