11-12 DECEMBER 2011, MIKVE ISRAEL, ISRAEL

MONITORING SYSTEMS & STRATEGIES

SPEAKER: PROF. CLAUDIO MODENA

DEPARTMENT OF STRUCTURAL & TRANSPORTATIONS ENGINEERING UNIVERSITY OF PADOVA, ITALY

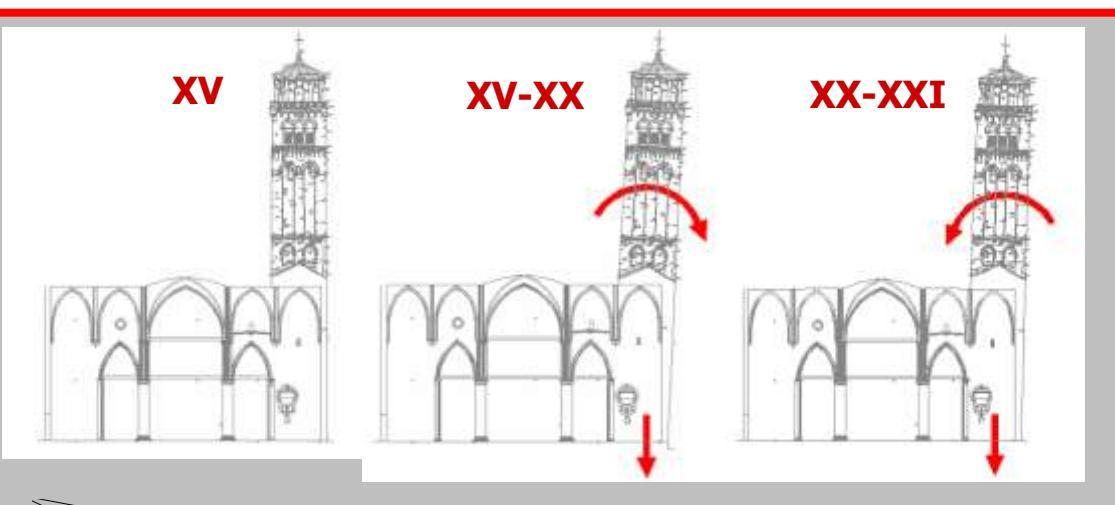
- 10 ÷ 20 mm
- 49.8 mm East corner
- 61.3 mm South corner
- 93.3 mm West corner

The differential settlements and the comparison between the fotogrammetric survey of 1995 and 2000, indicated that the bell-tower is tilting in the opposite direction respect the "historical" tendency, meaning that it is going back towards its vertical.

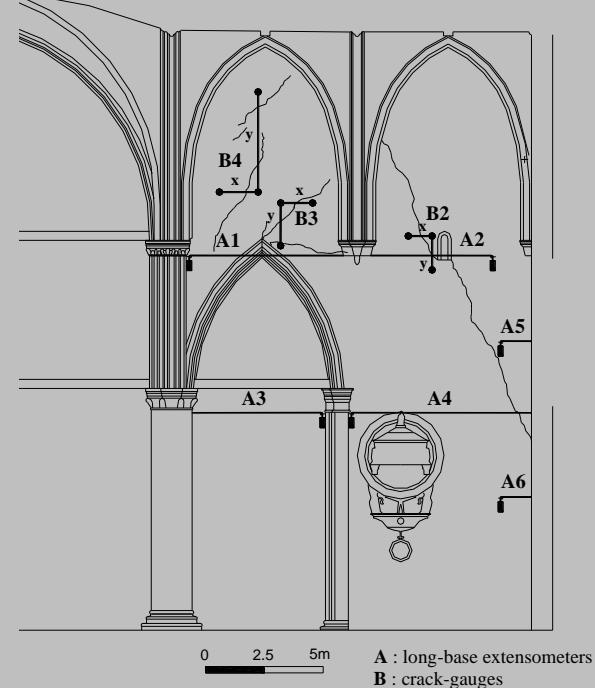
2001 automatic **monitoring system** (check of the deformations):

- **6 long base extensometers** relative displacements between the walls of the bell-tower and the adjacent structures of the basilica;

- **8 crack-gauges** installed on the main cracks of the South-West side of the bell-tower and of the wall above the stone arch.

the opening of the cracks is only partly caused by the settlement noticed at the foundations level

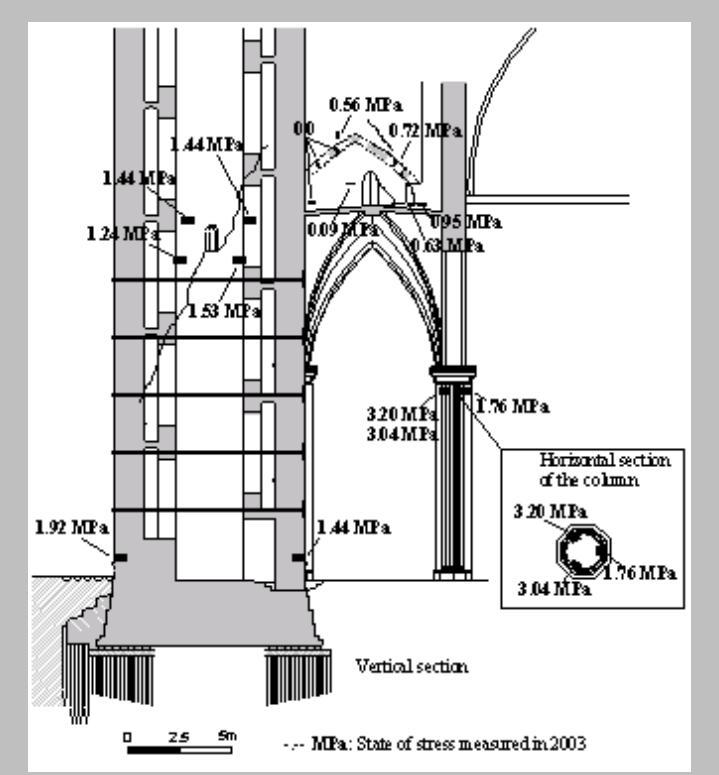
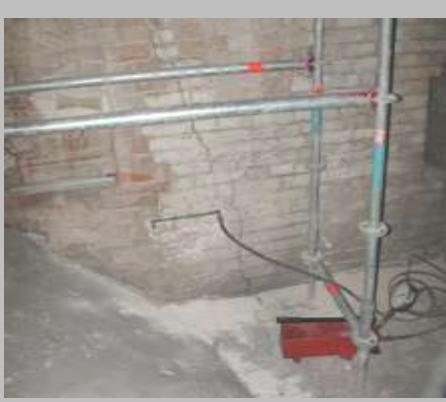
2003 investigation campaigns

Flat-jack testing technique: to measure the existing state of stress on the masonry structures of the bell-tower and of the adjacent structures of the Basilica:

a) **Inside the bell-tower**, on both sides of an **inclined oblique crack** which runs along the South-West side of the tower: the similar stress values measured, at two different levels show that the crack, even if passing through the entire thickness of the wall, does not induce particular stress concentration.

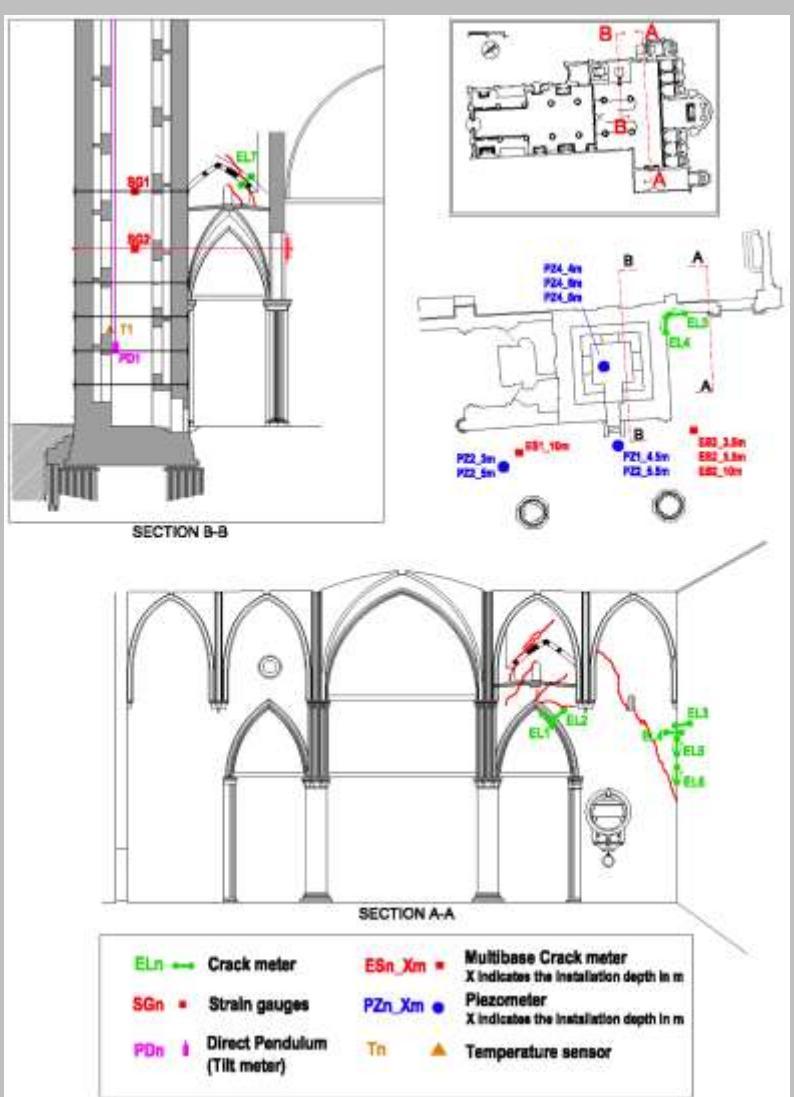
MONITORING SYSTEM

The automatic monitoring system includes:

•n.1 direct pendulum (PDn) equipped with automatic telecoordinometer, for the measure of the absolute horizontal movement of the top of the tower;

n.7 electrical crack-gauges (ELn) to check crack pattern's evolution and the opening of principal cracks;

•n. 2 multi base crack gauges (ESnXm) for the measurement of relative displacements between ground points on the same vertical line at the tower's base;

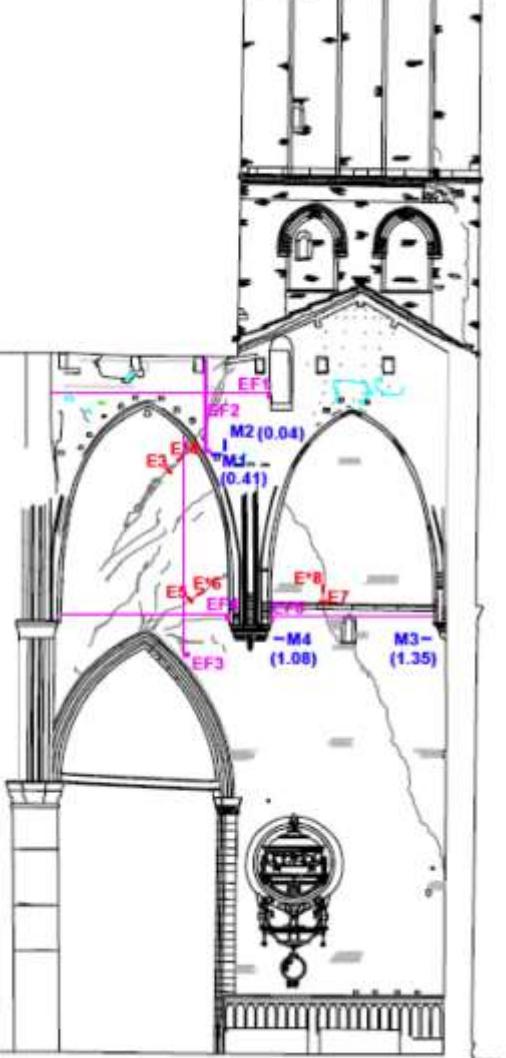
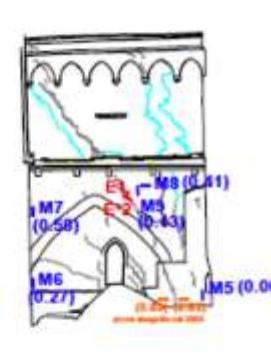
MONITORING SYSTEM

- Flat-jack tests for the tensional state analysis and manometers permanently installed
- (0.04) Tensional state measured perpendicularly to the flat-jack (Mpa)
- Crack-gauges for the measurement of crack opening's variation
- Crack-gauges for the measurement of tangential relative displacement
- Crack-gauges with long base

The semiautomatic monitoring system includes:

n. 8 electrical crack gauges (En) to control the opening of main cracks;

n. 5 long base crack-gauges to measure relative displacements between vertical structures;

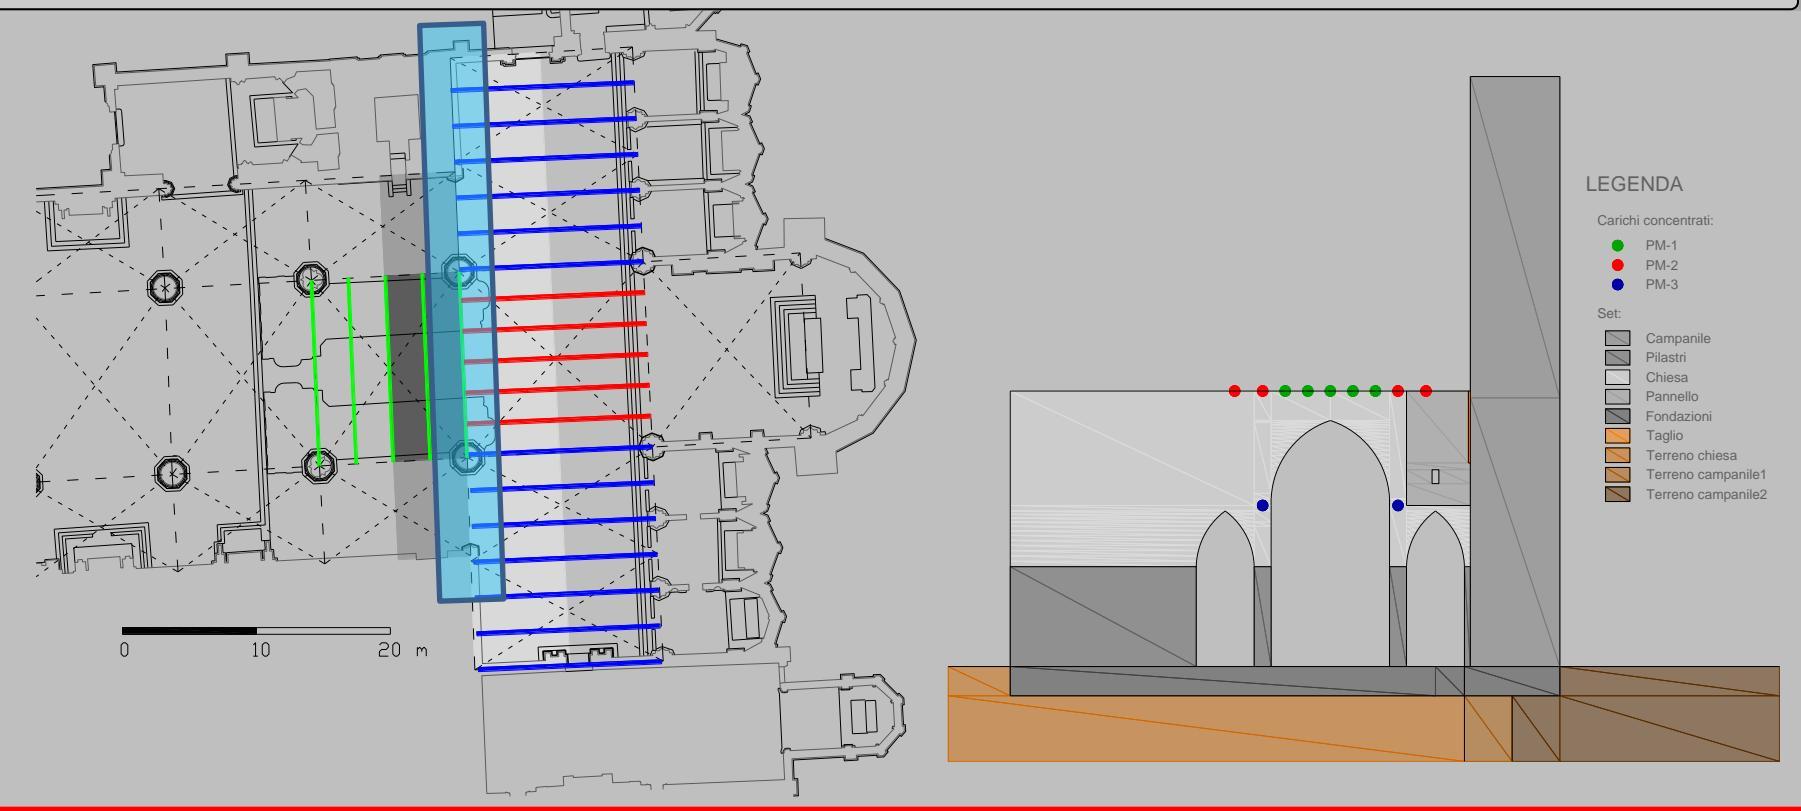
NUMERICAL MODELS

A 2D numerical model is created including the cross section of the church and considering parts of the structure and loading conditions that are relevant in relation to the structural problem.

Simulation of building's settlements during centuries through a non-linear phased analysis, varying the values of stiffness of the underlying soil.

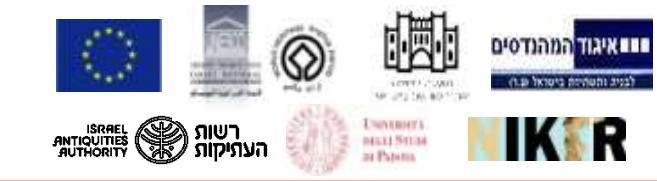
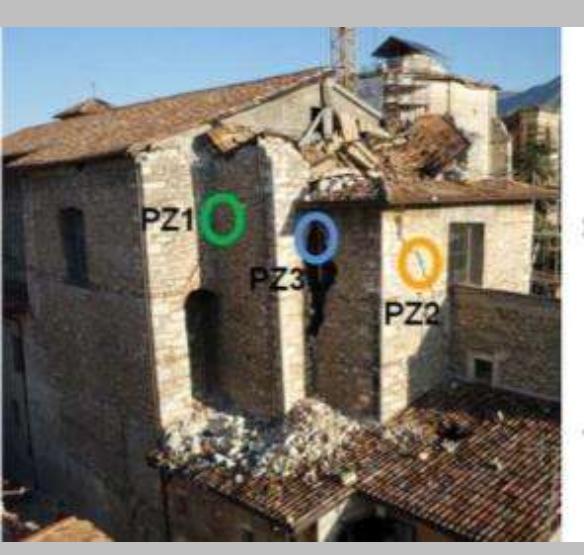
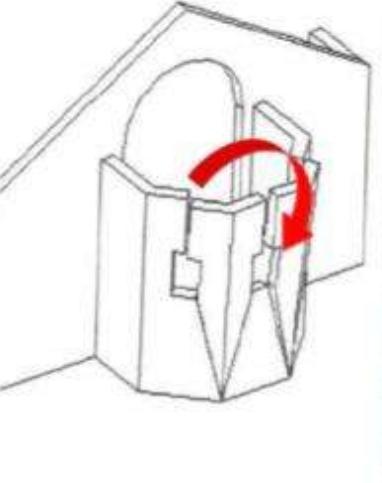
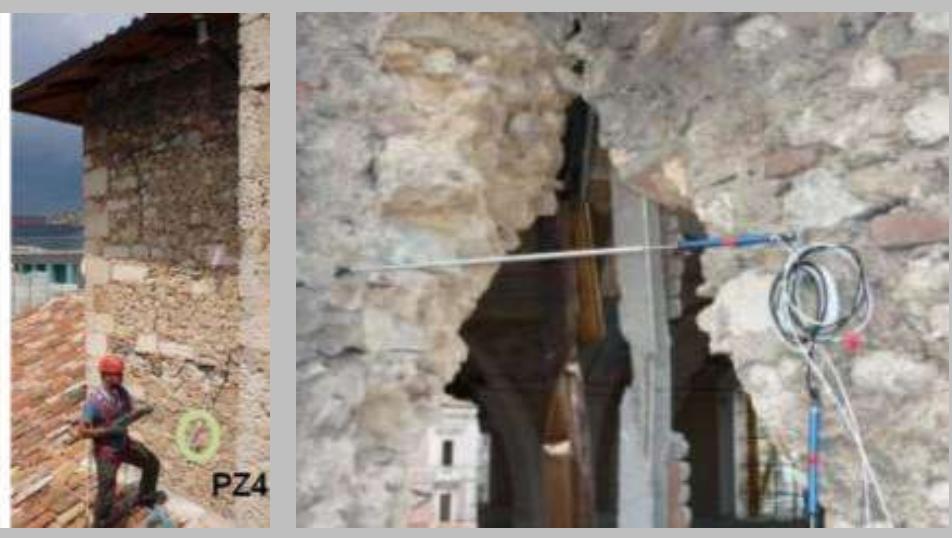
After the earthquake the church reported severe damage in the apsidal and transept area, where a critical crack pattern was noticed in the external walls, which manifested a visible outward overturning, involving the four pillars sustaining the dome. Also the transversal response of the church proved to be inadequate, since the most part of the vaults collapsed, such as a big portion of the external wall, at the clerestory level. Severe damage was finally reported in the vaults of the apse, of the presbytery, in the triumphal arch. The initial provisional strengthening intervention started the 4th of July and were completed in November 2009. This first intervention aimed at counteracting the most critical collapse mechanisms, such as the apsidal and transept walls overturning.

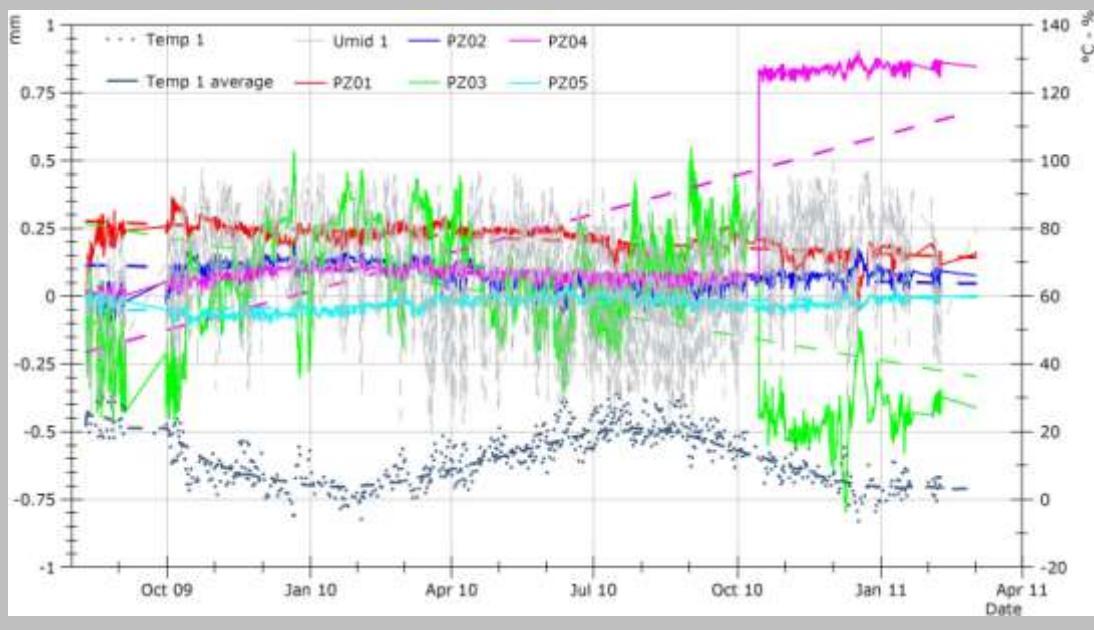
In parallel to the execution of the interventions, the opening of the main cracks was controlled by means of an automated low-cost SHM system which is continuously acquiring data, storing hourly the readouts coming from 5 linear displacement transducers positioned in the external area of both apse and transept, where the worst damage scenario is observed. Data are correlated to the environmental parameters recorded by a temperature – relative humidity sensor positioned at the base of the scaffolding.

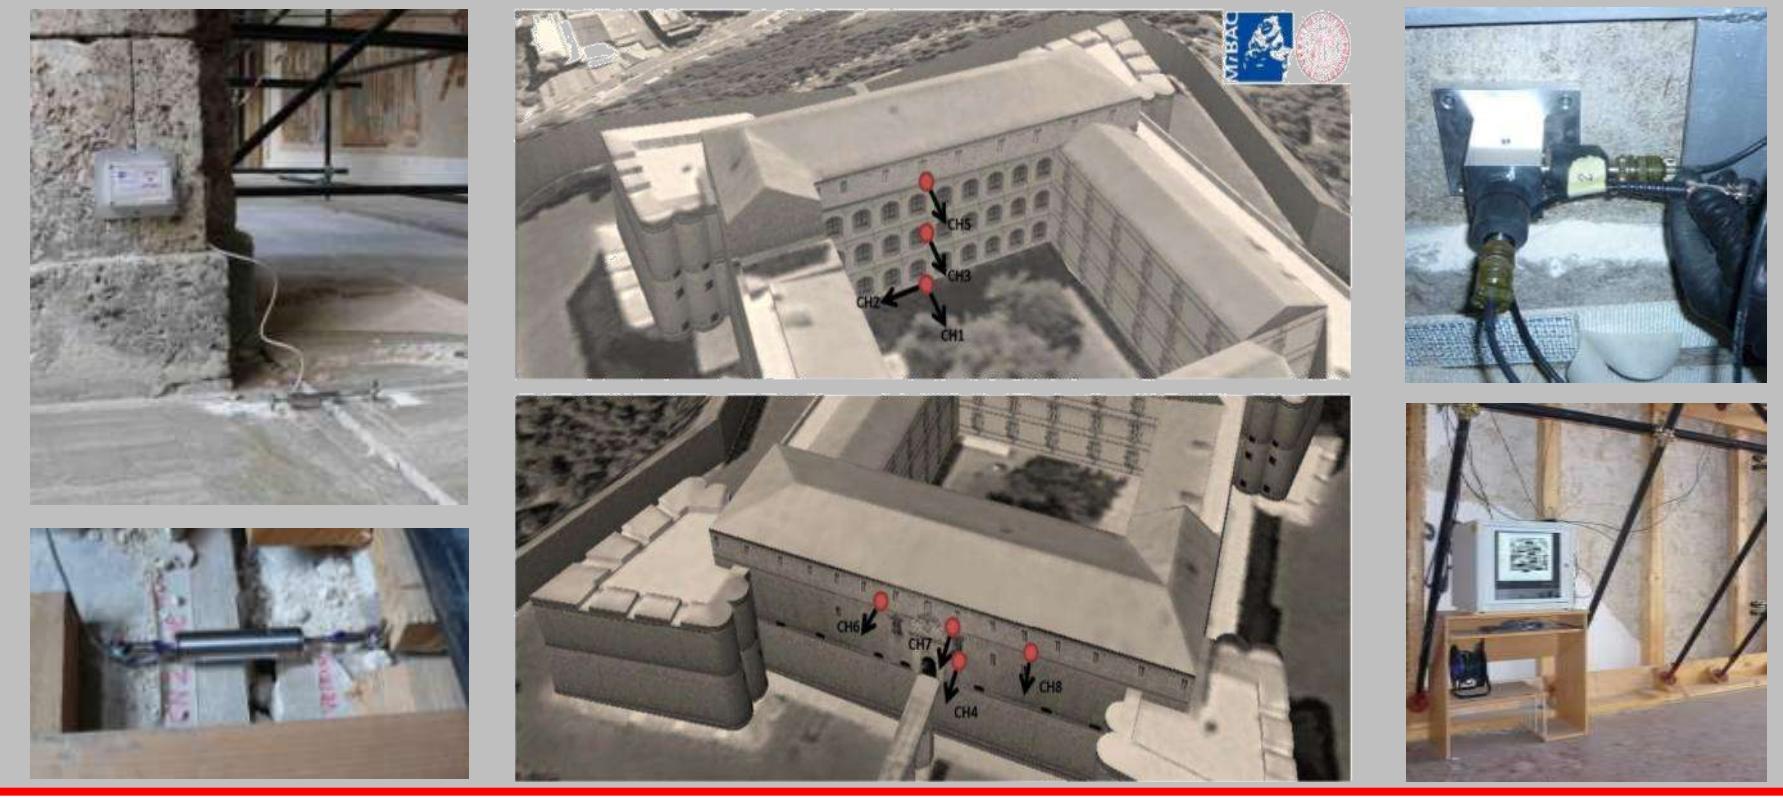
Following the 6th of April 2009 earthquake, the fortress was seriously damaged, especially in the upper floors, where several collapses were noticed. Between the recorded damage, overturning and flexural mechanisms on the external walls, shear damage in the external and internal walls, damage to vaults and arches, local collapses of floors and vaults, corresponded to the most worrying observations.

Damage manifested by the building were remarkable both for intensity and distribution, and were considered so serious to likely prejudice the overall stability of the building.

In December 2009 a dynamic monitoring system was installed in the Spanish fortress of L'Aquila, following a first investigation campaign carried out in September, including dynamic identification tests. The system complements a static monitoring system installed in the first months after the earthquake by the ISCR - National Conservation and Restoration Institute) of Rome, devoted to the control of the crack pattern evolution and the environmental parameters.

The dynamic system is composed by an acquisition unit connected to eight high sensitivity piezoelectric accelerometers. The central unit, located at the second floor of the fortress, in the S-East wing, is provided with a WiFi router for remote data transmission.

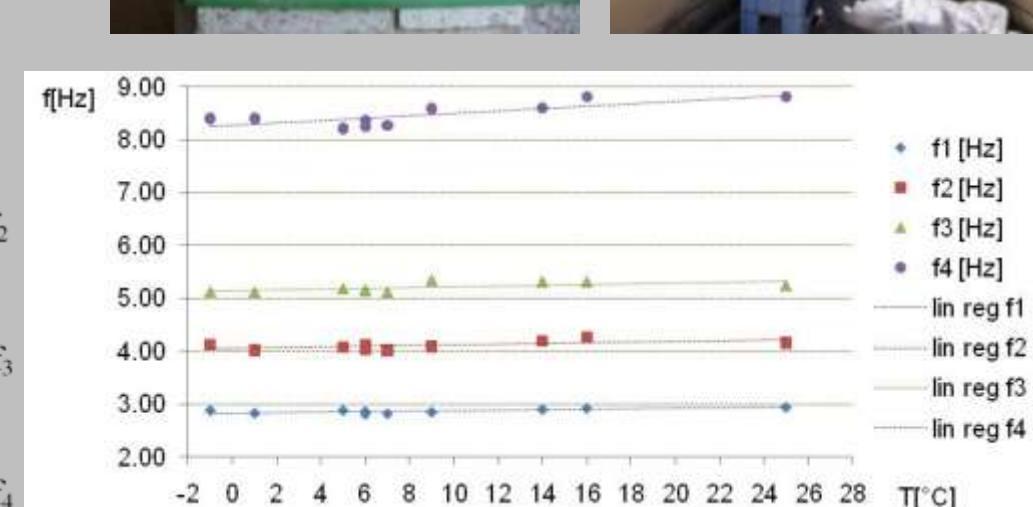
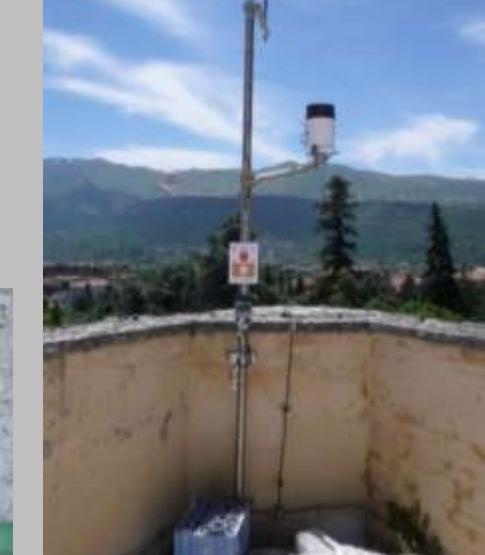
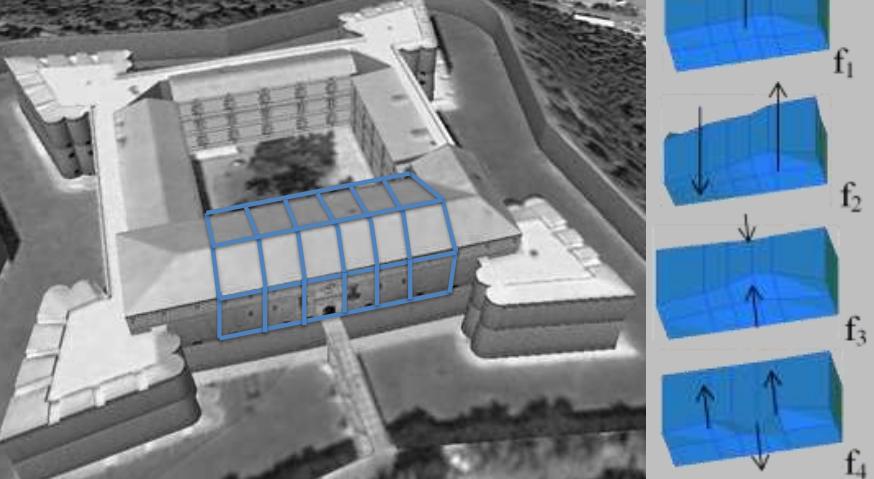
The dynamic system is composed by a central acquisition unit connected to the internet for the remote data transmission connected to 8 piezoelectric acceleration sensors. A couple of reference sensors is positioned at the ground floor, to record the base acceleration in occurrence of an aftershockt, and the remaining sensors are fixed at the structure at the upper levels, according to the identified mode shapes.

Displacement sensors are located on the pillars to assess the progression or stationariness of the overturning of the inner facade of the bulding, towards the courtyard.

Up to now, monitoring results indicate a general correlation between the environmental parameters and the dynamic properties
