POSSIBLE SOLUTIONS BEFORE AND IMMEDIATELY AFTER EARTHQUAKE.

SPEAKER: PROF. CLAUDIO MODENA

DEPARTMENT OF STRUCTURAL & TRANSPORTATIONS ENGINEERING UNIVERSITY OF PADOVA, ITALY

THE SPANISH FORTRESS

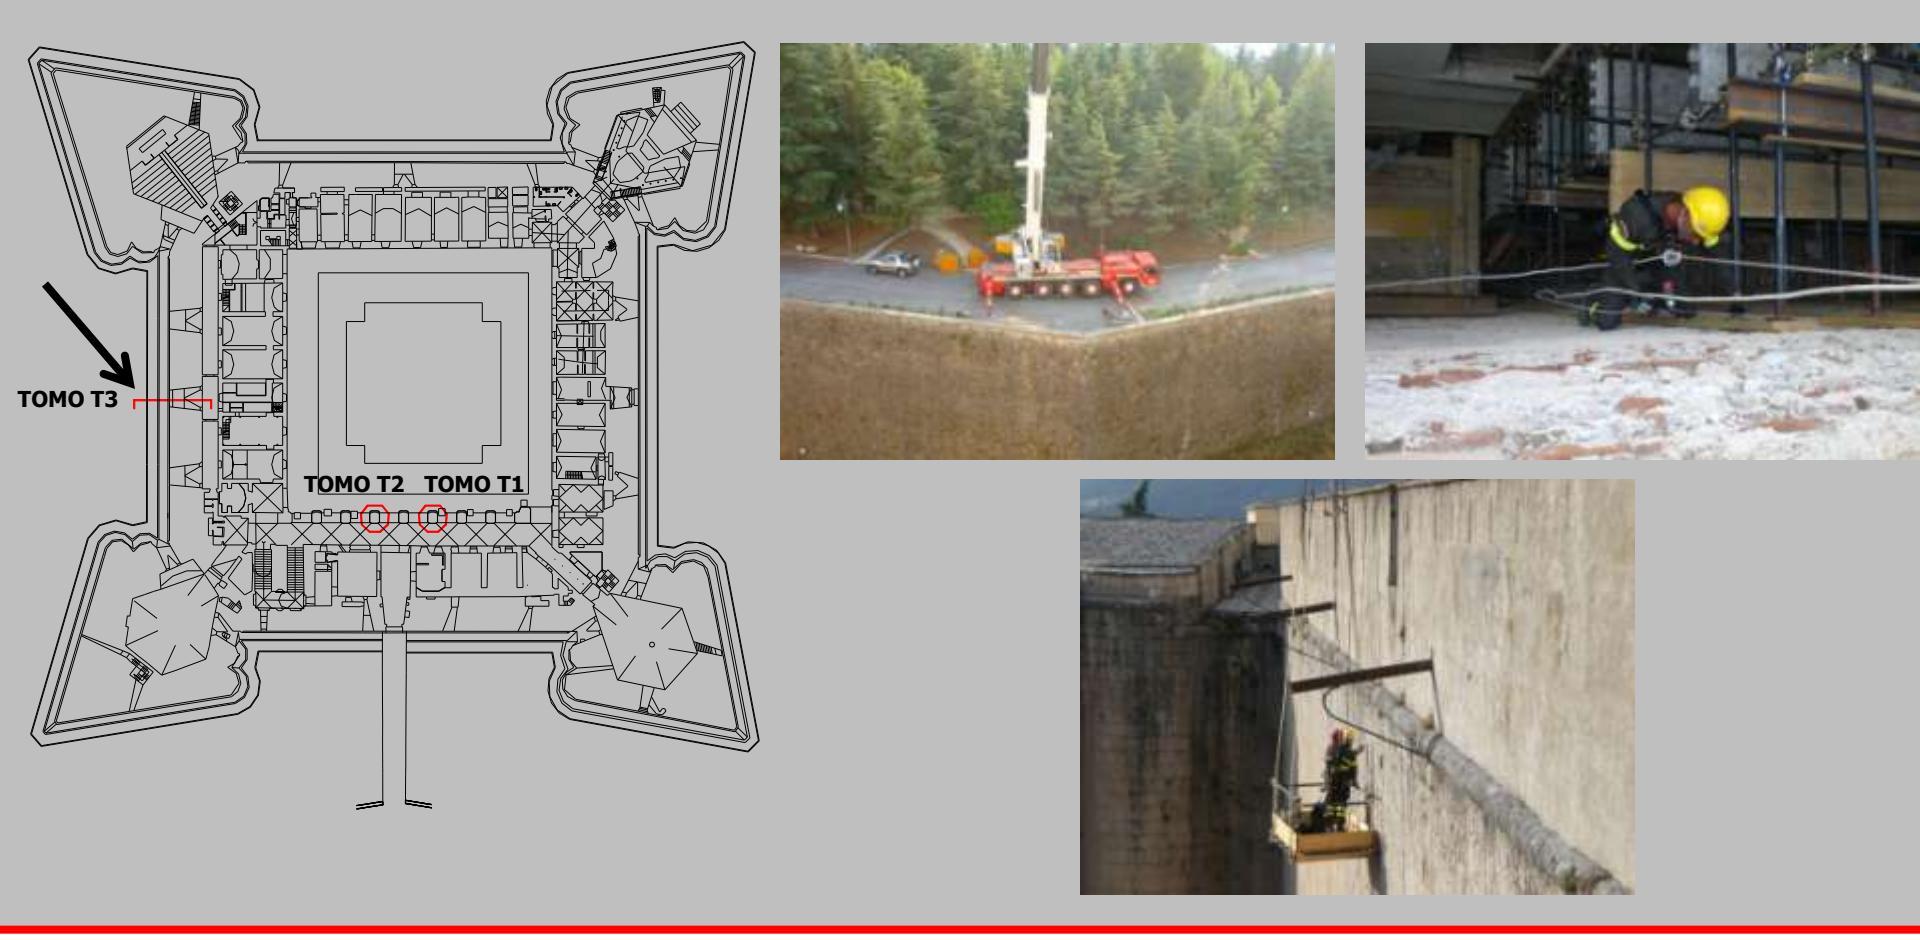
The third tomography involved the vertical section of a masonry wall in the South-West wing of the. The aim was to collect qualitative data of masonry in this part of the castle that was heavily damaged by the earthquake.

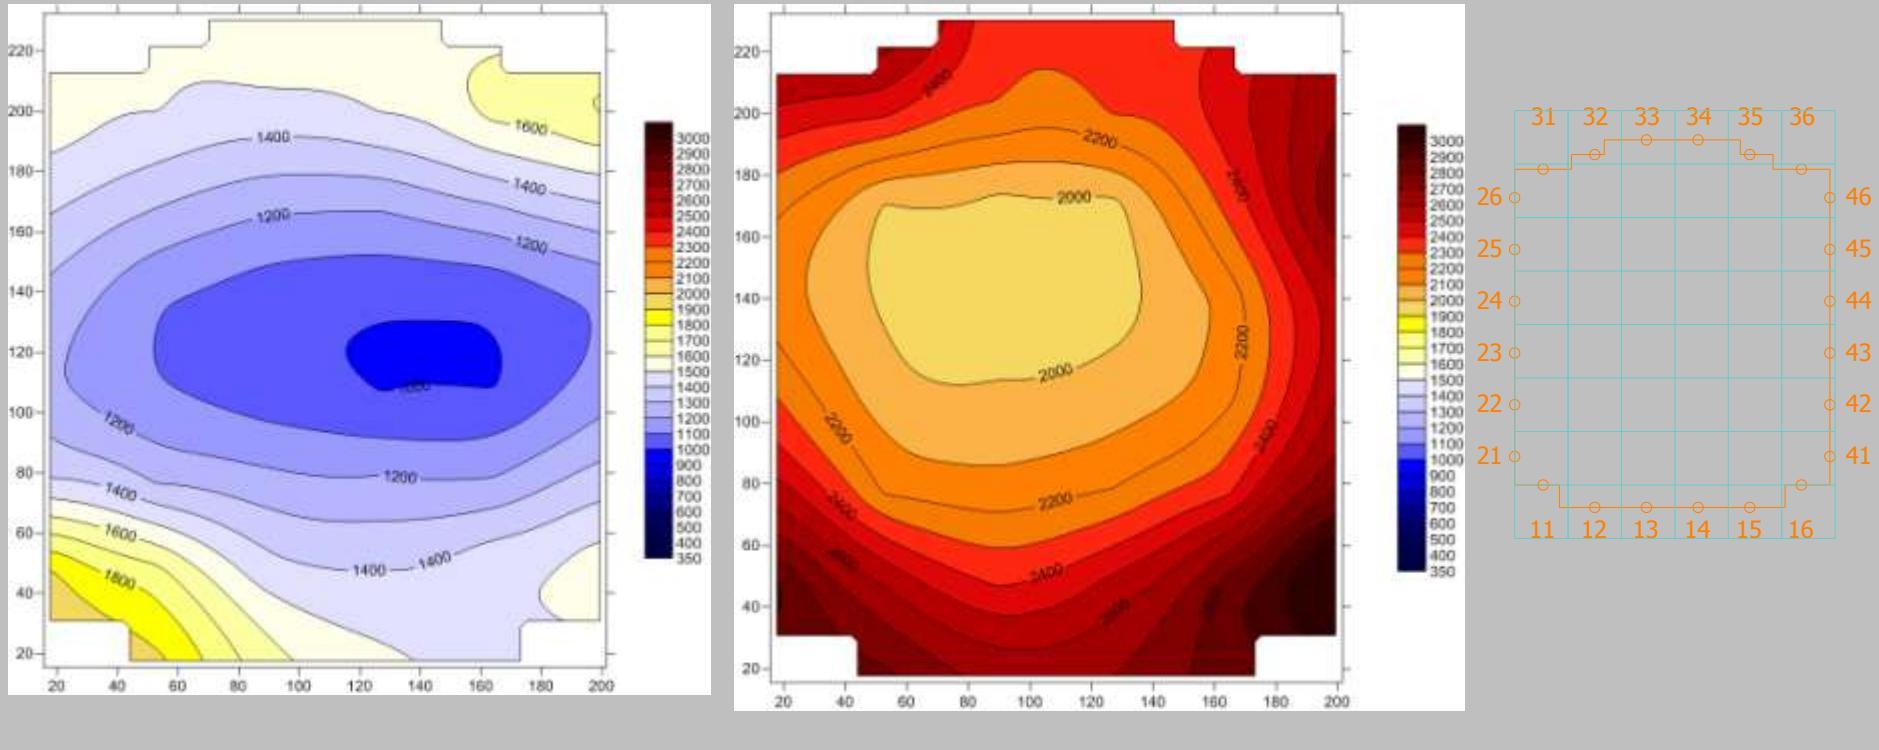
SONIC TOMOGRAPHY

TOMO 1: DAMAGED PILLAR

TOMO 2: UNDAMAGED PILLAR

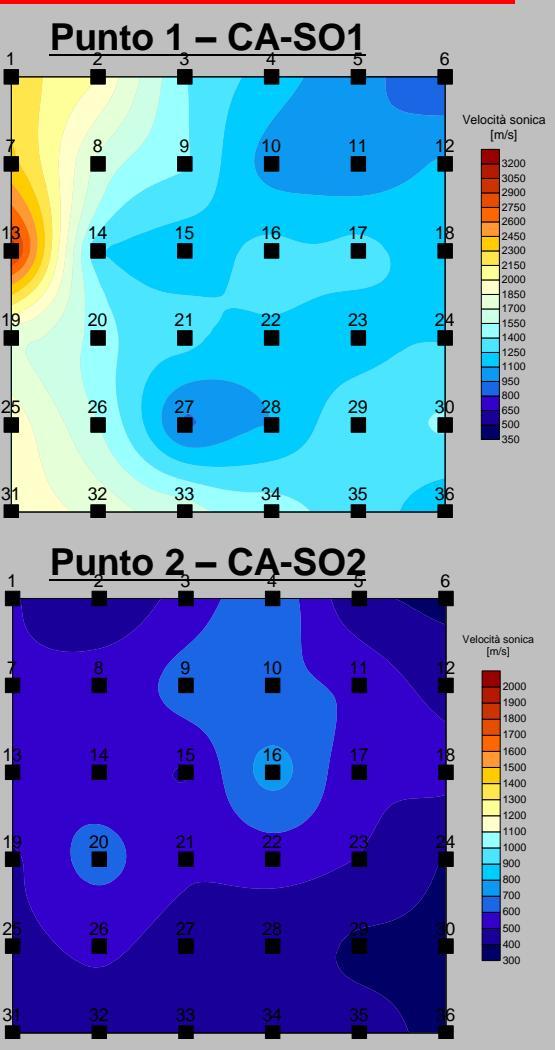
<u> Punto 1 – CA-SO1</u>

Punto 1 - Risultati in m/s

Velocità Max	punto 13	3046.41
Velocità min	punto 6	823.48
Velocità Media		1453.45
Deviazione Standard		454.11

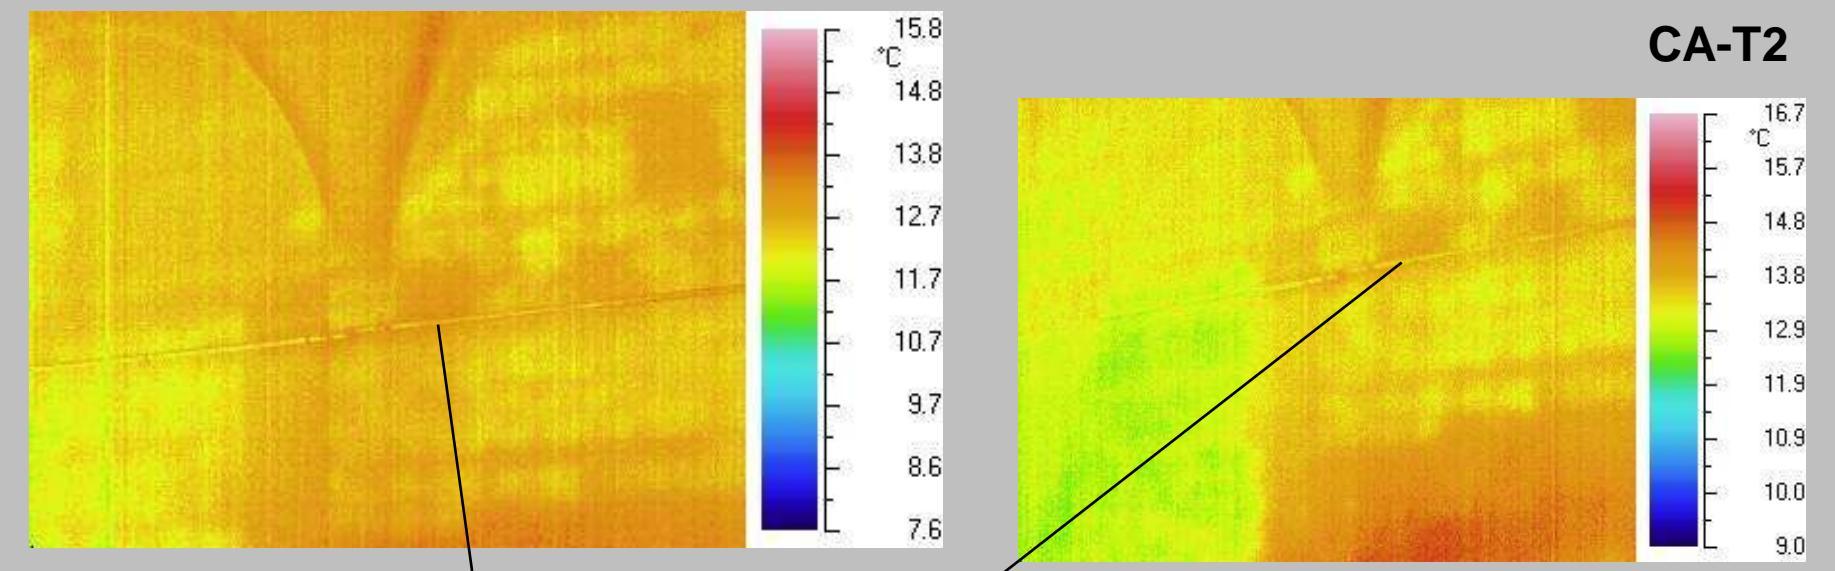
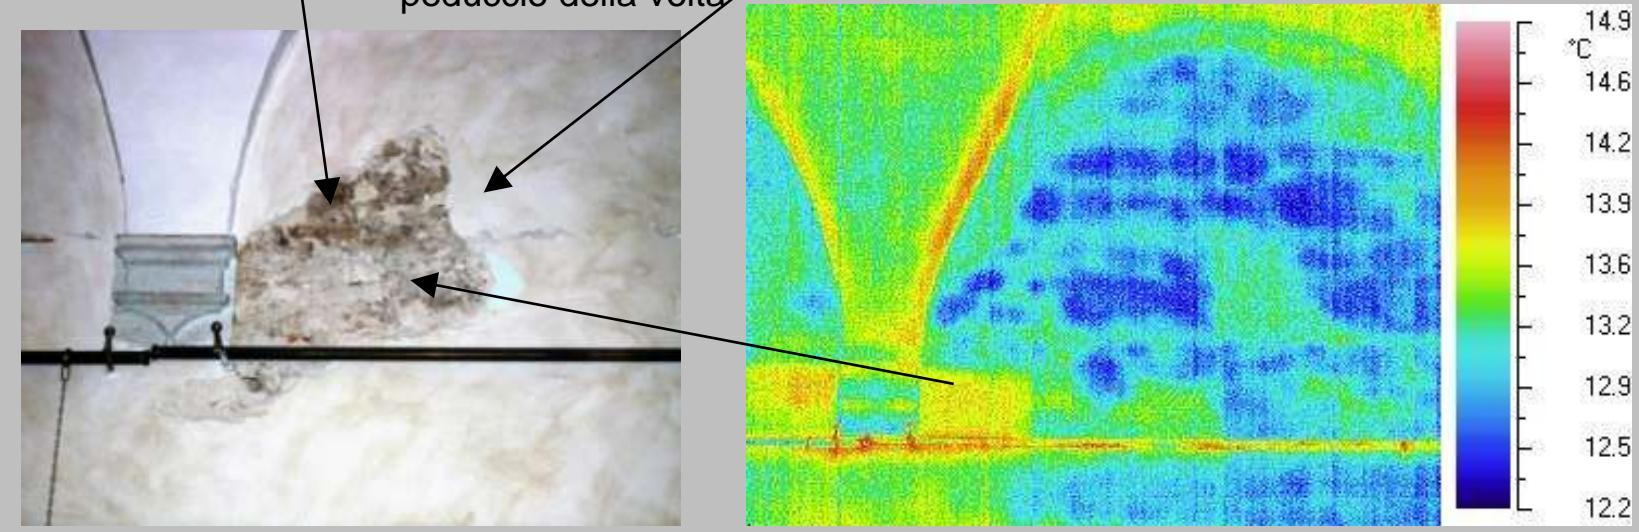
Identificazione di un'area composta da mattoni-e di blocchi grandi di pietra sotto il peduccio della volta

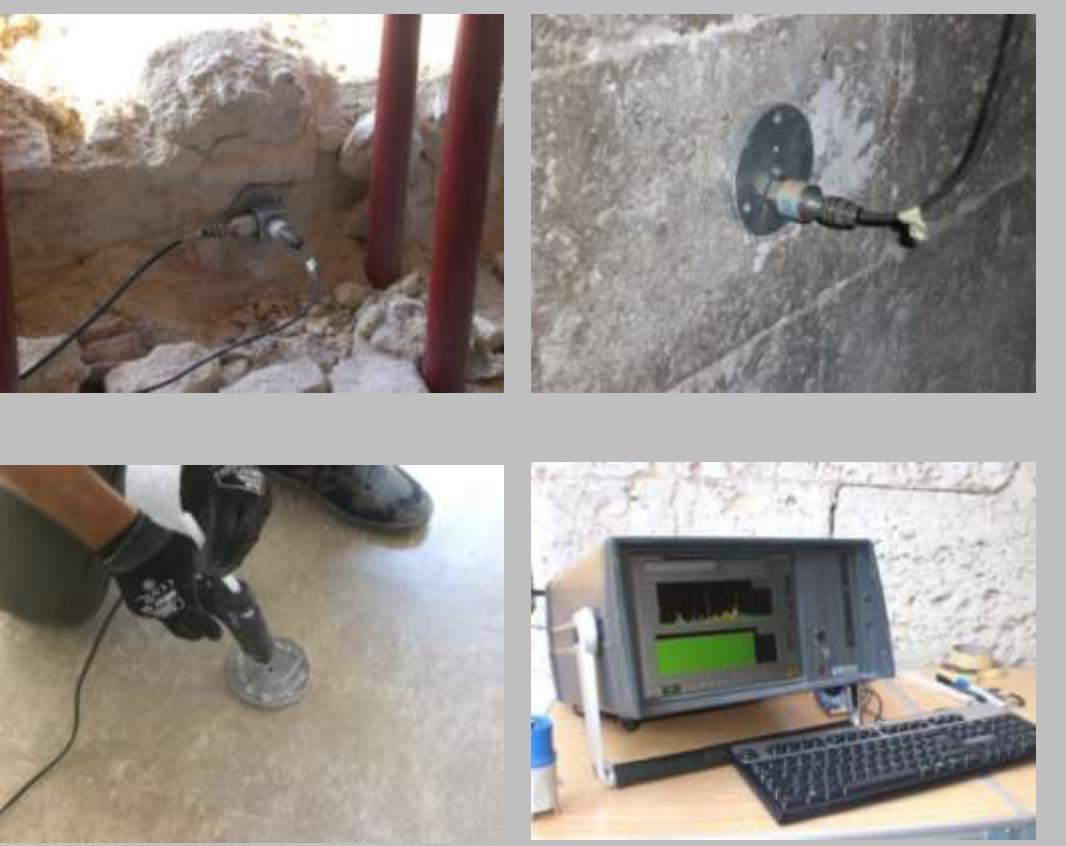
Fissaggio dei sensori e registrazione dei segnali

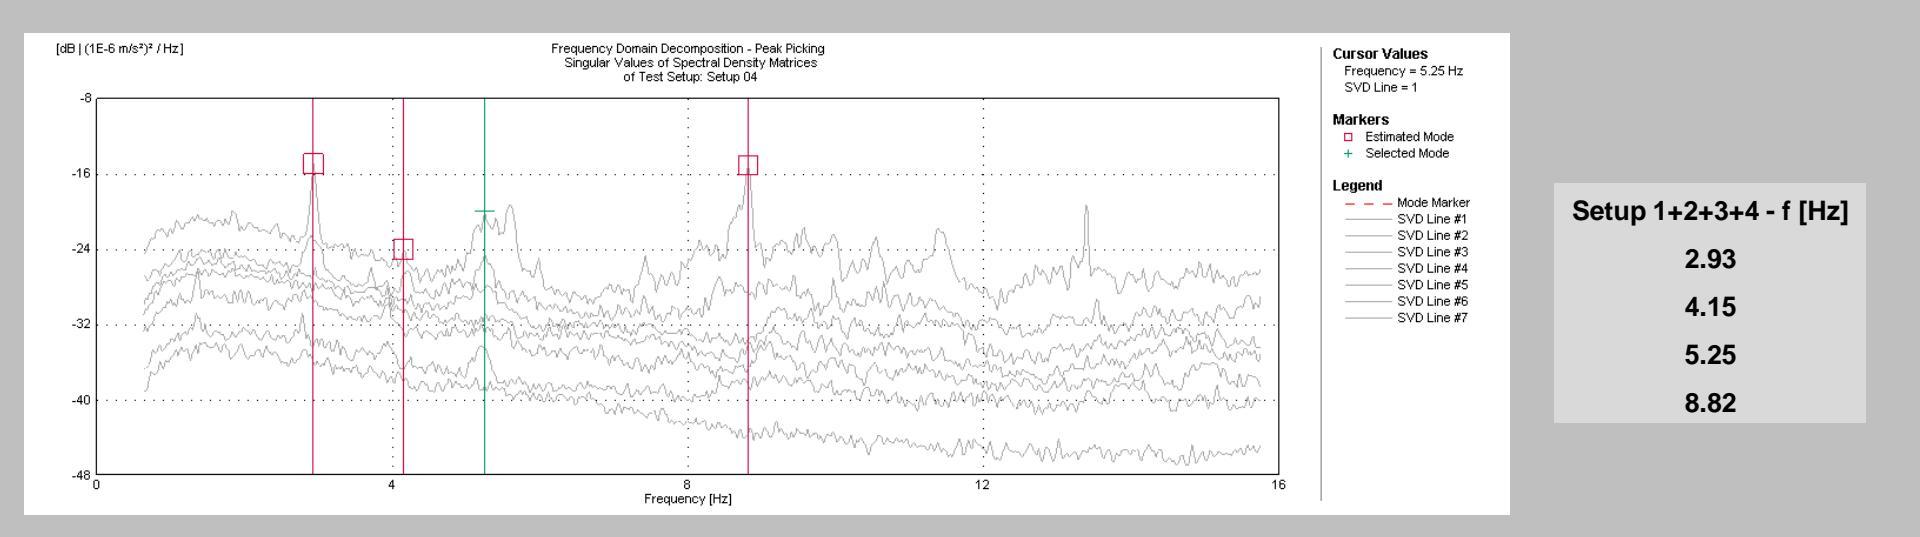
The analysis of the results clearly identify the first out-of-plane bending mode, corresponding to the frequency of 2.93 Hz, emerged in all acquisitions (*Fig.37* and *Tab.2*). The identification of the global vibration mode of the structure indicates that the building, in spite of the high level of damage and the disconnection of the perimeter masonry walls, has still a unitary dynamic response, probably thanks to the provisional emergency system of steel cables. Another vibration mode is detected by the analysis of individual data for each setup, and it is an out of phase bending mode recorded at the frequency of 5.2 - 5.4 Hz.

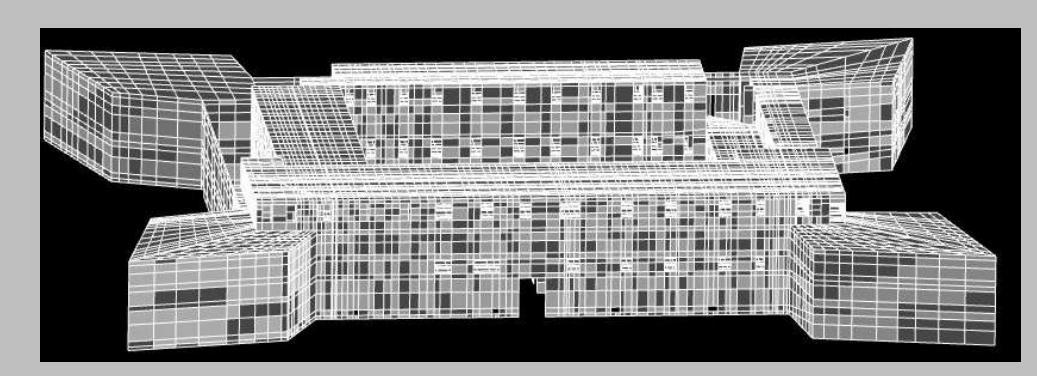
Mode shape at 2.76 Hz

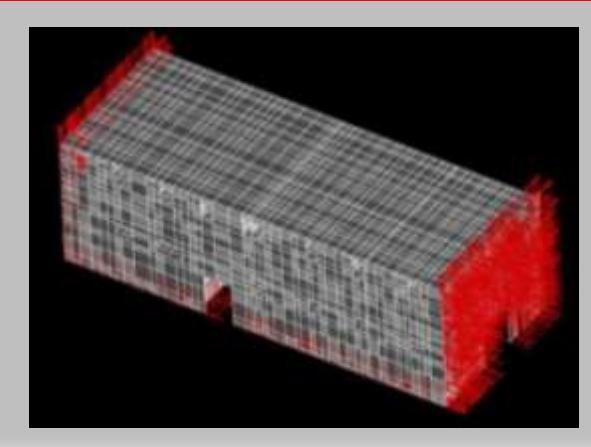
Mode shape at 4.21 Hz

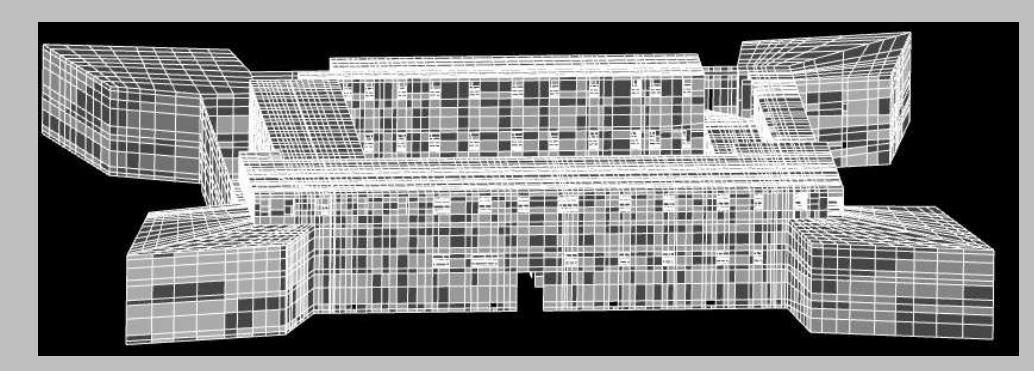
Forma modale ottenuta col modello per 5.14 Hz

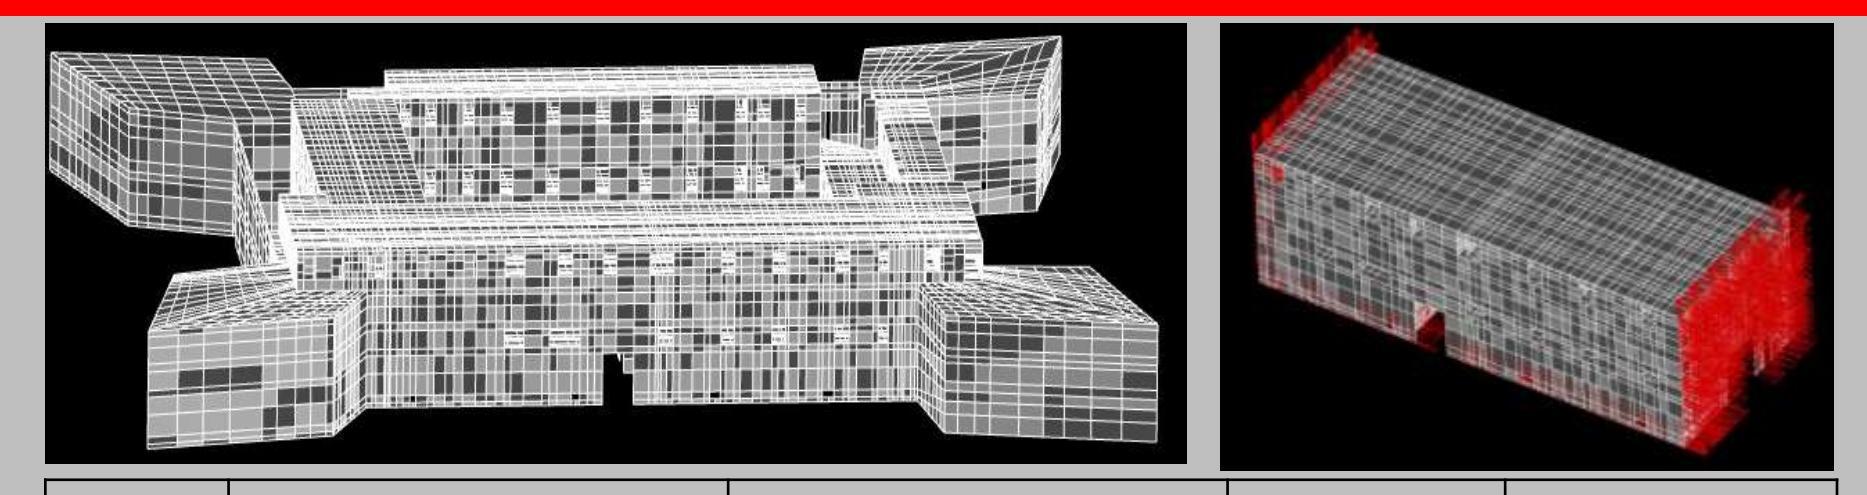
Experimental results	FEA results	Difference [%]	
f ₁ [Hz]	2.88	2.76	4.3	
f ₂ [Hz]	4.11	4.21	2.5	
f ₃ [Hz]	5.21	5.14	1.4	
f ₄ [Hz]	8.47	8.65	2.1	f4

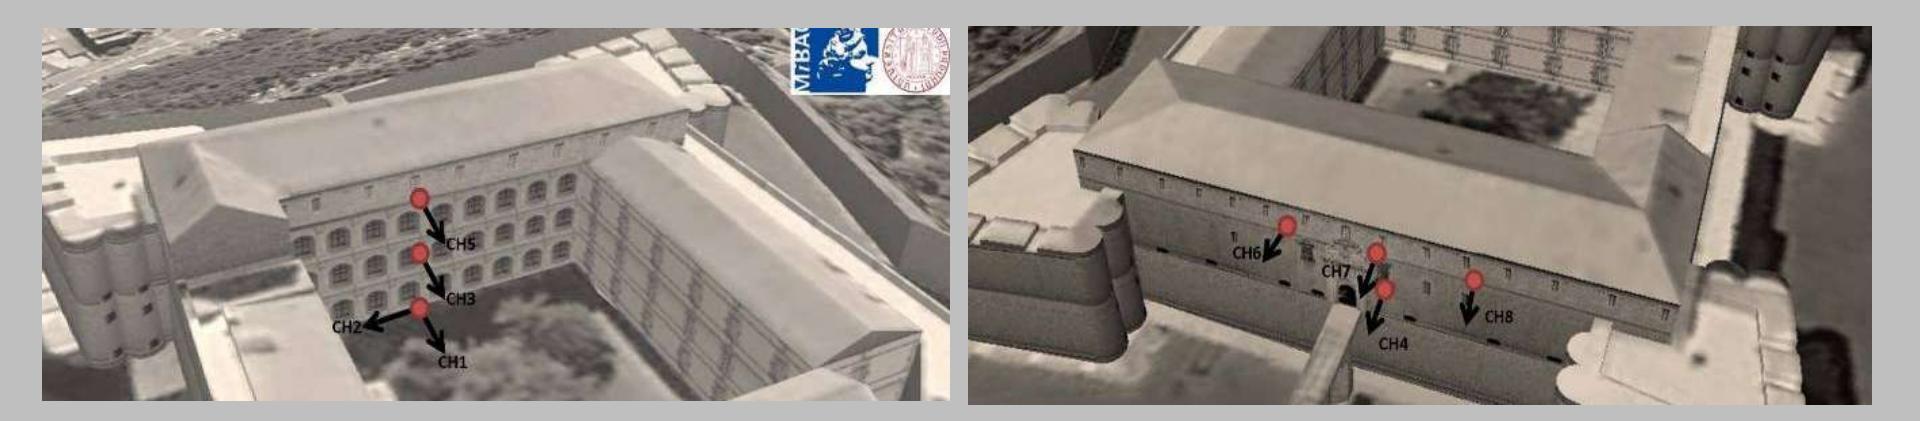
In December 2009 a dynamic monitoring system was installed in the Fortress, composed by an acquisition unit connected to eight high sensitivity piezoelectric accelerometers. The central unit, located at the second floor of the fortress, in the South-East wing, is provided with a Wi-Fi router for remote data transmission.

A couple of reference sensors is fixed at the base of the structure for the record of the ground acceleration both in operational conditions and during seismic events. The positioning of the acceleration sensors on the elevation of the S-East wing was decided as a result of the structural dynamic identification.

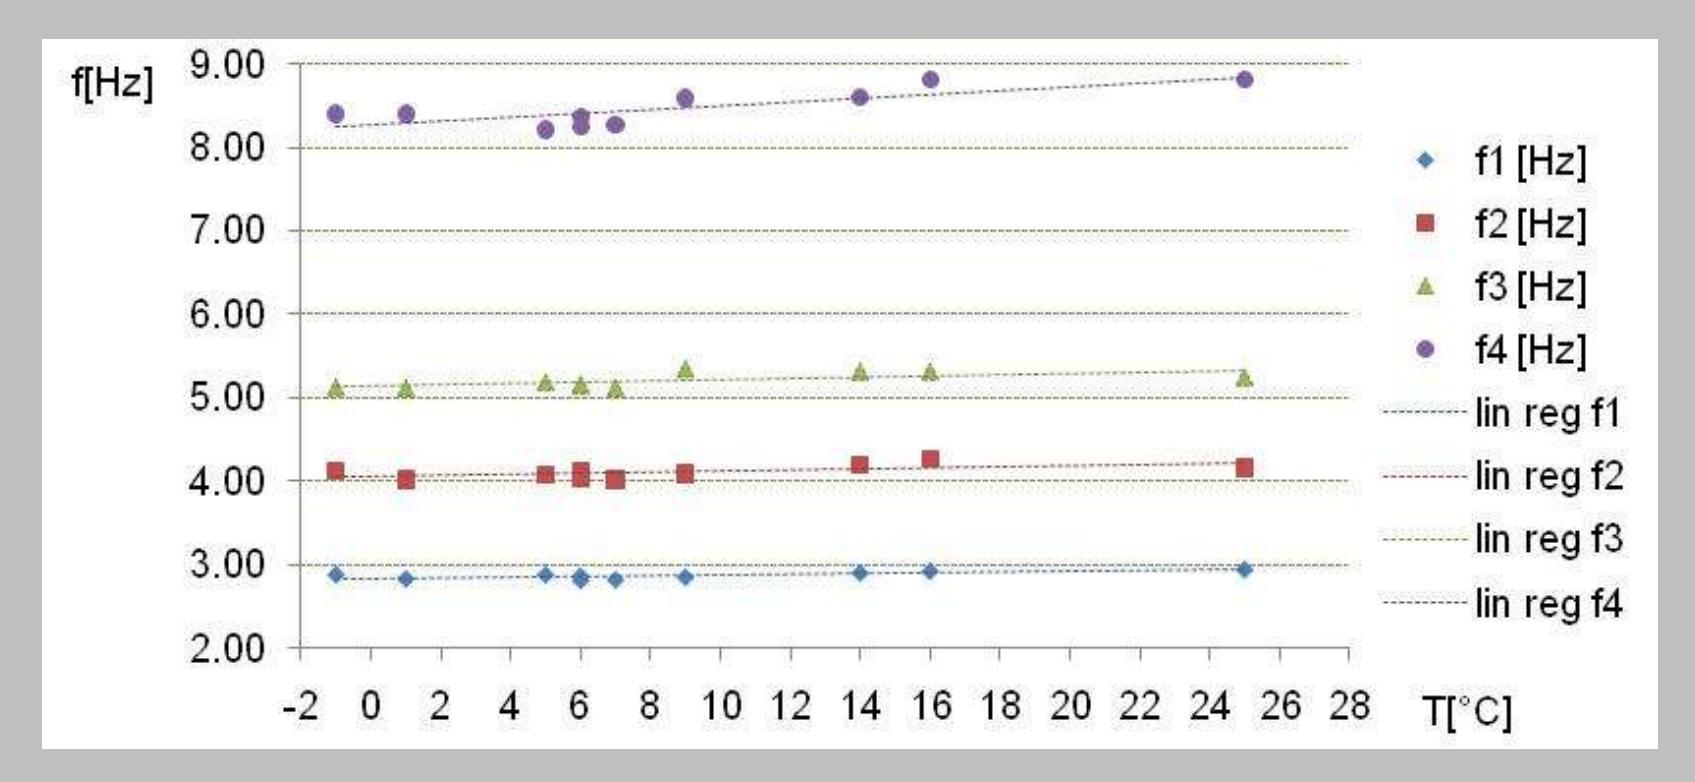
From the observation of the initial results, it seems that there exists a correlation between natural frequencies and environmental parameters, that is to say that frequencies tend to increase with the temperature

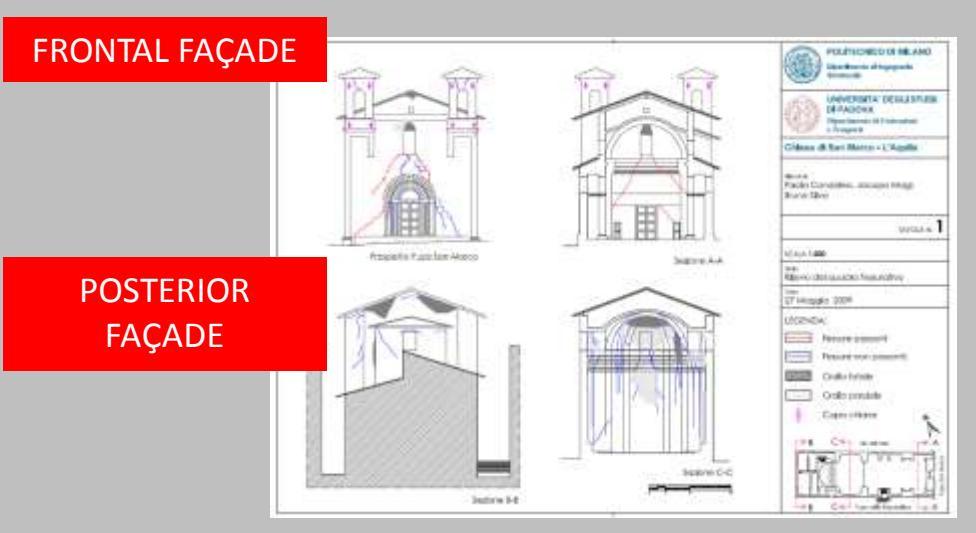
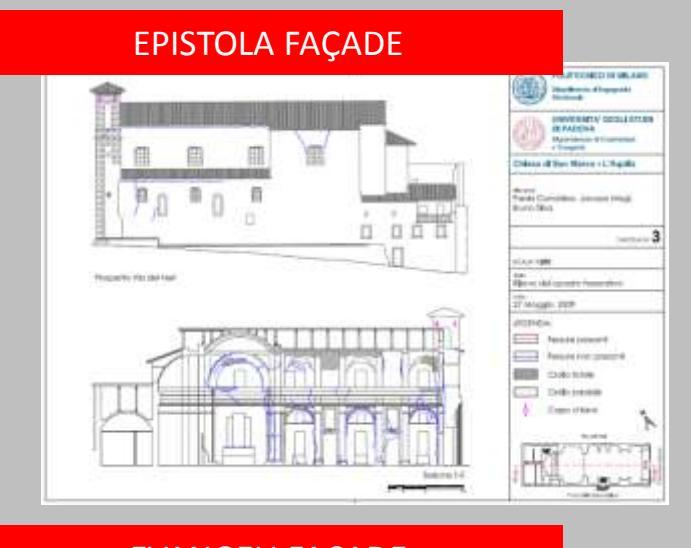
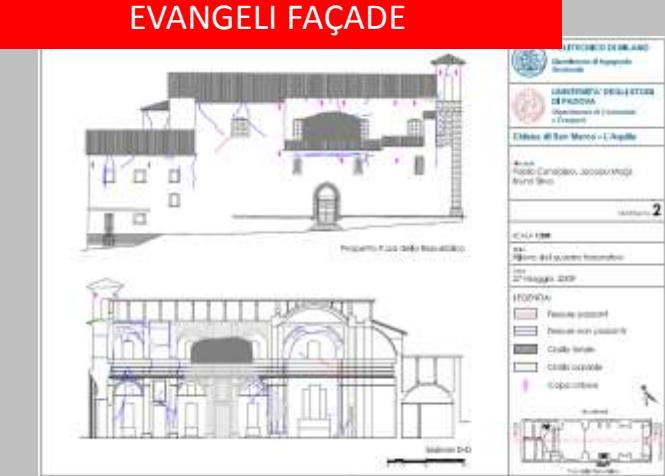
SURVEY AND DESCRIPTION OF THE CARCK PATTERN

The several technical inspections to the church during the months following the earthquake allowed the creation of detailed internal and external crack pattern maps. The interpretation of the crack pattern can be of great help in understanding the state of damage of the structure, its possible causes and the type of survey to be performed, provided that the development history of the building is already known. In this case the crack pattern maps allowed an easy and intuitive assessment of the damage during the seismic event.

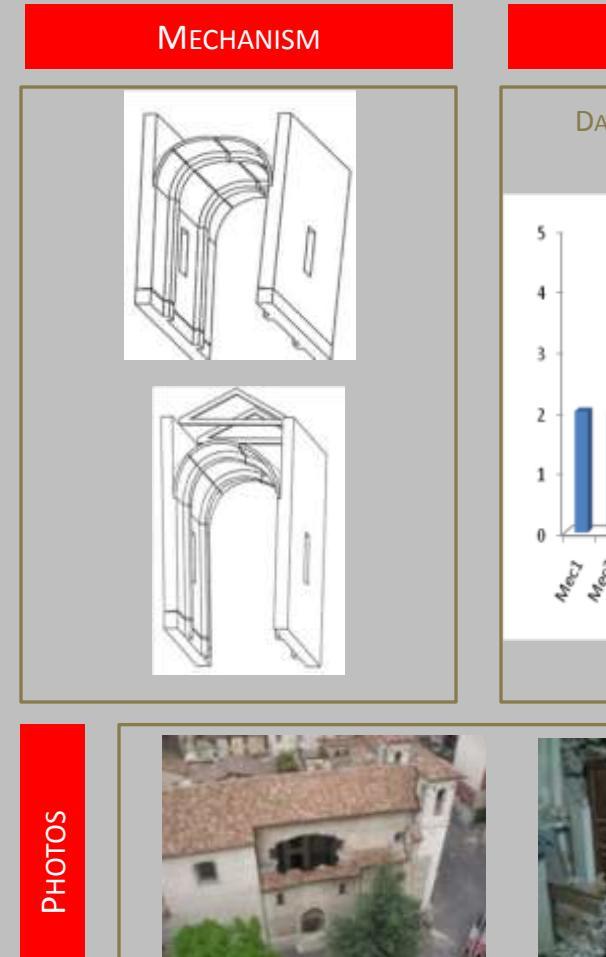
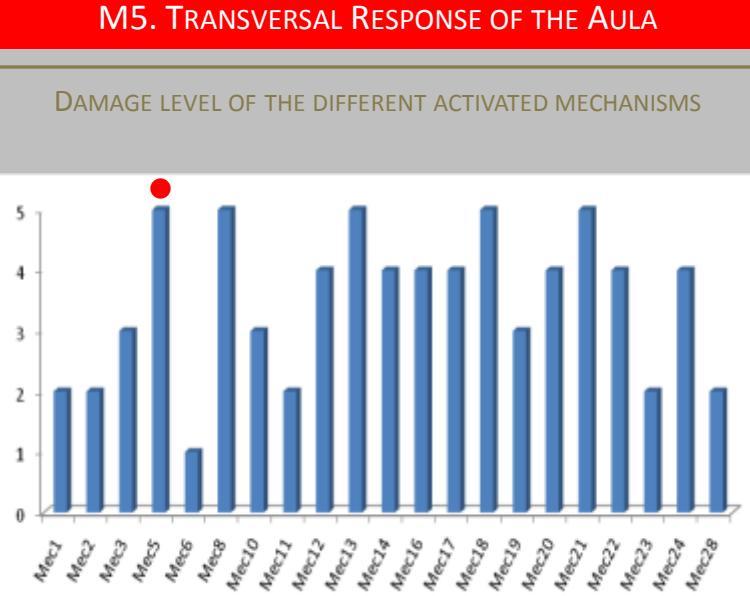
ACTIVATED DAMAGE MECHANISMS

DETAILED ANALYSIS OF THE MECHANISMS, OUTLINING A SET OF POSSIBLE CAUSES THROUGH THE CORRELATION OF THIS MECHANISMS WITH ALL THE PREVIOUSLY GATHERED INFORMATION (CRACK MAP, INTERVENTIONS, TRANSFORMATIONS, ETC...)

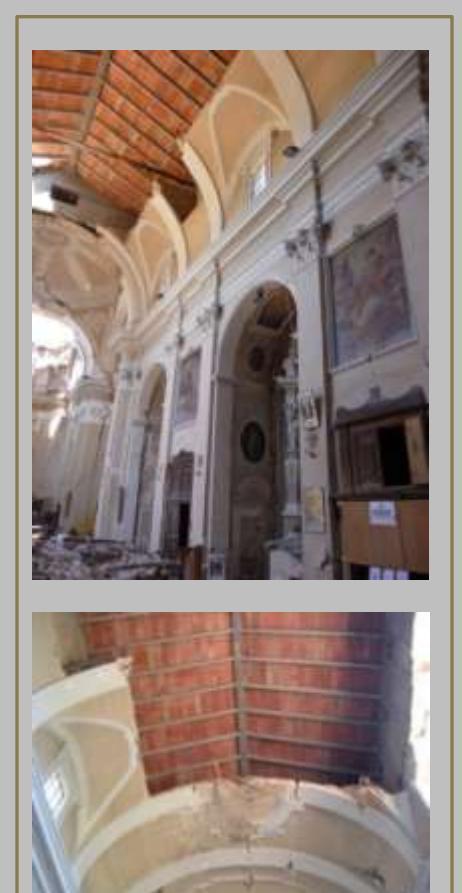
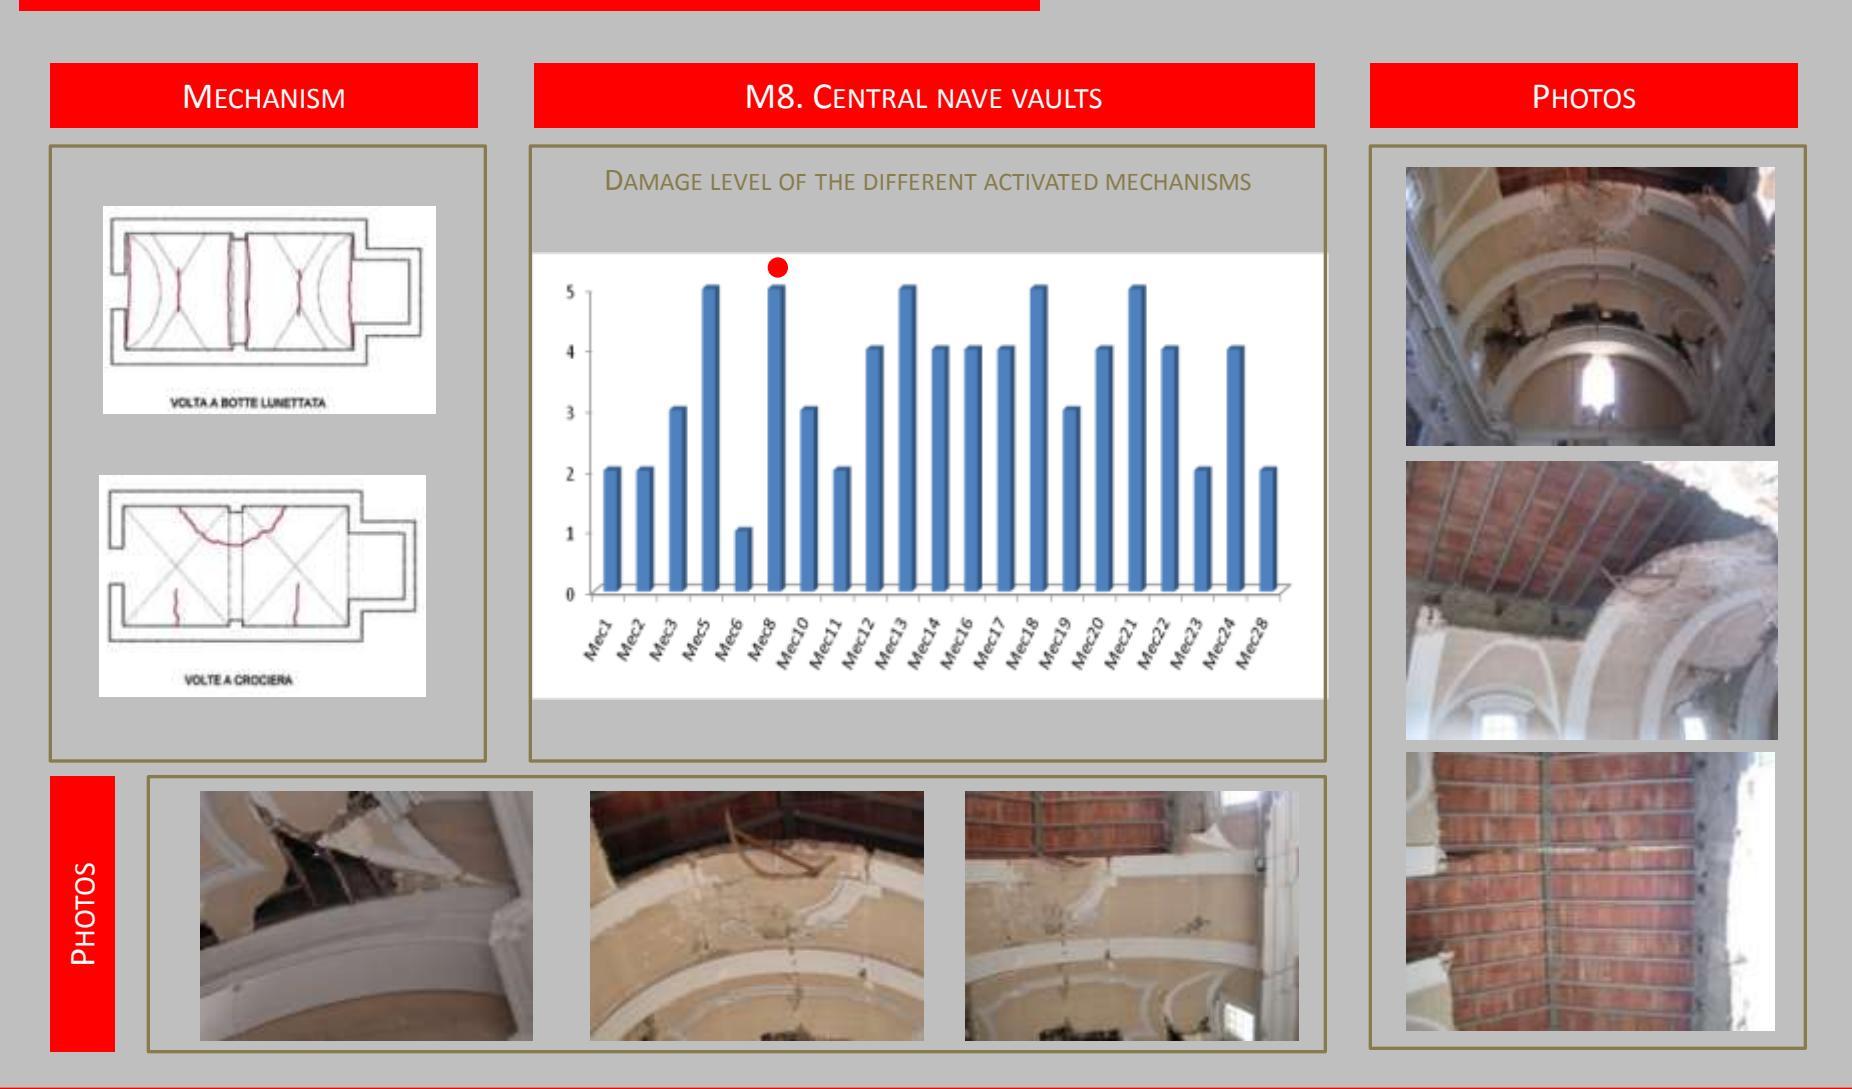
Рнотоз

After the earthquake the church reported severe damage in the apsidal and transept area, where a critical crack pattern was noticed in the external walls, which manifested a visible outward overturning, involving the four pillars sustaining the dome. Also the transversal response of the church proved to be inadequate, since the most part of the vaults collapsed, such as a big portion of the external wall, at the clerestory level. Severe damage was finally reported in the vaults of the apse, of the presbytery, in the triumphal arch.

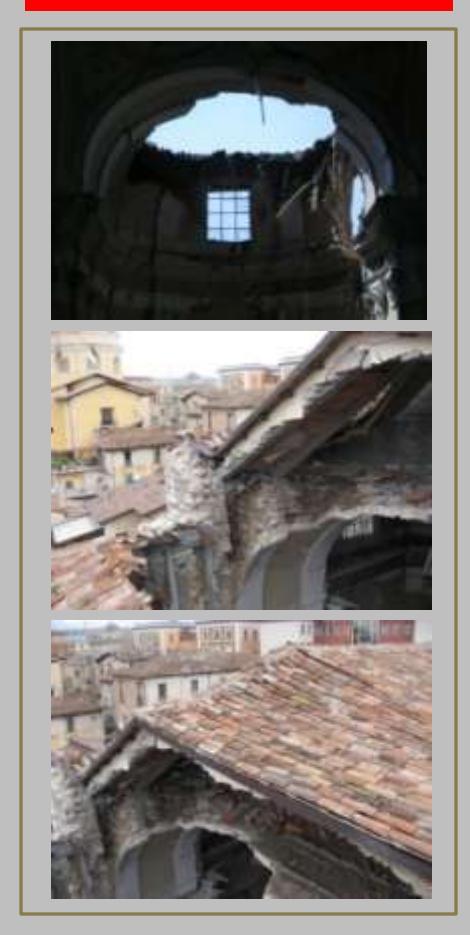
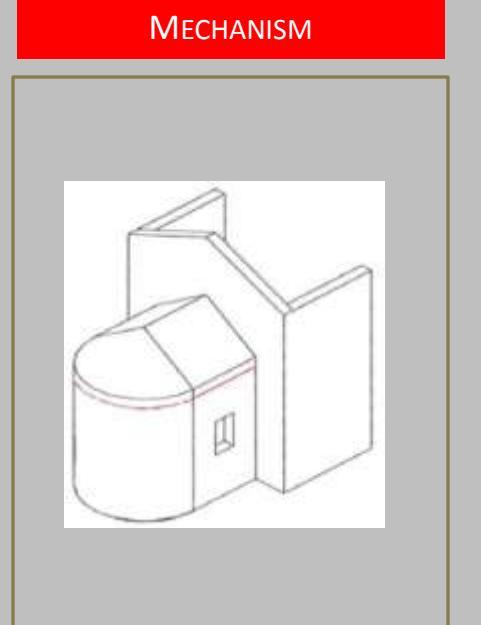
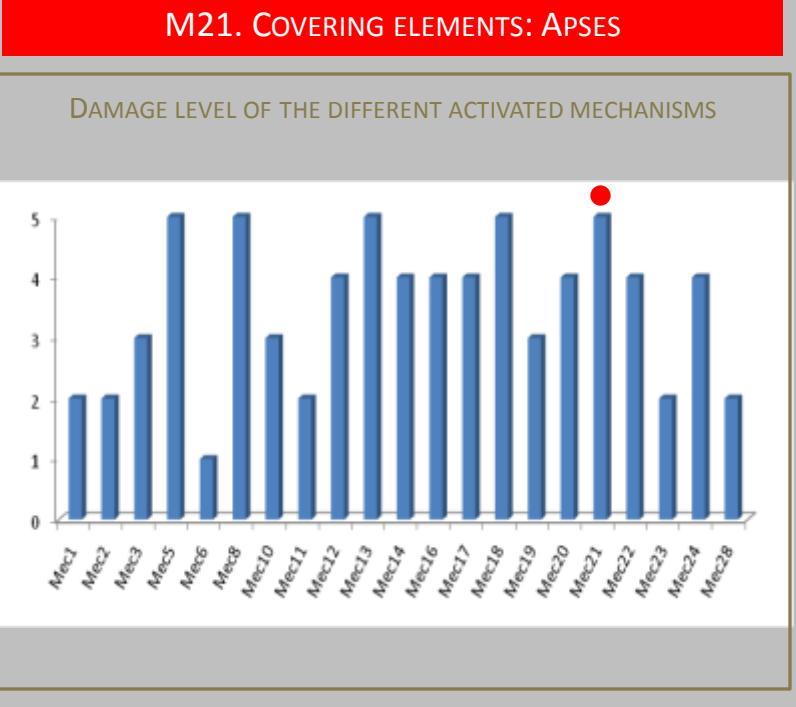
Рнотоѕ

ACTIVATED DAMAGE MECHANISMS

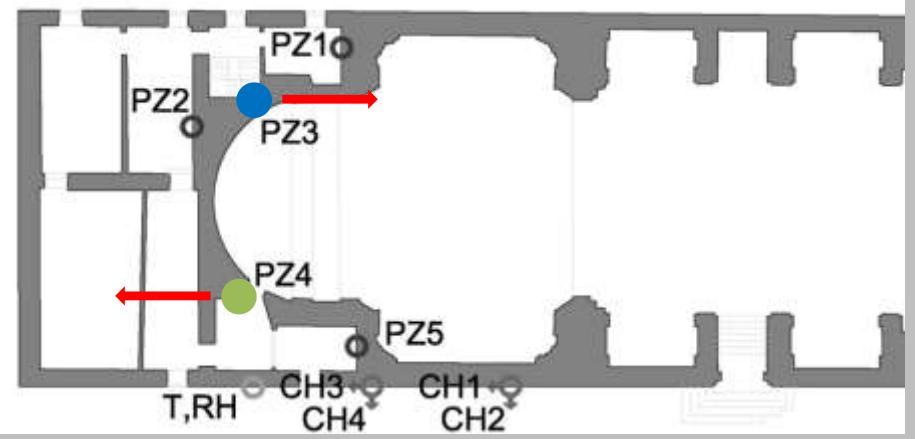
PZ 3 and PZ 4 (14.10.2010)

Stability of the crack pattern
Settling and climate factors

- same modulus ~ 0.80 mm
- opposite verse
- symmetric position in the apse
- no correlation with aftershocks

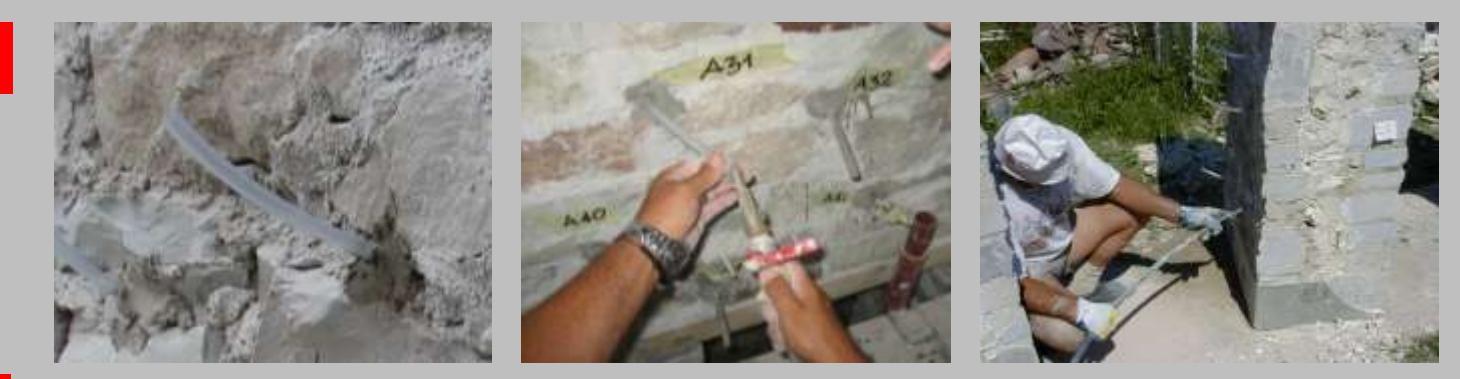
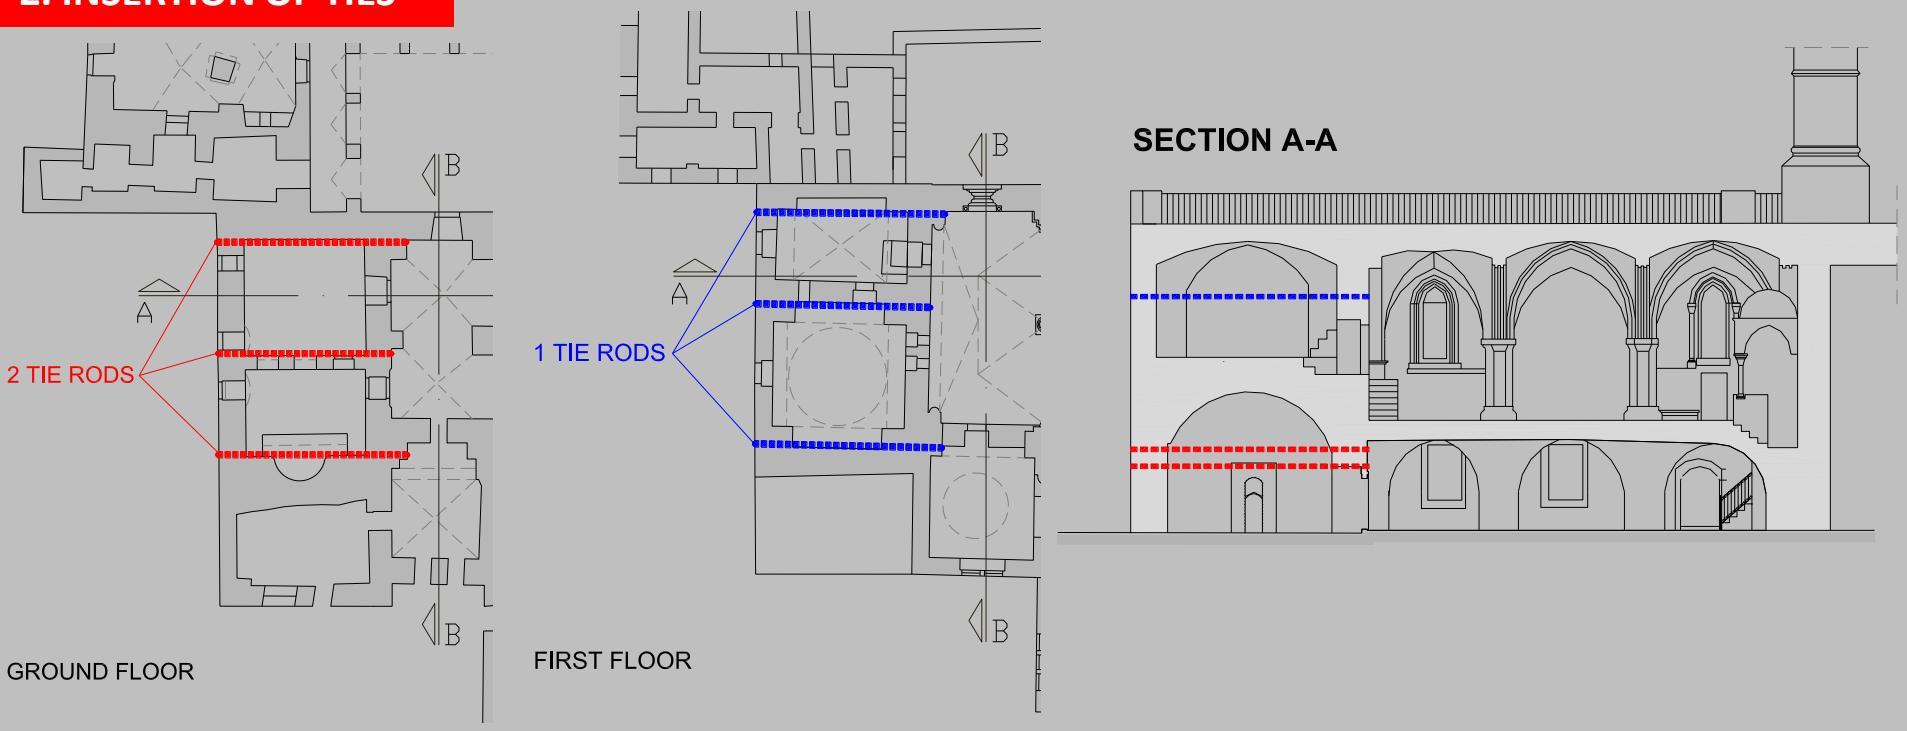
2. INSERTION OF TIES

The limit analysis showed that the most vulnerable structural element in relation to the seismic risk is the eastern façade on the cemetery. The thrusts of the barrel vault on the ground floor and of the vault and cupola on the first floor are particularly high and induce to a precarious stability condition of the whole structural system. This is also testifies by the fact that most likely the façade has been reconstructed several times during centuries, since it is possible to recognize different kind of stone and different textures and arrangements of stones in the façade's elevation

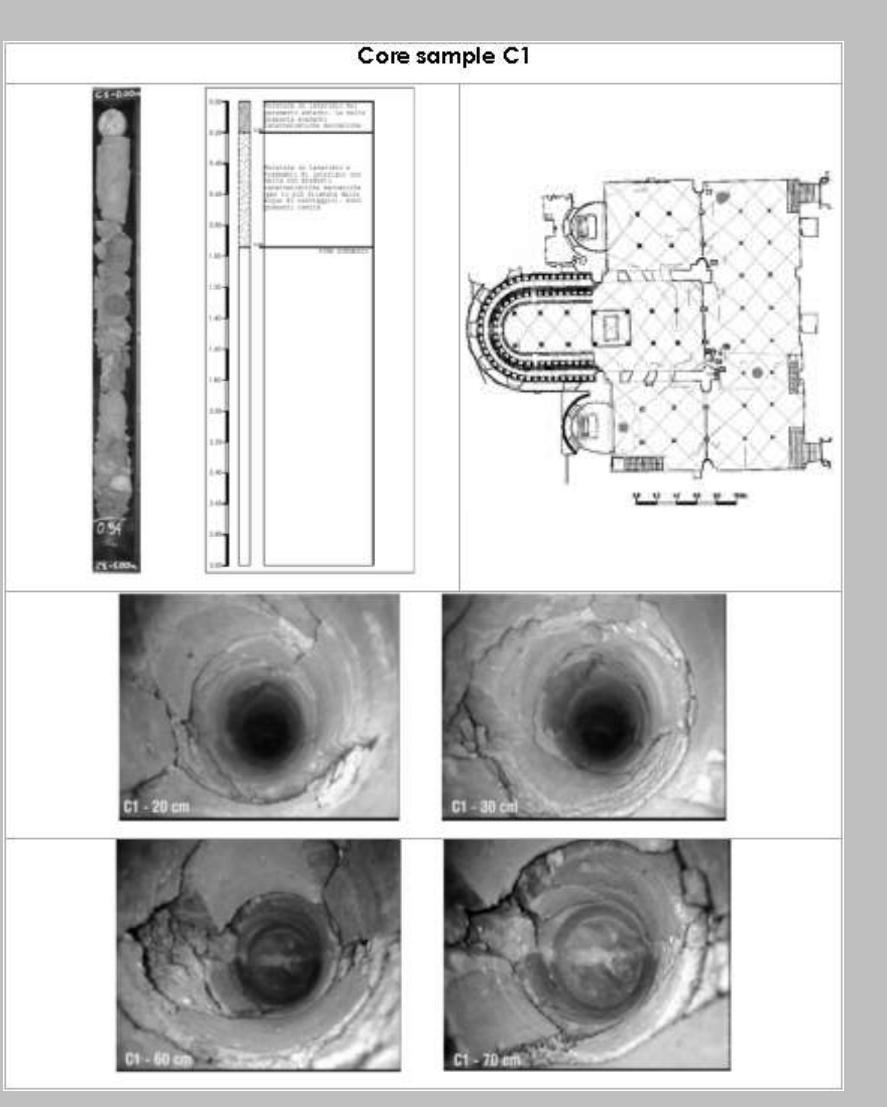
The **core samples** encountered brick masonry presenting in general poor mechanical characteristics. In particular, inside the masonry of the pillars, some pieces of disarranged bricks and several cavities due to the scarce cohesion of the mortar, which has been often washed away by the water used for the perforation, were found.

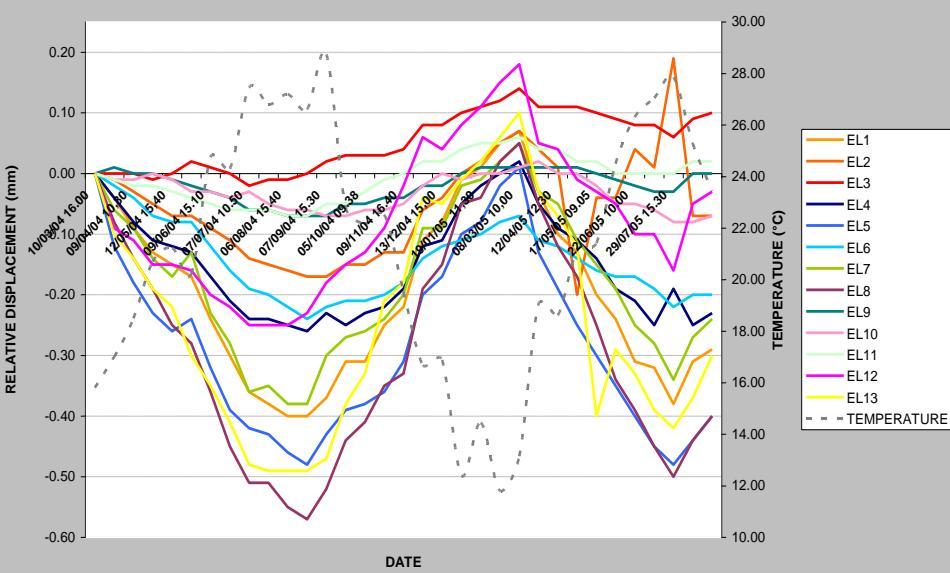
linear potentiometric transducers EL1... EL13

Crack mouth opening

The **seasonal effect** is generally visible and the relative displacement are generally contained within **narrow variations** (the tenth part of a millimeter/half mm).
