POSSIBLE SOLUTIONS BEFORE AND IMMEDIATELY AFTER EARTHQUAKE.

SPEAKER: PROF. CLAUDIO MODENA

DEPARTMENT OF STRUCTURAL & TRANSPORTATIONS ENGINEERING UNIVERSITY OF PADOVA, ITALY

THE SPANISH FORTRESS

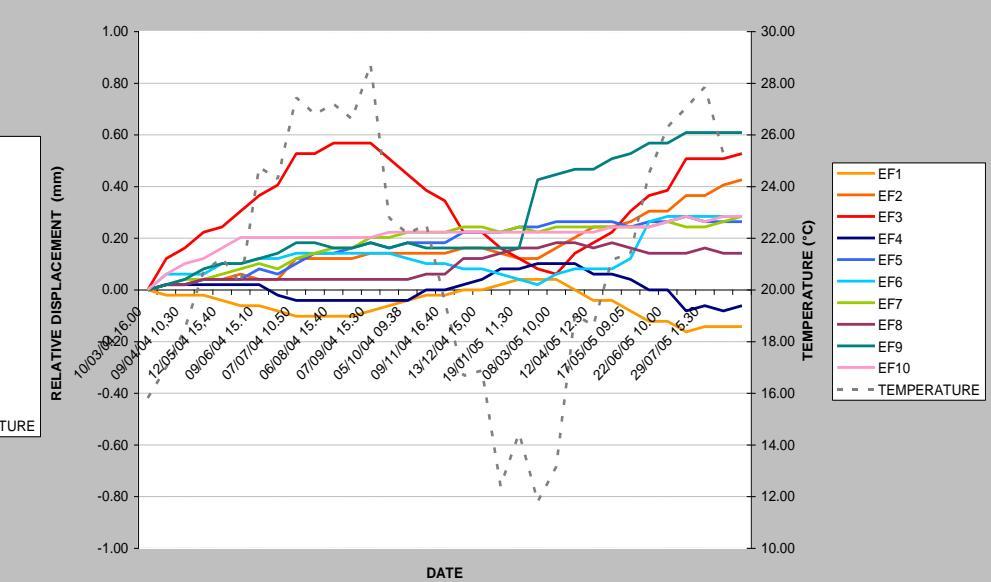
cable extension position transducers EF1...EF10

Relative distance

The **seasonal effect** is generally visible and the relative displacement are generally contained within **narrow variations** (the tenth part of a millimeter/half mm).

Since maintenance works are being carried out where the sensors are positioned, some of the curves were modified in order to remove inconsistent data caused by accidental sensors disturbance (EF3, EF6, EF8).

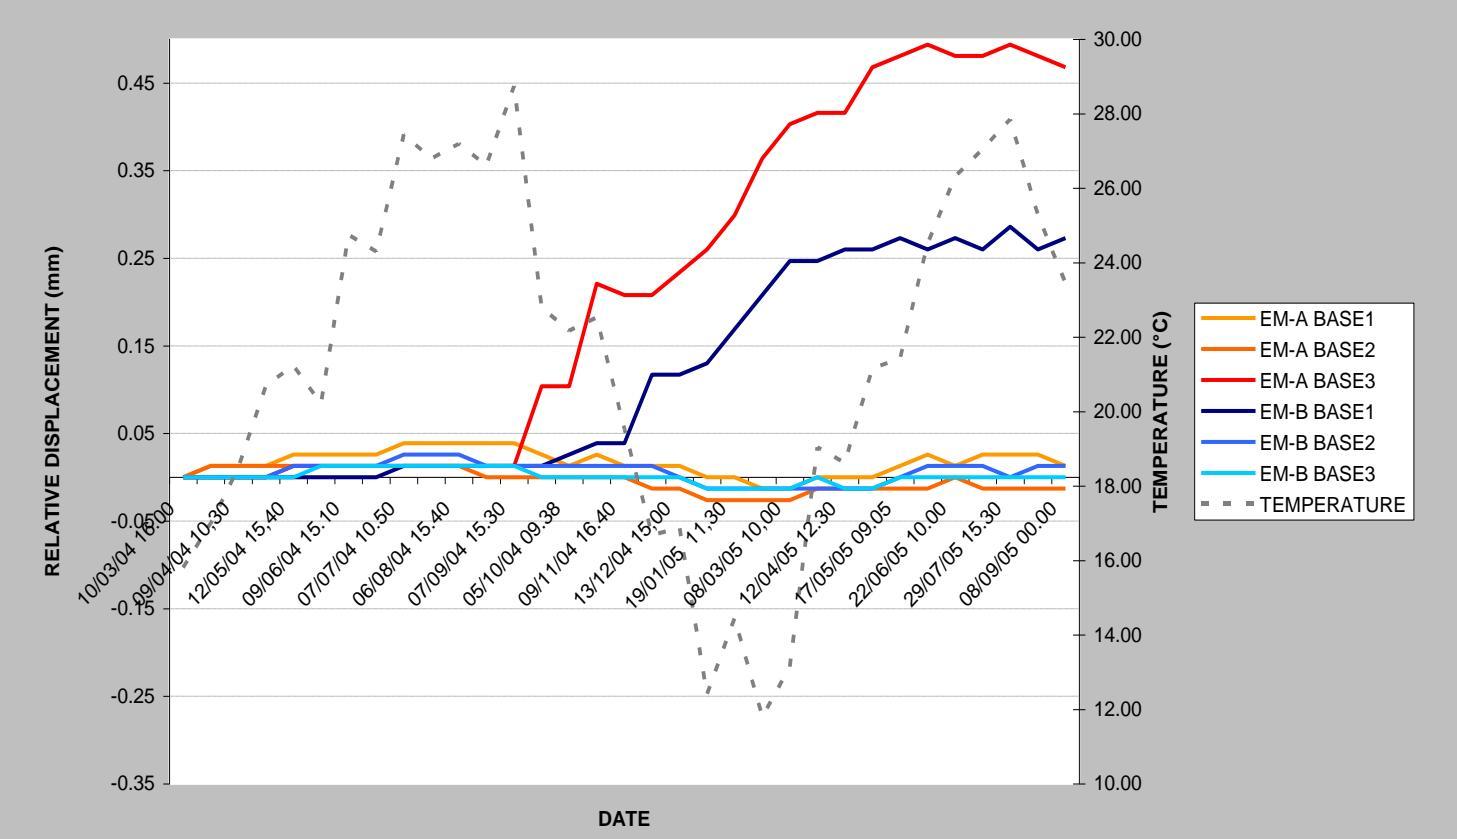
It is visible a general slight tendency to "open" (positive values are related to increase in terms of distance between the measuring fixed points): however, the recorded data present **reduced values**. Four over six of the borehole rod extensometers measuring heads did not detect significant variations: some remarkable residual displacement are noticed, on the contrary, on base 3 of EM_A (5 m deep) and on base 1 of EM_B (15 m deep).

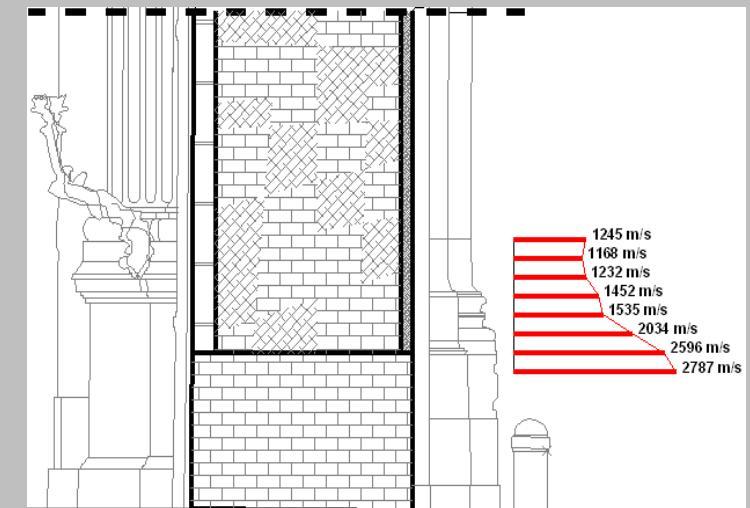
Sonic investigations results proposed the impression that the successive implementation the of kinematic mechanisms approach analyses, considering the selected masonry portions (macroelements) rigid as bodies. is **possible**, since the tested masonry portions did not denounce structural severe deficiencies, possible cause of sudden collapse (e.g. masonry crumbling) before beginning considered the of the mechanisms.

Sharp variation from the 1st two lower lines (average on 4 points equal to 2692 m/s) respect the upper ones (average on 12 points equal to 1444 m/s)

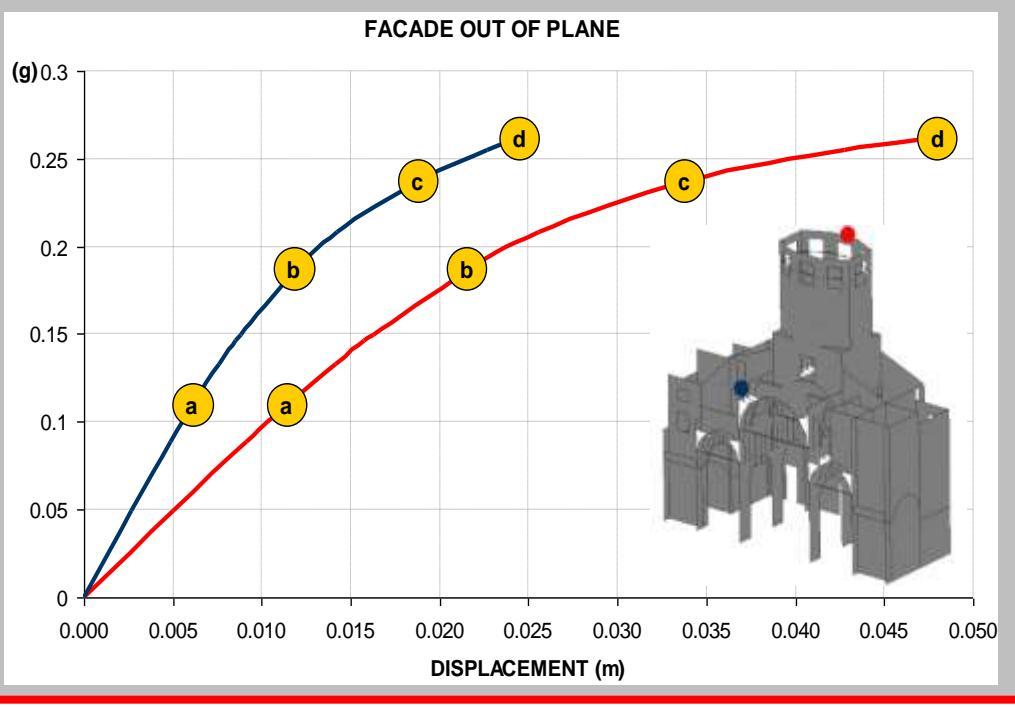
Model FL

The **horizontal mass proportional growing load** was applied towards the Cathedral's square.

Progression of the damage mechanism; deformation is magnified (x100)

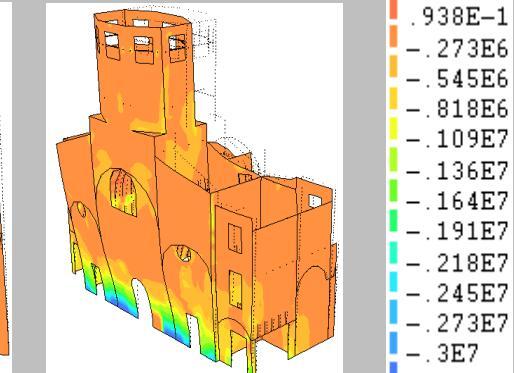
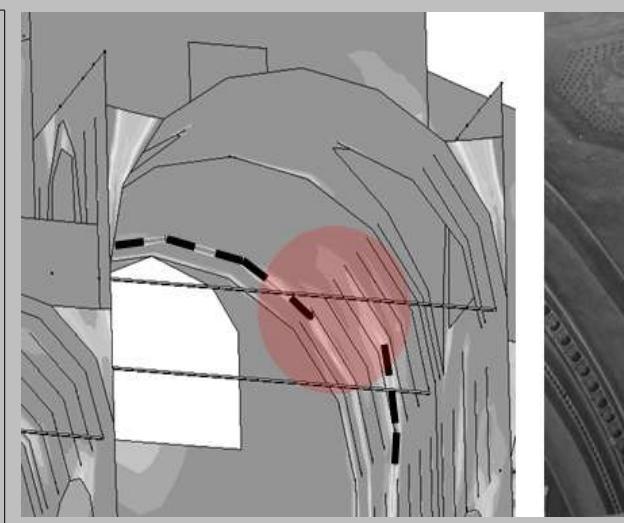
The **damage pattern predicted** by the analysis finds a remarkable correspondence with the **effective damage** denoted by the structures, in several positions:

Cracks opening - last step of the analysis (0.26 g)

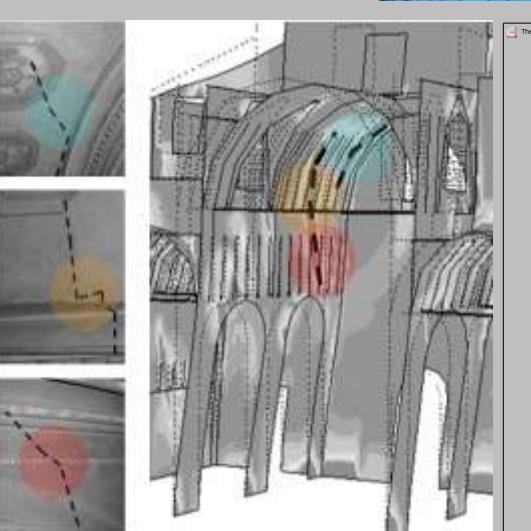
Principal minimum stresses - last step of the analysis (0.26 g)

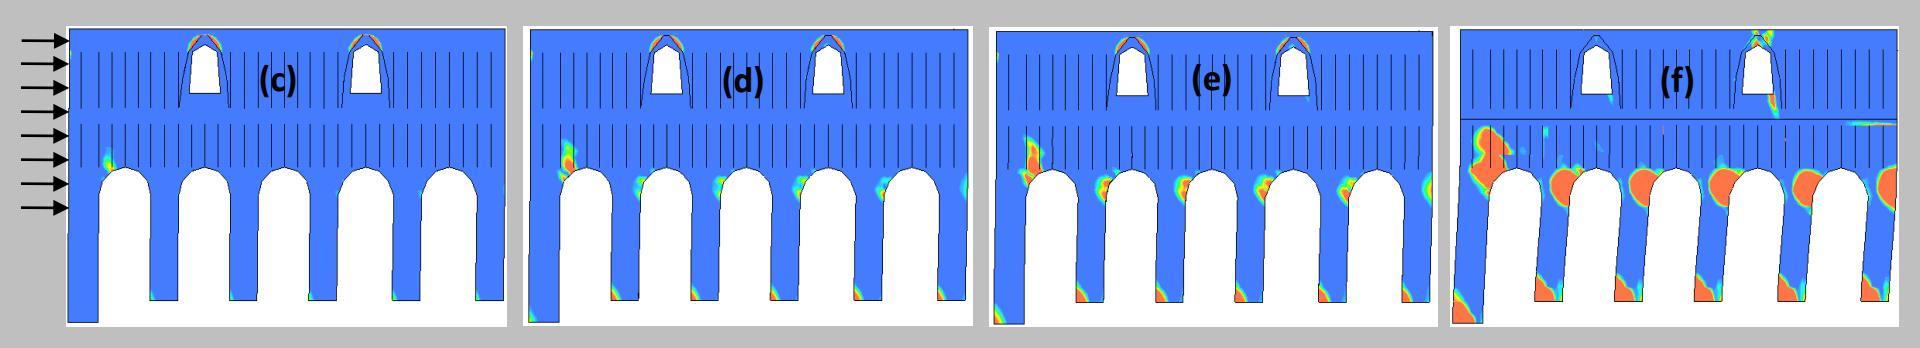
Model NL

The failure mode, following the application of growing horizontal loads, is determined by the overturning of the pillars

Damage identification – model prediction experimental verification

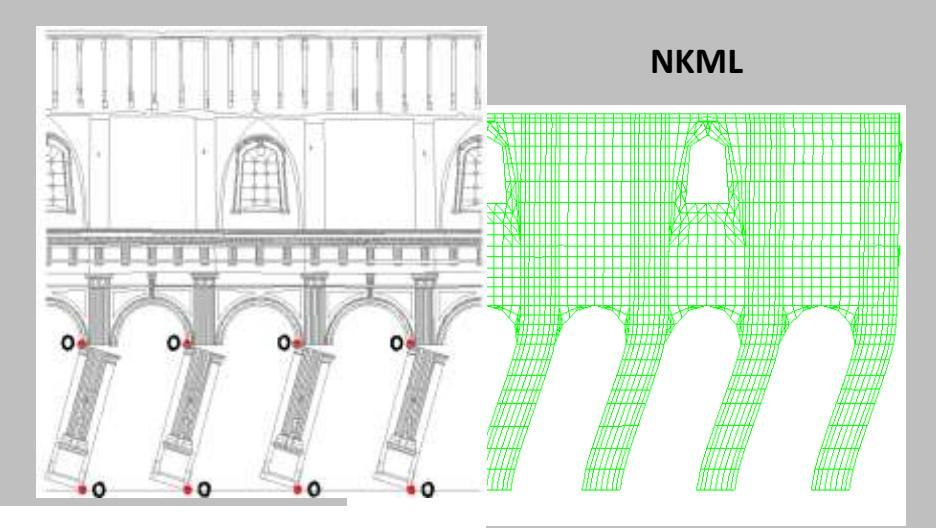
Nave longitudinal and transversal failure mechanisms

Two kinematic mechanisms were considered, evaluating the nave longitudinal seismic capacity and the response of the barrelled vault of the main nave to transversal seismic actions

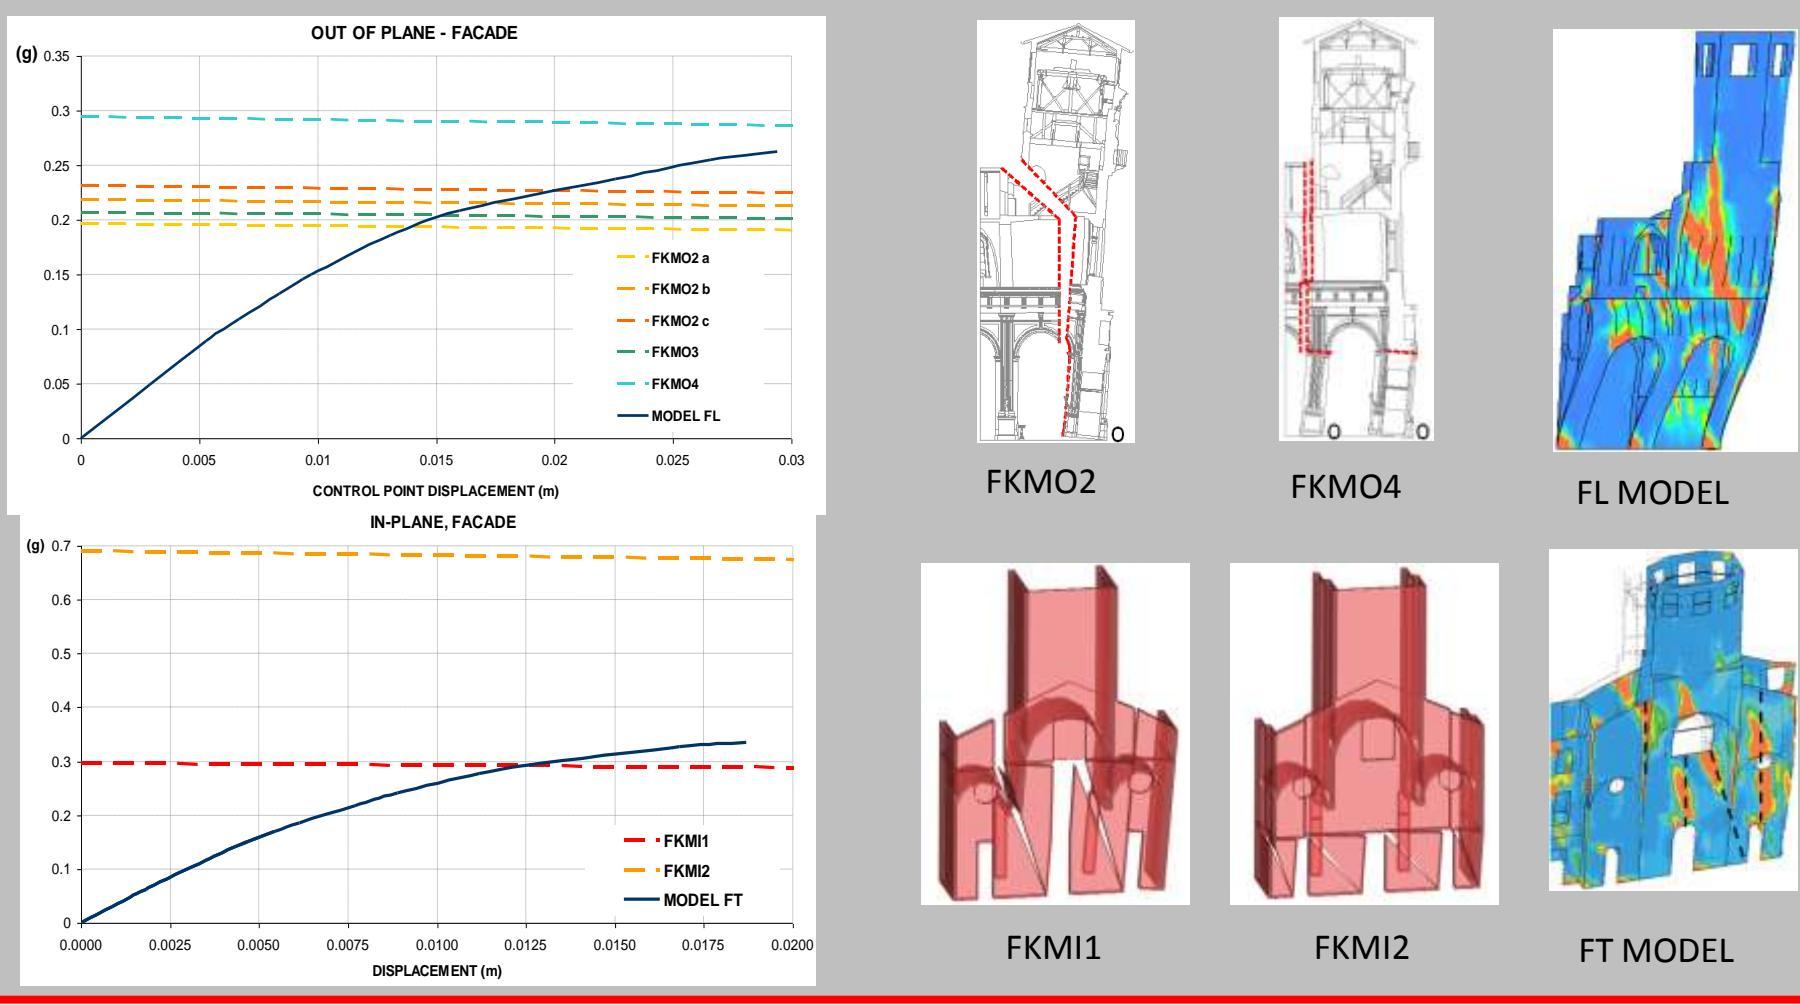
Both the limit analysis kinematic approach and the FE modelling strategy provided fairly satisfactory results in terms of comparative evaluation.

From the comparison between models, it is evident that, according to the numerical outcomes, the closer failure mode implemented with the limit analysis corresponds to model **FKMI1**
