NIKER WORKSHOP

MALLORCA CATHEDRAL

Pere Roca

**NEW INTEGRATED KNOWLEDGE BASED APPROACHES TO THE PROTECTION
OF CULTURAL HERITAGE FROM EARTHQUAKE INDUCED RISK**

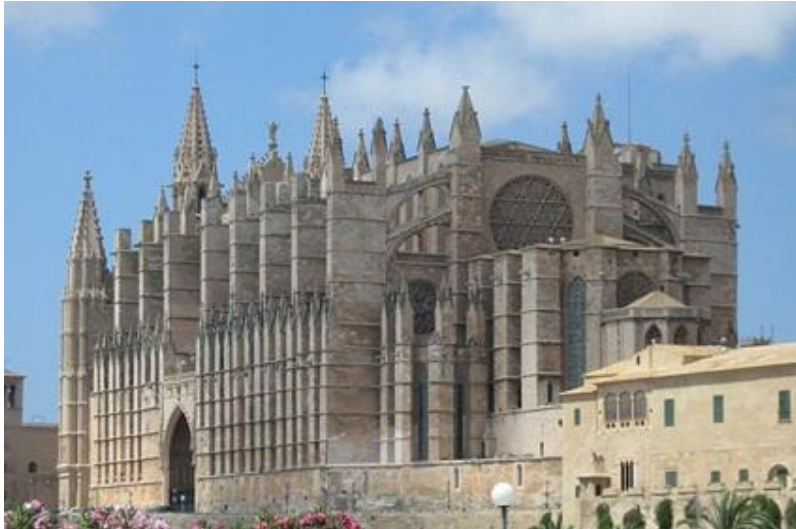
Total length 121 m, total width 55 m
Central nave: 44 m high, 17.8 m wide
Lateral naves: 29 m high, 9 m wide
Limestone masonry and lime mortar

Piers with octagonal section
(1.5 ÷ 1.7 m circumscribed diameter),
22.7 m high (slenderness ratio 14.2)

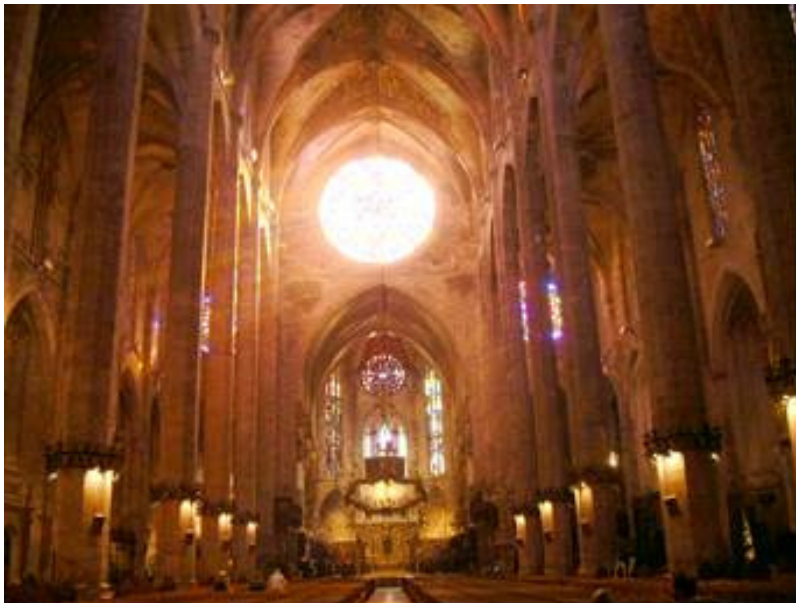
Construction: 1306-1600
long interruption period (1460-1560)

Repair interventions, especially during the
18th and 19th centuries

(4th vault partially collapsed 30 years after
the construction, repairs of many vaults,
dismantlement of Renaissance façade in
1851 due to 1.3 m out-of-plumb)

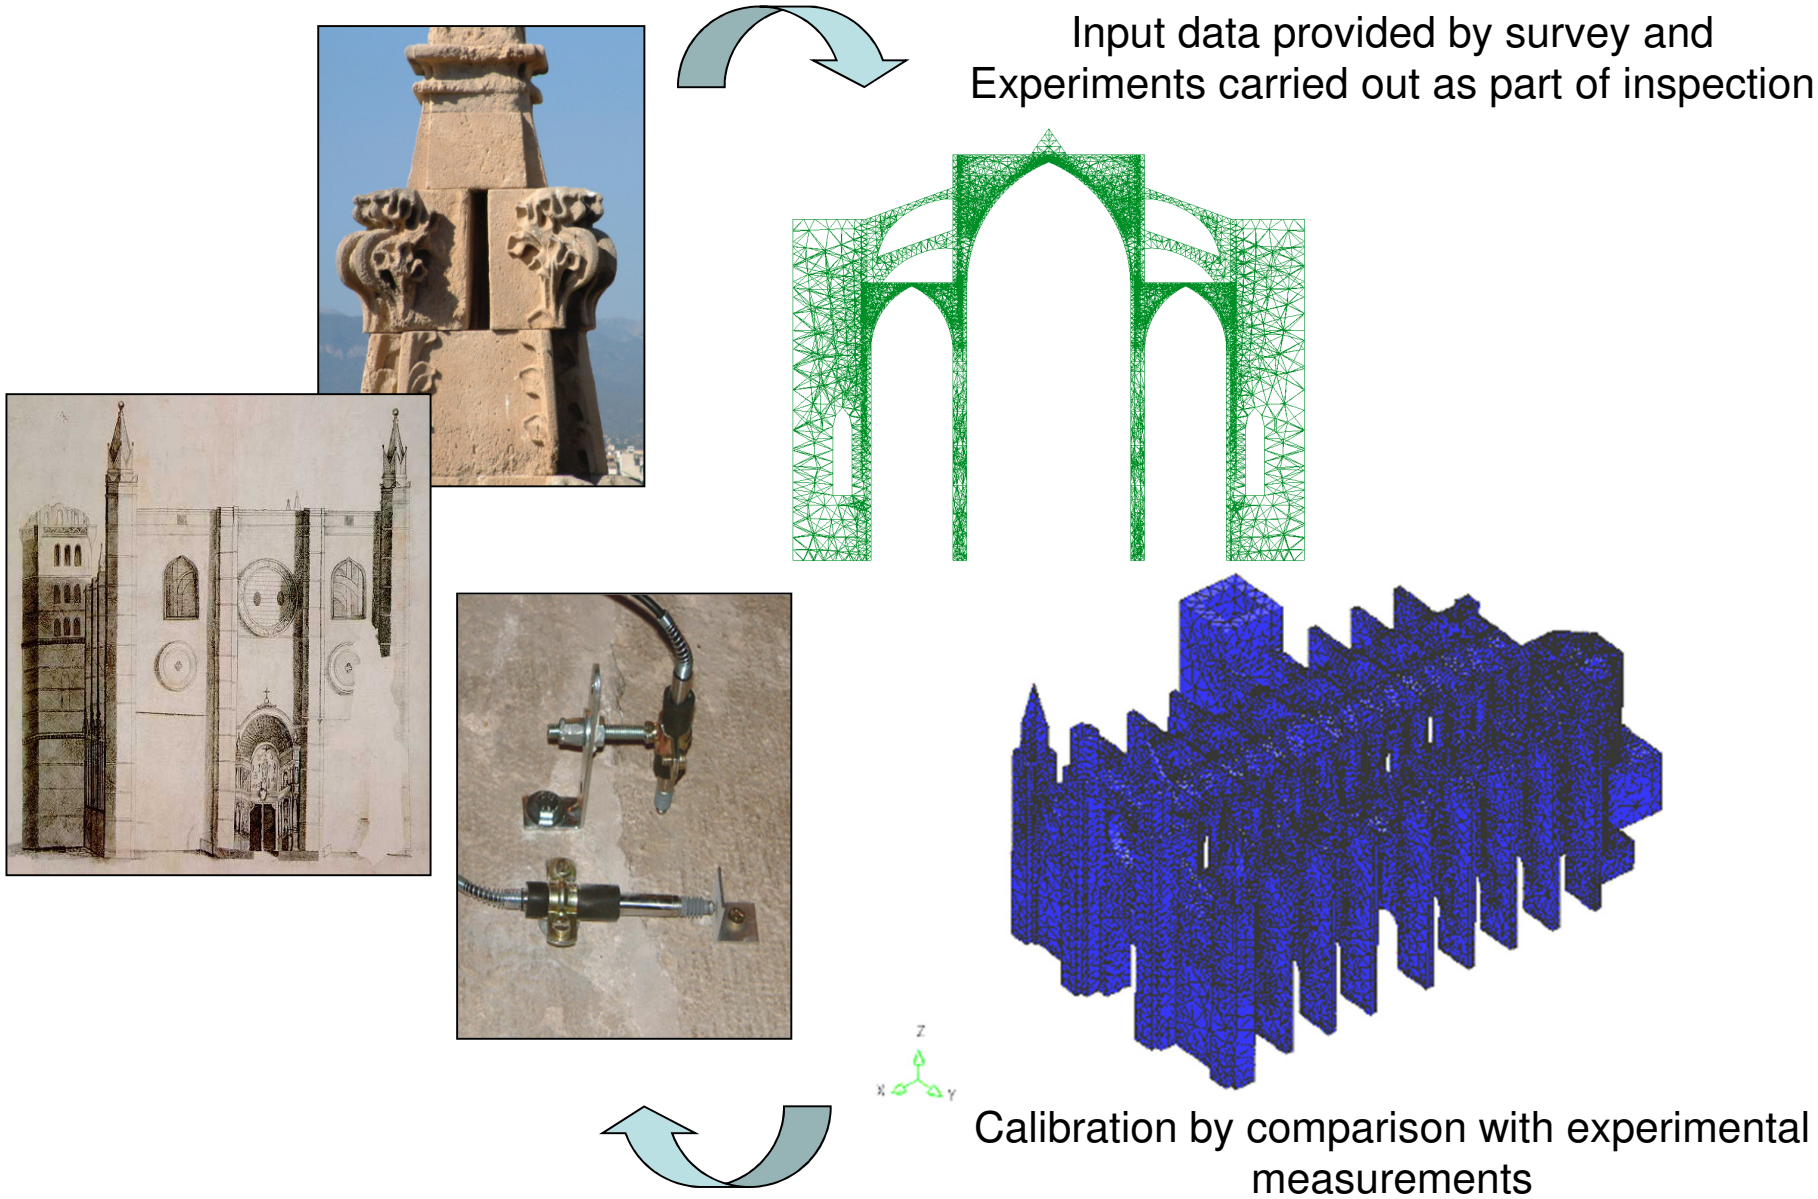
- a) Large lateral deformations of the slender piers (even $1/90 H$). The deformation is progressing at a rate of **0.1 mm per year** (monitoring from 9/2003 to 9/2008)
- b) Cracks at the base of some piers (stable)
- c) Cracks in buttresses following the perimeter of false windows
- d) Deformation of flying arches

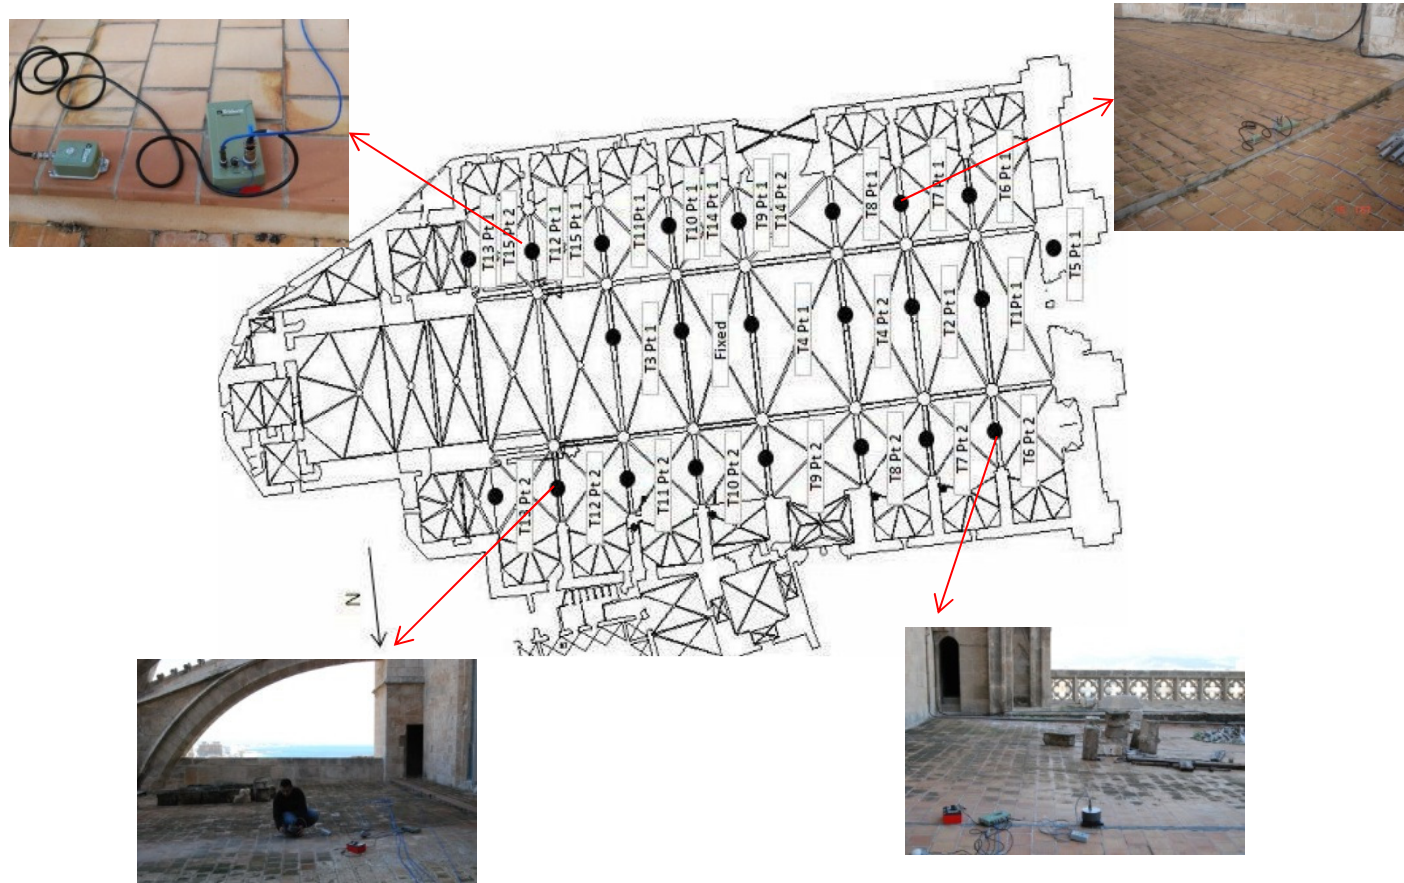
DYNAMIC IDENTIFICATION

Carried out on 15&16-12-2010 using three tri-axial accelerometers in 15 different setups.

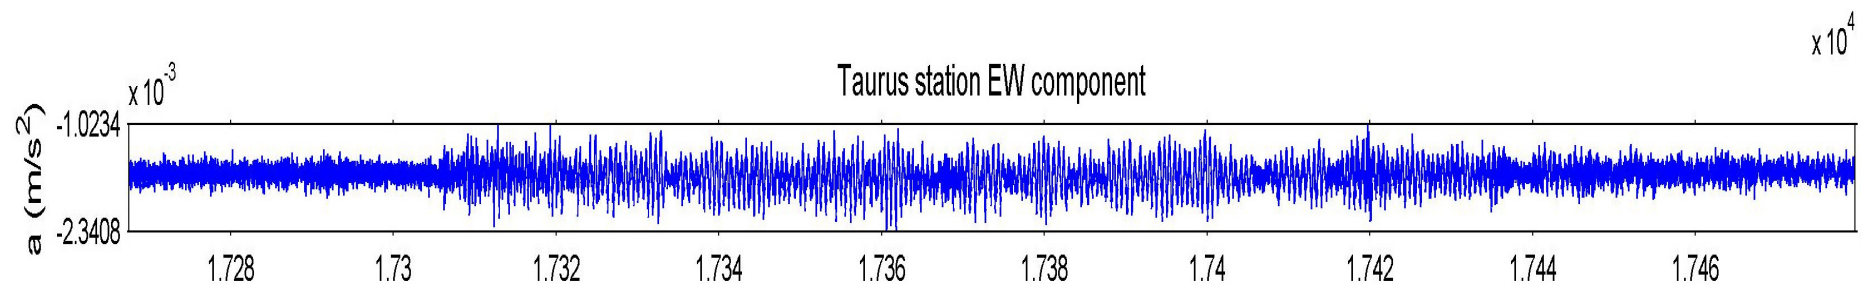
The values of the first natural frequencies are in average of 1.36 Hz, 1.47Hz, 1.59 Hz and 1.94 H.
