# Field report of work in Biet Loya on 3/6,17/6, 24/6,

Dagan Amadeus Farancz

This is a field report of the work done on the site of Beit Loya on the days of 3/6, 17/6, 24/6. The building is a byzantine church with a large mosaic floor. When hte initial excavation was done the gaps in the mosaic were filled with cement as were the boarders of the mosaic where there were large losses. The site has minimal maintenance and there is some plant growth as well as the accumulation of dust and debris. The site has logistic issues due to its far removed location. The site is located near a military training ground and is only accessible one day a week and only until noon. All the supplies to be used for conservation work need to be brought in and removed on the day of work due to there being no storage at the site.

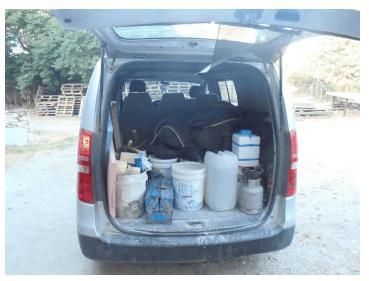
Fig.1

All the materials that are needed on site have to be brought every time a crew goes out to the site. The truck is loaded up with pre-mixed mortar, mesh nets for shade, a hoe, small tools like brushes and spatulas, water both for drinking as well as for mixing into the mortar, prepping areas for mortar and to put on blankets when the work is done to slow the drying process, cushions ,coffee and a burner.

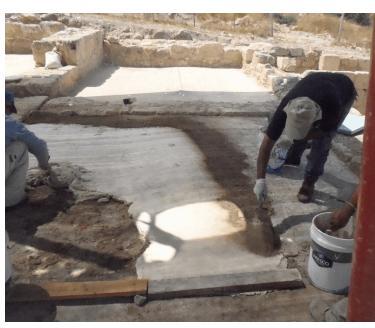
Fig. 2.3

a brush(Fig 2.3,2.4). The area was then covered with blankets and then the blankets were wet and then 2x4s and rocks are used to keep them weighted down(Fig 2.5). An area around 2x2 meters was completed.

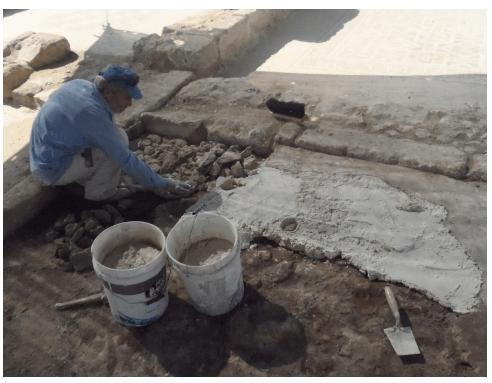
Fig. 2.1

- While the area is being dug up stones are collected that are between 8 and 15 cm long and Xcm wide. The mortar that was brought is also being mixed together with water and a little hydraulic lime. Once the area is ready the stones are placed within it side by side touching to make a new layer across the dirt ground(Fig2.1). In some areas the depth of the floor compared to the height of the mosaic was enough that two layers of stones had to be put down. The stones are wet with water, then a layer of hydraulic lime is placed over that and then the mortar is

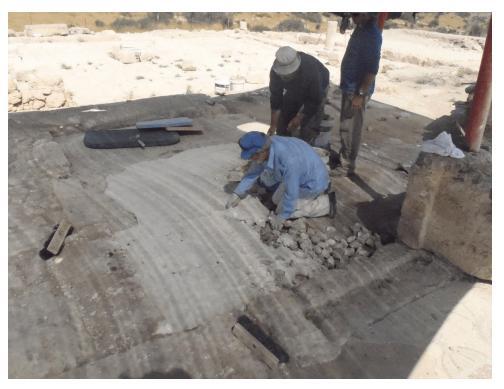
Fig. 2.2

dumped by the bucket onto the area. This is then smoothed out and brought to the proper level with the mosaic(Fig2.2). This is done systematically, one area at a time usually coinciding with one bucket of mortar. Once the mortar set ups it is covered with dirt and then tamped with

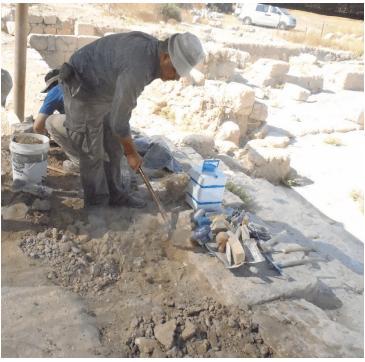
- Same initial routine as 3/6 and 17/6. Truck is loaded up to full capacity with the same supplies with the addition of more water and a pickaxe.
- The area worked on is the continuation of the work done on 17/6. The same methodology is implemented. The ground is dug up to make way for the new statumen(3.1), while this is being done stones are gathered and the mortar is mixed. This area was not as deep and so required one layer of stones and in some places no stones in others.

• The main difference in this area was the islands of tessera. There were intact sections located in the middle of the lacuna Fig.3.1

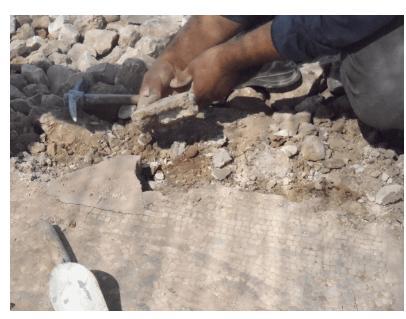
Fig. 3.3

surrounded by cement. The cement was carefully removed along the edge of the island that would be touched by the new mortar(Fig 3.2,3.3). A makeshift level was also used so check the level of the statumen in the forward area.

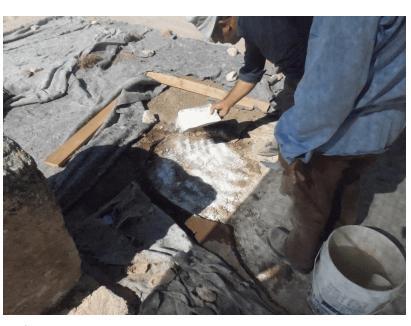
Fig. 3.6

- Some plant life was also found under the surface these were forcibly removed with hand tools(Fig 3.4,3.5).
- The stones were wet with water and then covered in hydriodic lime and then had the mortar put on one bucket at a time. The area was then smoothed out and made level(3.6-3.8).
- Where the Mortar and the tessera islands touched a raised lip was made.
  Extending 2-3 cm out from the edge of the tessera on the same plane and then sloped down into the main body of the mortar area. At

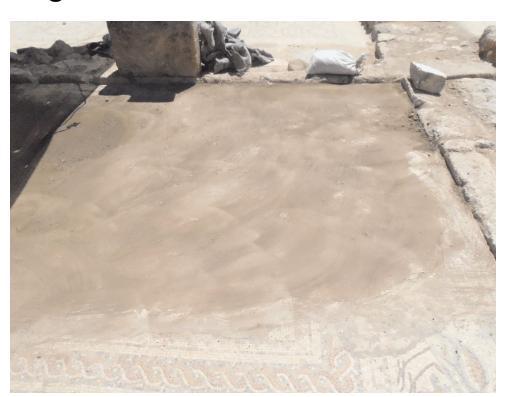
Fig. 3.9

- While this was being done the blankets were removed from the area done the previous week and the area was swept slightly to check the work that was done(fig 3.9).
- The area also had to be utilized as footing position to put dirt and then tamp the dirt down into the area completed on this day. This was done over the entirety of the new area and then covered with blankets which were wet and then kept down with rocks and 2x4s. The area was then packed up and all the materials loaded into the truck and then the crew exited the site.
