Grouting for Caesar: The Vault Complex and High Level Aqueduct  
at Caesarea After 20 Years

A Pilot Project Presented to the:

Israel Antiquities Authority  
and  
International Conservation Center, Citta di Roma

August 2012

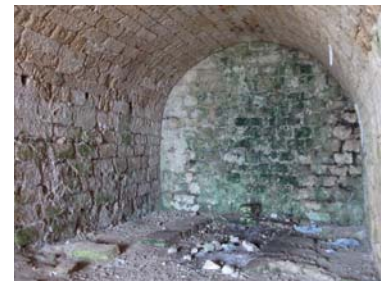
The structure of Vault 1 makes it particularly susceptible to environmental causes of deterioration. The 30m length of the windowless vault traps salty moisture and humidity, leading to large amounts of biological growth and a constant layer of fresh, wet salt to penetrate and corrode the stone (Figures 14-16). Water

Figure 16. Biological Growth and Salt Crystallization. Overview. Vault 1. East Wall.

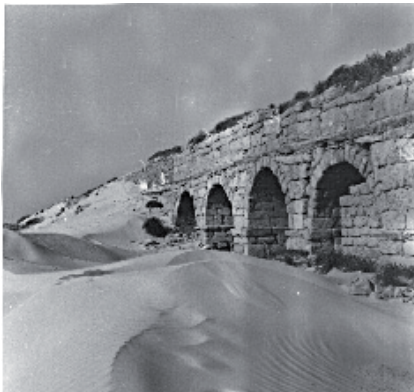
The High Level Aqueduct at Caesarea was built to be and still is a high quality building (Figure 27). It was repaired throughout its centuries of use, as is evidenced by the occasional difference in building style, numerous interventions, buttressing of the western arches (Figure 28), and even inscriptions. By and large, the eastern aqueduct (A) has remained stable throughout the centuries and has proven to be a much higher quality than the later western addition. This is largely due to the fact that the western aqueduct (B) protects the former from the effects of the sea, although it does cause structural problems in some areas. Since the western aqueduct is built against or a few centimeters away from the eastern aqueduct and overlaps the foundation of the earlier building, one structure's problems can drastically affect the integrity of the other structure, especially in cases where the western aqueduct leans on the eastern (Figure 29).

Figure 27. General Condition. (IAA)

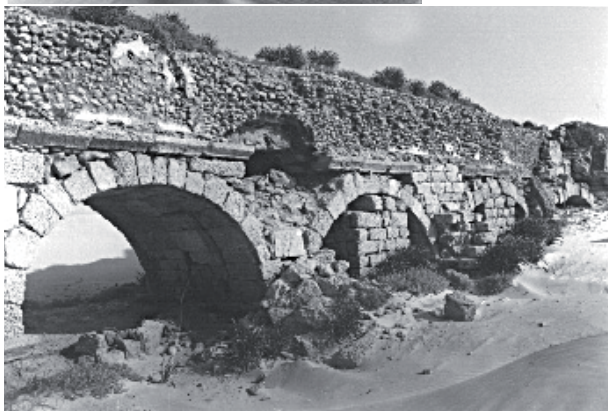
Figure 28. Buttressing of Western Aqueduct. (IAA)

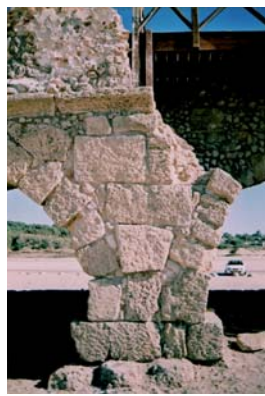
Figure 34. Joint Fill and Stabilization of Collapse of B. (IAA)

Some areas of the High Level Aqueduct did suffer from collapse (Figures 30, 32-33), destabilization of the core of the structure or foundation (Figure 31), stone deterioration, and mortar decay (Figure 33) over time. These problems were consolidated through joint filling (Figure 34), restoration for stabilization (Figure 35), stabilization of foundations (Figure 36) and, of course, grouting.

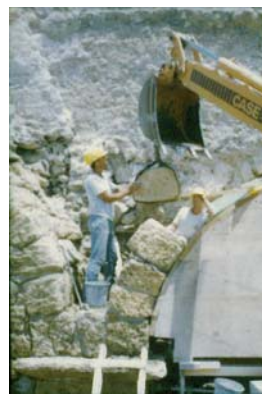
Figure 35. Restoration. (IAA)

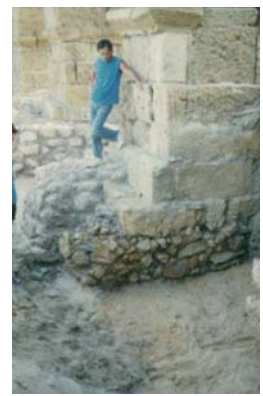
Figure 36. Reinforcing Foundation, In Progress. (IAA)

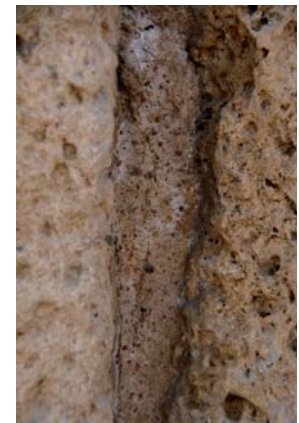
Figure 38. Salt Crystallization. Detail.

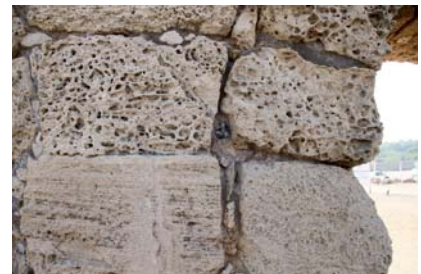
After 20 years of continued exposure to natural conditions common to life by the sea (See “3.4 Causes of Deterioration”), including a major storm that damaged parts of the High Level Aqueduct and other sites along coastline in 2010, the joint fill on the aqueduct at Caesarea is in various stages of disrepair. The western facade shows the most wear since it faces the sea and has maximum exposure to salt, water, wind, and blowing sand. The joint fill shows signs of weathering and deterioration but is mostly intact with gaps here and there (Figure 69-72). The joint fill on the facades that are protected, including the arches and eastern facade, is generally in better condition.

Figure 70. Joint Fill 2012. Example 2  
(West Facade).

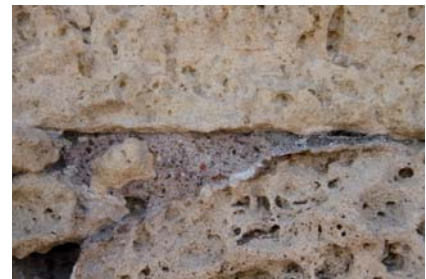
Figure 71. Joint Fill 2012. Example 3.

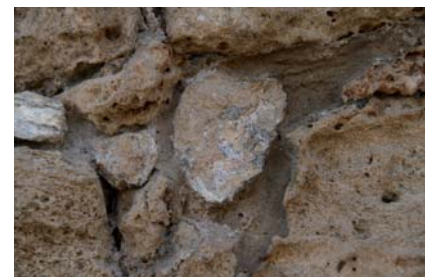
Figure 72. Joint Fill 2012. Example 4.

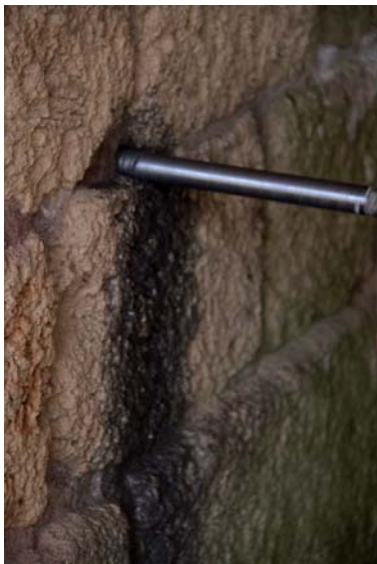
The eleven core samples suggest that Vault 1 may be in need of further intervention in the near future. On average, the walls are 74% earth or void and only 12% stone, 4% grout, and 10% stone and grout combined (Chart 1). The black or brown-red color of the water that came out during wet drilling suggests that those areas of the wall are filled with earth or sand, whereas clear water suggests a void in the wall (Chart 1; Figures 85-87). Sometimes the black or brown-red water was accompanied by a foul odor, possibly indicating the presence mold or some other form of biological growth in the core of the wall. The presence of earth or sand suggests that the washing procedures carried out before injection were only partially effective.

Figure 85. Black Water During Wet Drilling.

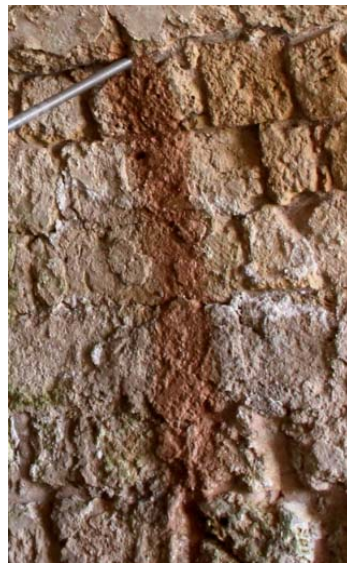
Figure 86. Brown-Red Water During Wet Drilling.

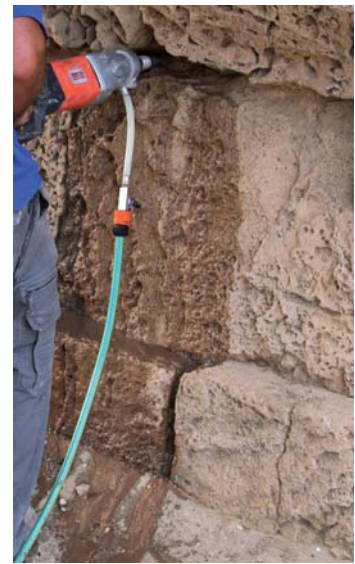
Figure 87. Clear Water During Wet Drilling.

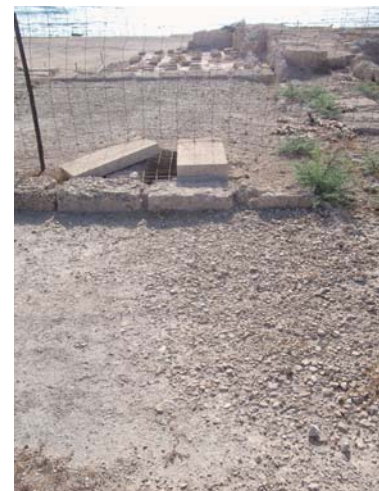
Figure 95. Roof of Vault 1. Facing West.

In respect to the question of why one grouting intervention has fared better than the other, the issue of water penetration must be considered. The collapse of the second floor and eastern 10m of the vault in antiquity left the structure particularly vulnerable to water (See “2.3 State of Preservation”). Furthermore, the degree of biological attack on Vault 1, particularly the eastern end, and the odor that accompanied some of the drilling samples both point to a problem with water penetration (See “2.4 Causes of Deterioration”). The IAA did install a drain above the eastern wall of Vault 1 during its conservation, but the continued presence of mold, the foul odor, and a visual inspection of the drain itself strongly suggest that water continues to enter the vault

from above, washing out the earthen core and transporting other environmental hazards. Since Caesarea is located by the sea, water penetration also means the penetration of salt and sand, both of which speed the process of deterioration. This is particularly problematic when it occurs in the core of a wall where there is no evaporation. Warm, wet, and dark earthen places tend to grow mold which affects the integrity of the structure. If salt is present, its deposits will continue to grow and deteriorate the stone and other materials from inside the wall, where the damage cannot be seen.

2. Reduce the amount of water that penetrates Vault 1 by 1) fixing the drainage system above, 2) regrading the flat, gravel surface that serves as a roof in order to direct water away from the Vault Complex (Figure 95), and 3) replacing joint fill between the stones above Vault 1.
