DOCUMENTATION, ASSESSMENT AND INTERVENTIONS TO THE MAIN CHURCH OF DAPHNI MONASTERY

E. Vintzileou
Acre, Dec. 17th, 2012

The Dafni Monastery (built in the 11th century) is one of the most important byzantine monuments in Greece (mainly because of the mosaics of the Katholikon, (UNESCO-list of world monuments)).

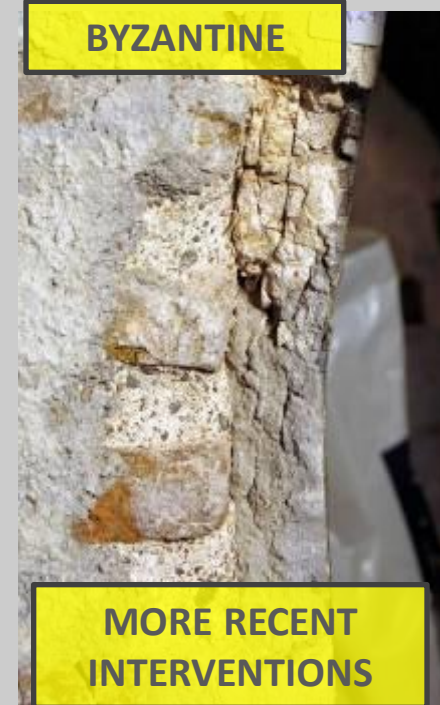
Removal and replacement of mosaics by Italian conservators (NOVO, 1890-1897). Use of hydraulic lime

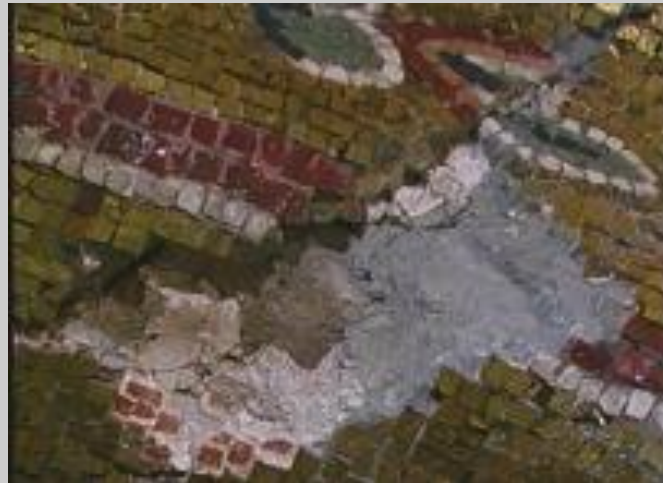
Use of cement in the more recent interventions

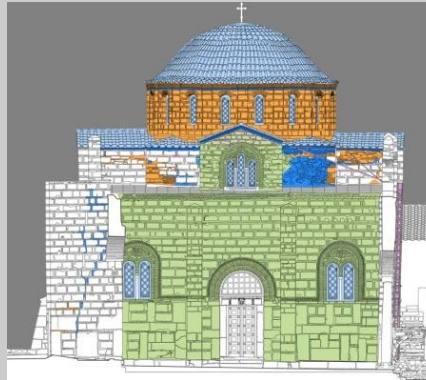
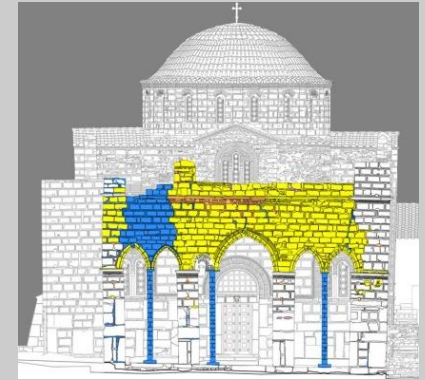
The coloured parts are reconstructed.

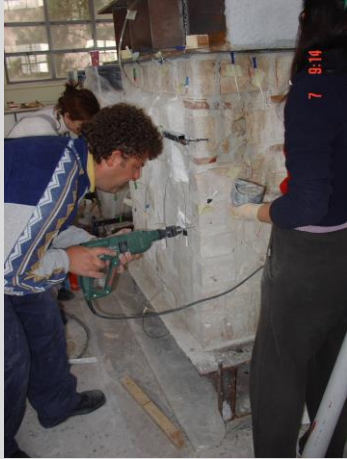
Drilling holes

Drilling of holes and installation of plastic tubes

Holes at distances $0.5-1.0m \leq \text{thickness}$ of masonry + along cracks

Holes deep enough to reach filling material

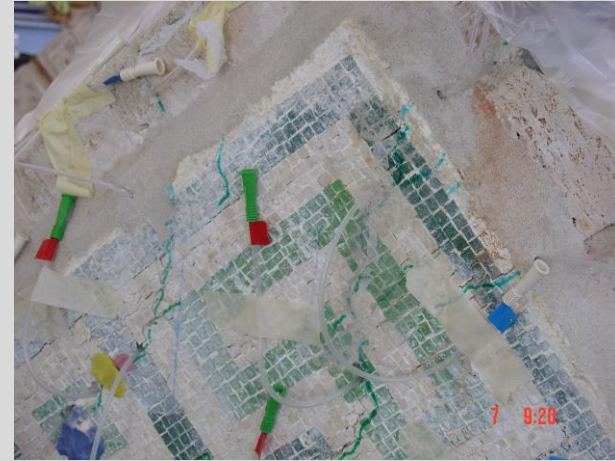
Installing tubes

Tubes are numbered and reported on drawings

Transparent tubes (1.0 to 10.0mm)

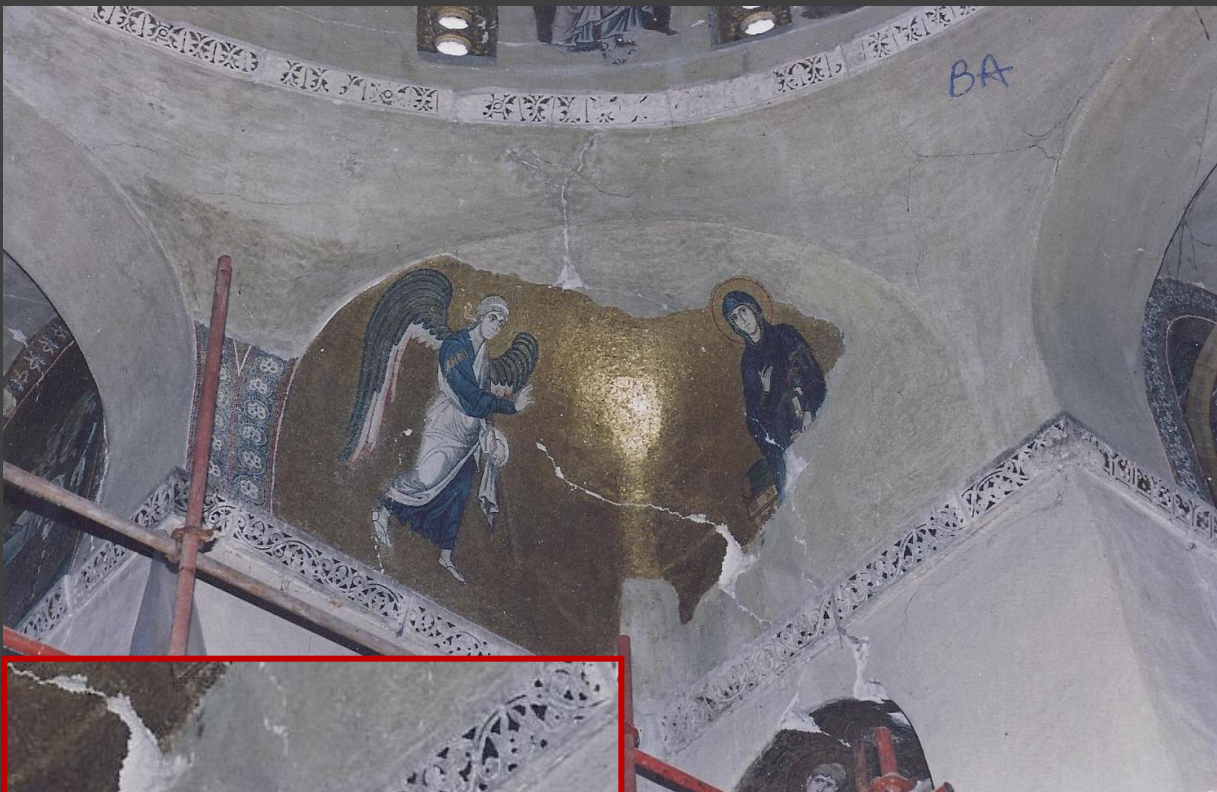
REPRODUCTION OF OBSERVED DAMAGES-PENDANTIVES-ARCHES

MAXIMUM TENSILE STRESSES
FOR THE BEARING SYSTEM
BEFORE INTERVENTIONS

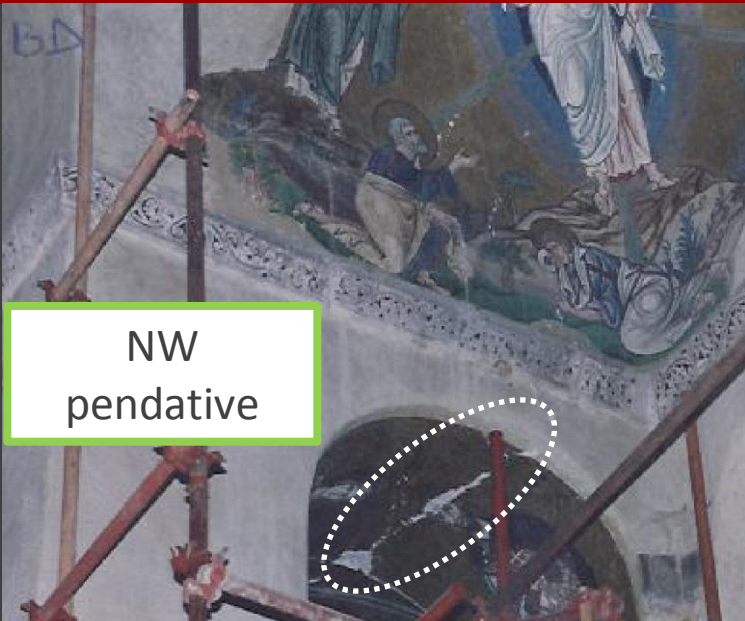
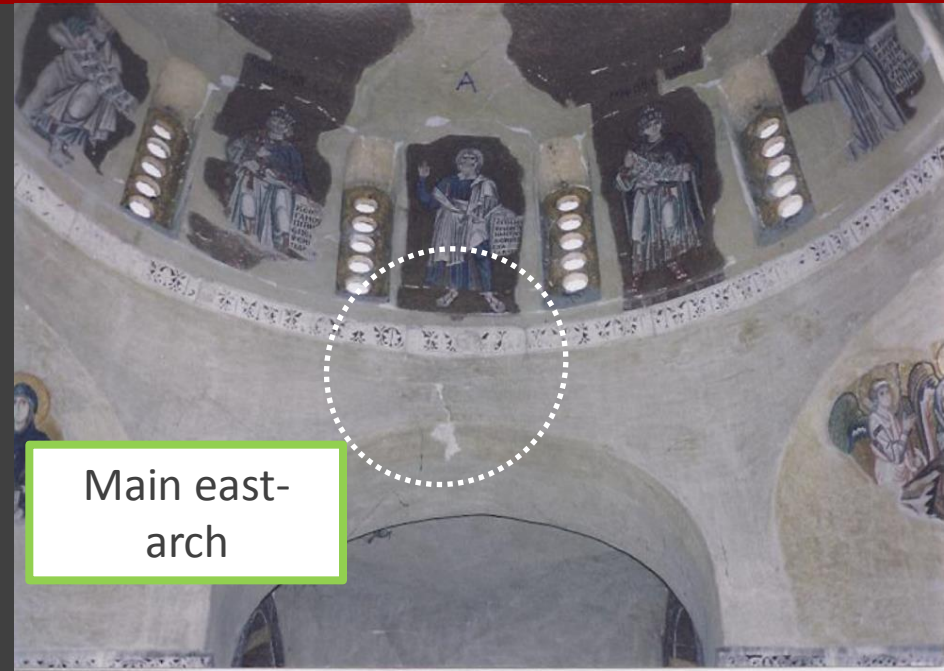
REPRODUCTION OF OBSERVED DAMAGES

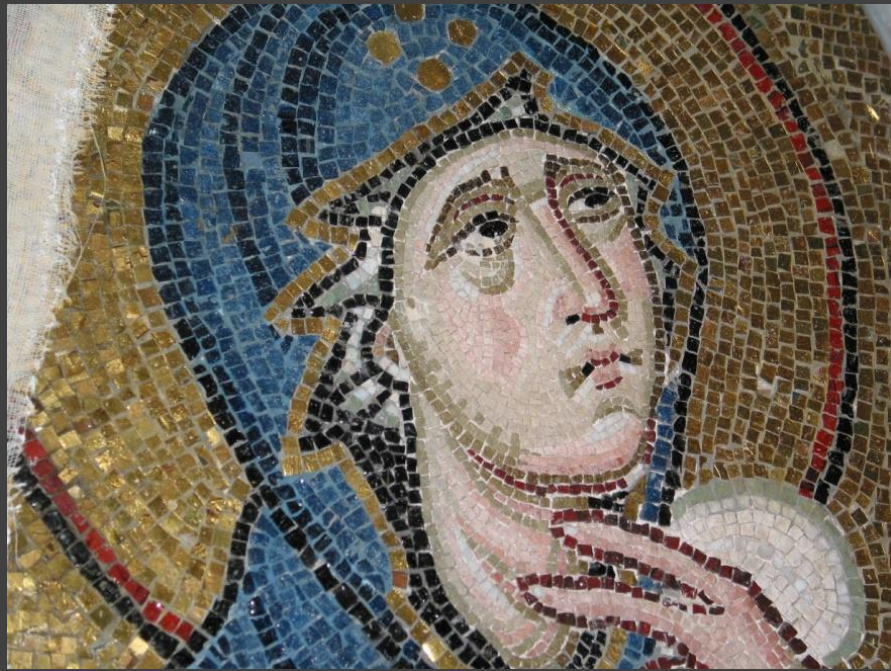
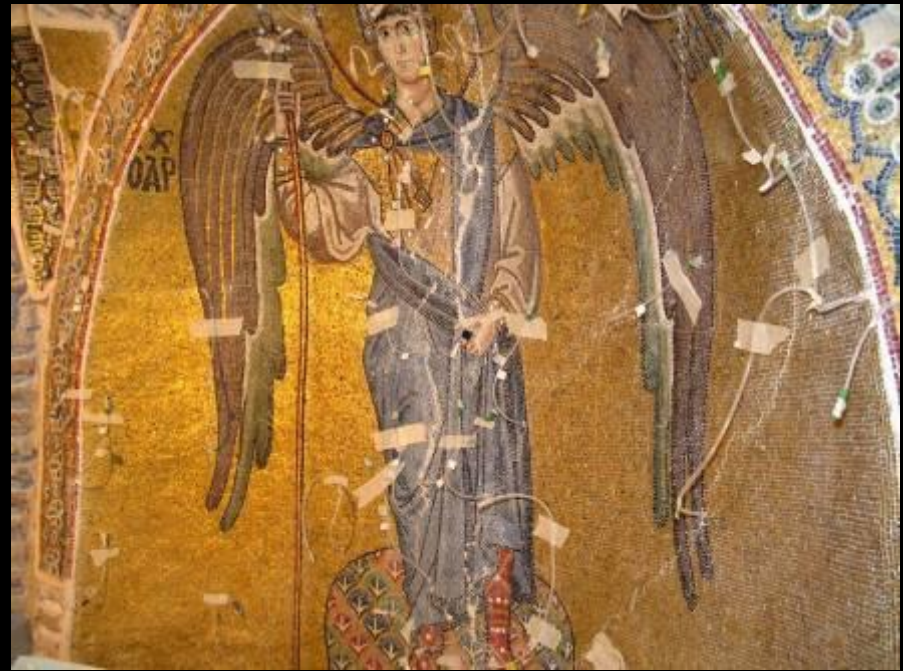
EFFICIENCY OF INTERVENTION MEASURES

Significant improvement of the seismic behaviour of the monument is achieved.
However, damages are to be expected in case of a strong earthquake!
