### Assessment and improvement of structural safety under seismic actions of existing constructions: Reinforced Concrete Structures and Historical buildings

### Lessons learned from the past earthquakes: damages catalogues and interpretation

Prof. Maria Rosa Valluzzi

University of Padova, Department of Cultural Heritage  
[mariarosa.valluzzi@unipd.it](mailto:mariarosa.valluzzi@unipd.it)

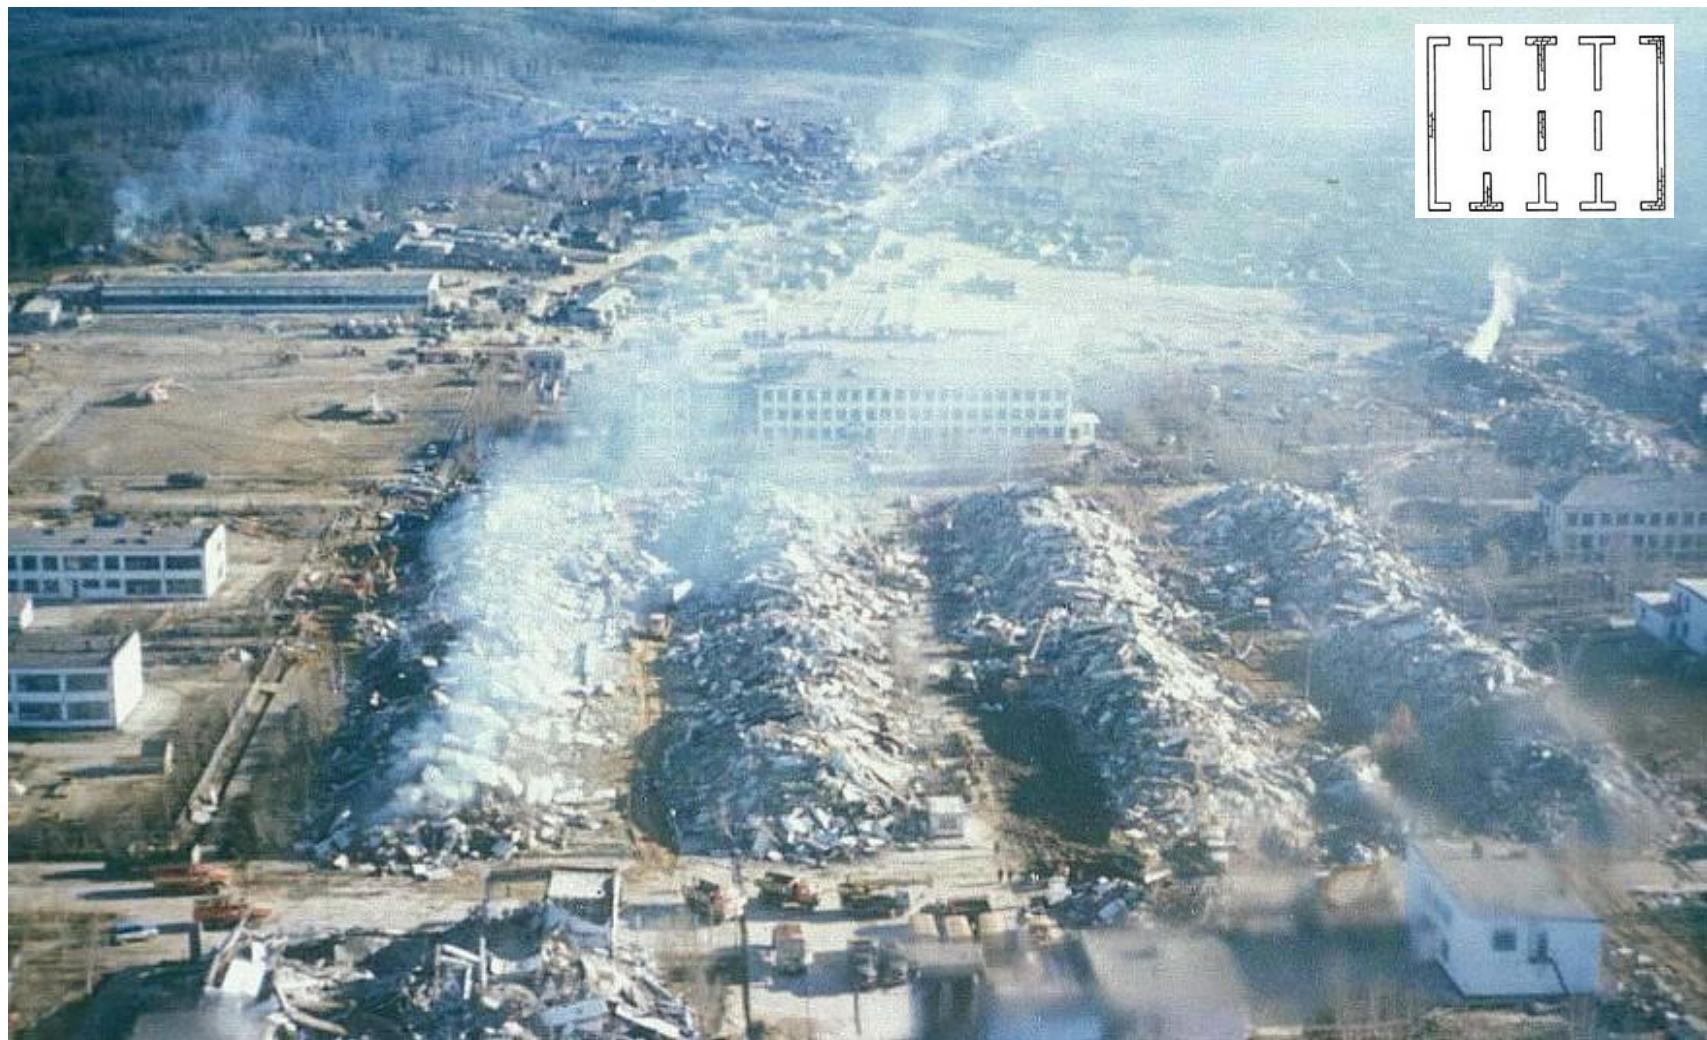
Neftegorsk, 1995 (Tomazevic)

# GEOMETRIC UNIFORMITY

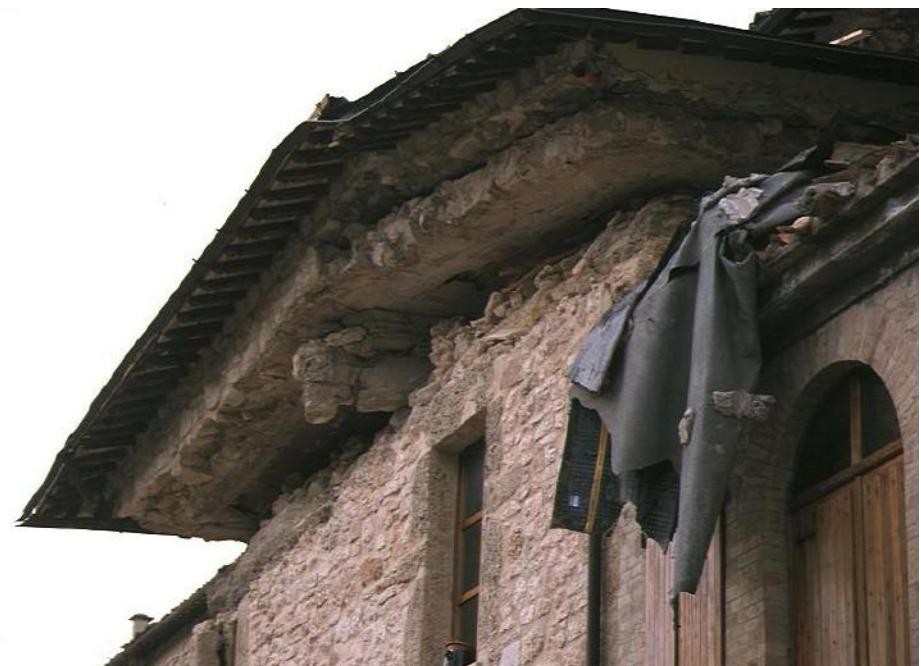
- Stiffening of horizontal diaphragms with non adequate strengthening of masonry walls

Rigid sliding of roof

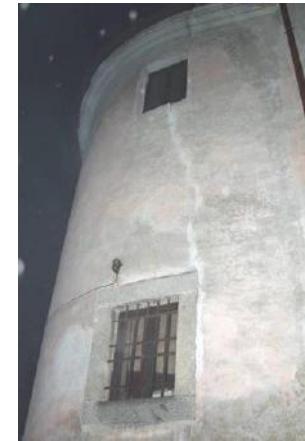
OVERTURNING OF APSE

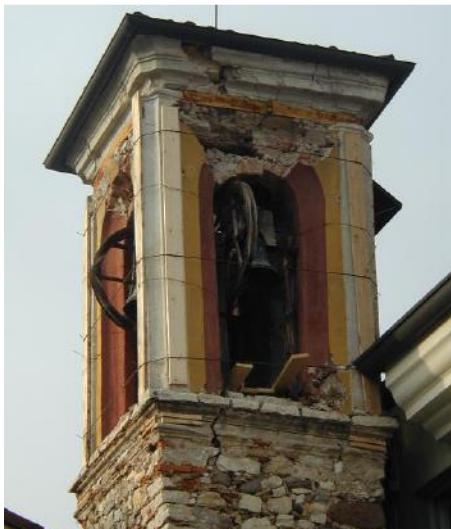
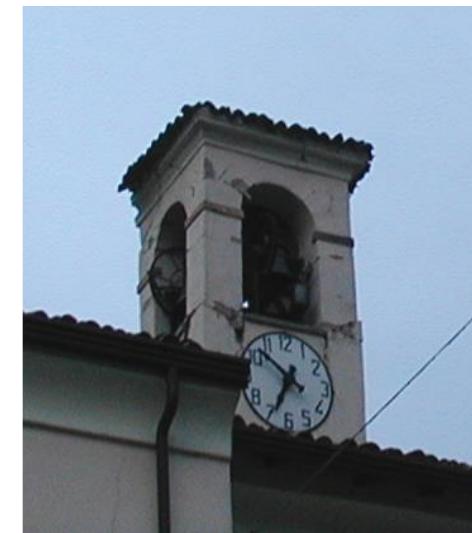
BELL TOWER AND BELFRY

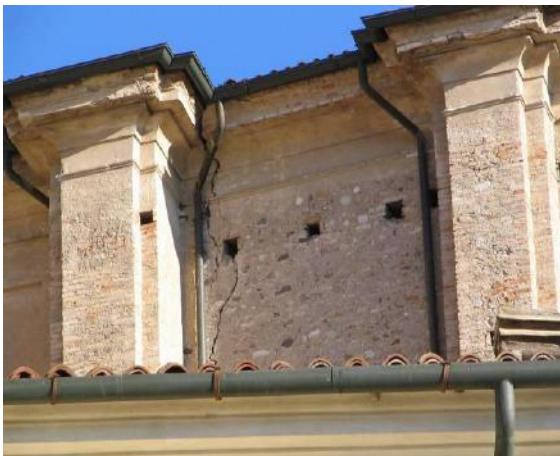
Overturning of transept

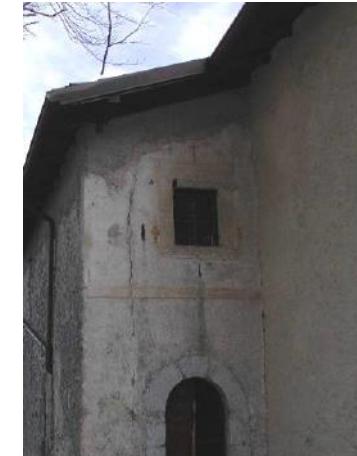
Overturning of side chapels

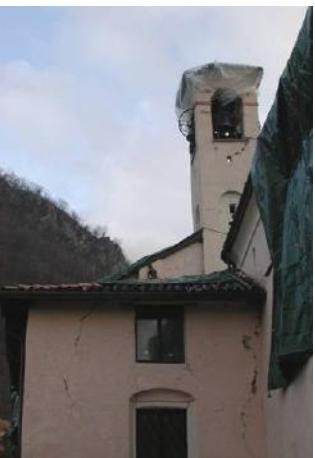
Interaction due to plan-elevation irregularities

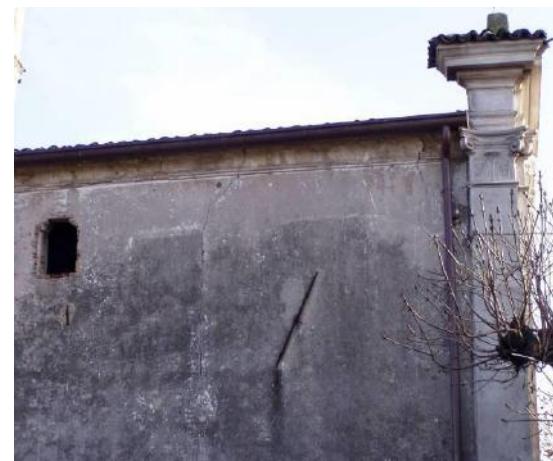
Mechanisms in roof elements

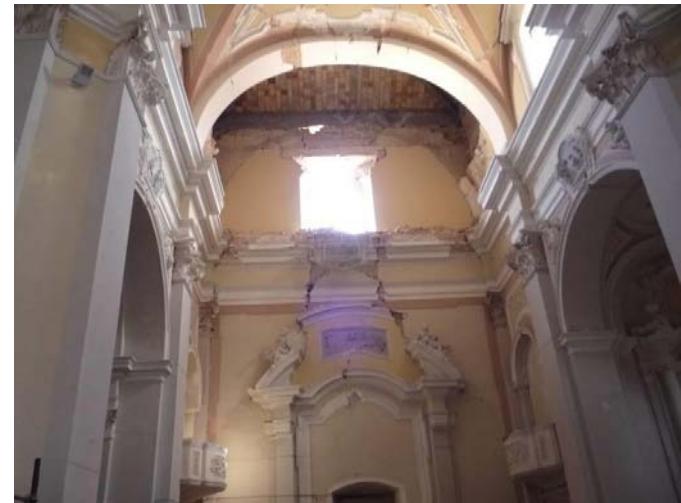
12 - VOLTE DEL TRANSETTO

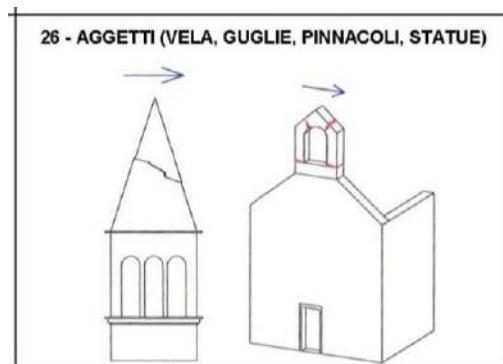
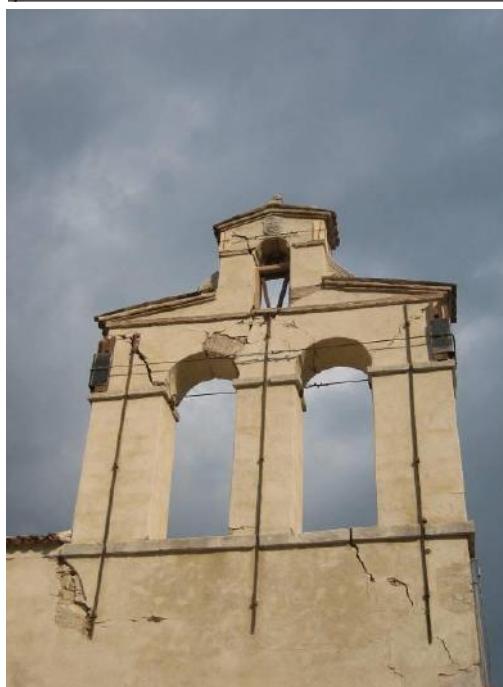
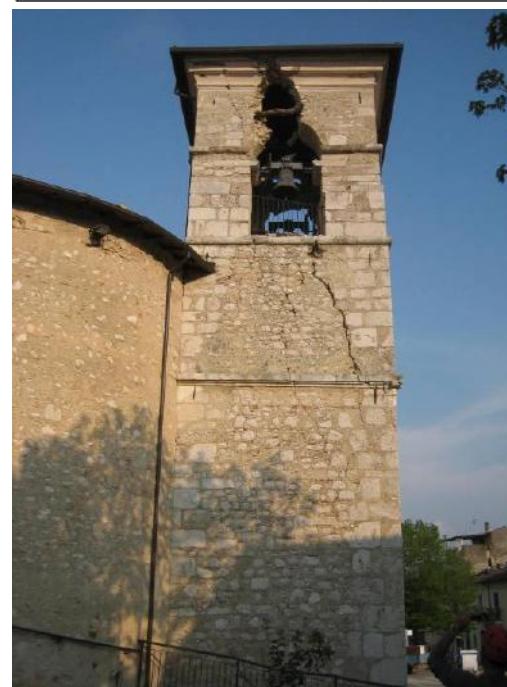
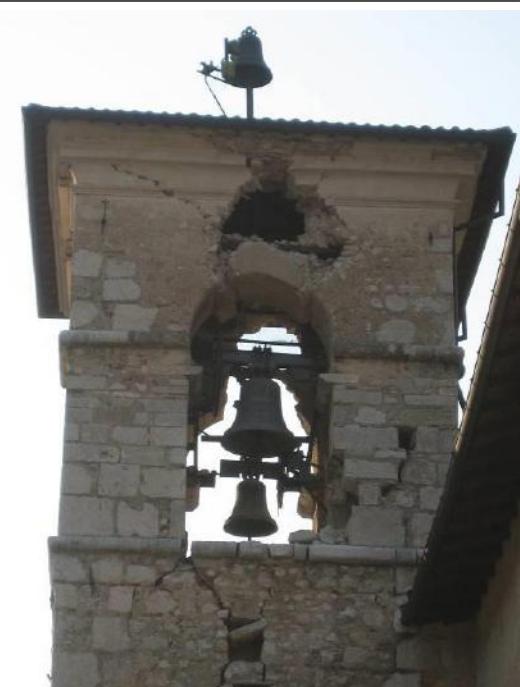
Chiesa di San Michele & Chiesa Parrocchiale, Villa Sant'Angelo (AQ)

# DAMAGE OF CHURCHES: PROJECTIONS, PINNACLES, BELL TOWER

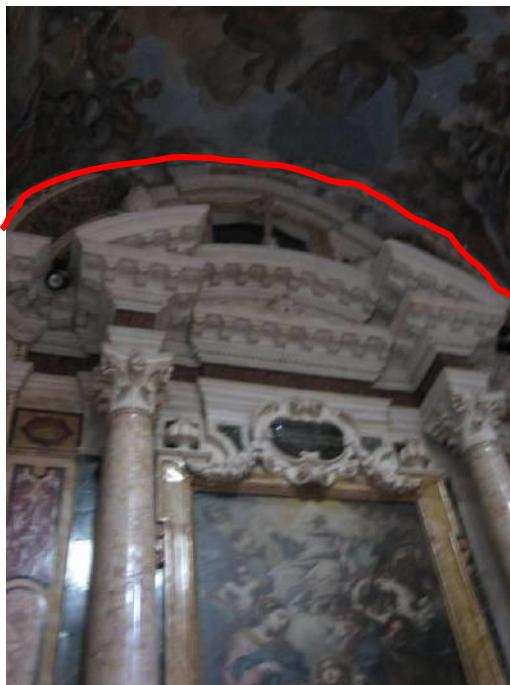
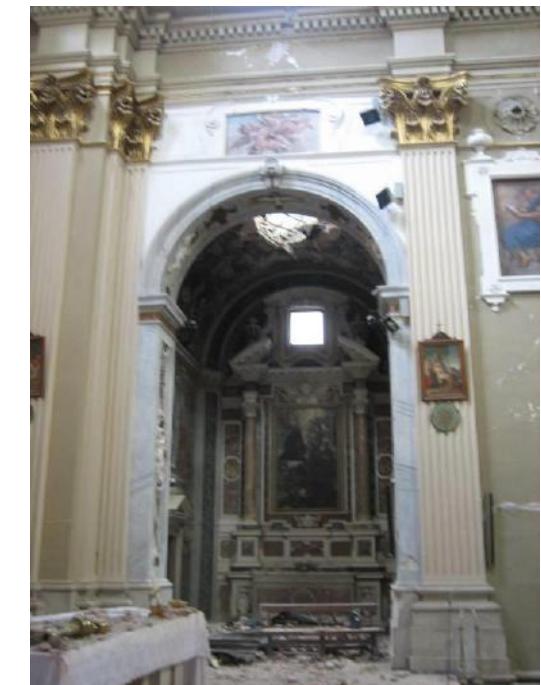
Santa Margherita (dei Gesuiti), L'Aquila

# DAMAGE OF CHURCHES: SIDE CHAPELS AND VAULTS

23 - MECCANISMI DI TAGLIO NELLE CAPPELLE

24 - VOLTE DELLE CAPPELLE

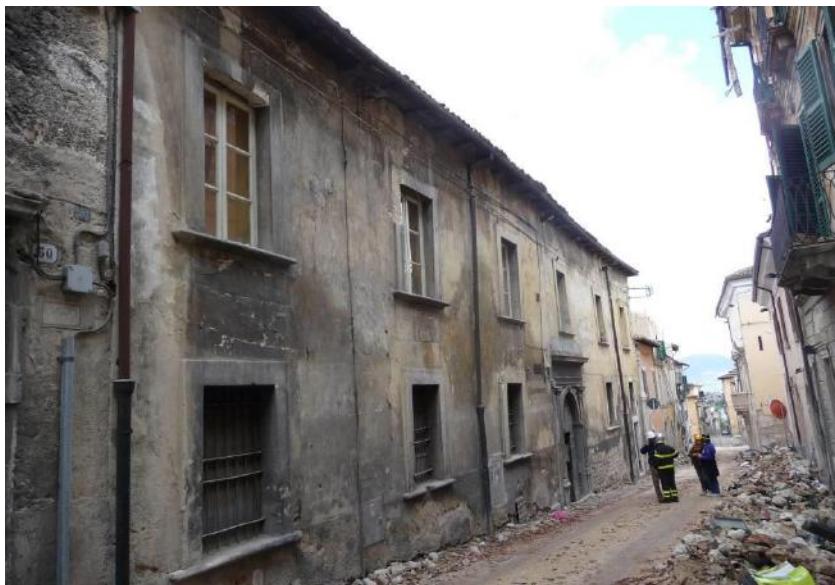
Ex Monastero di Santa Teresa, L'Aquila

# DAMAGE OF PALACES: FLEXURE OF WALLS

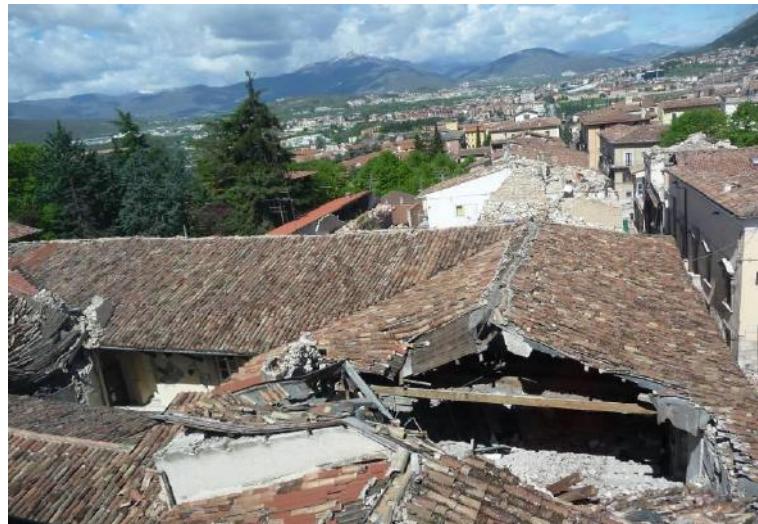
Ex Monastero Santa Teresa,  
L'Aquila

# DAMAGE OF PALACES: VAULTS AND ROOFS

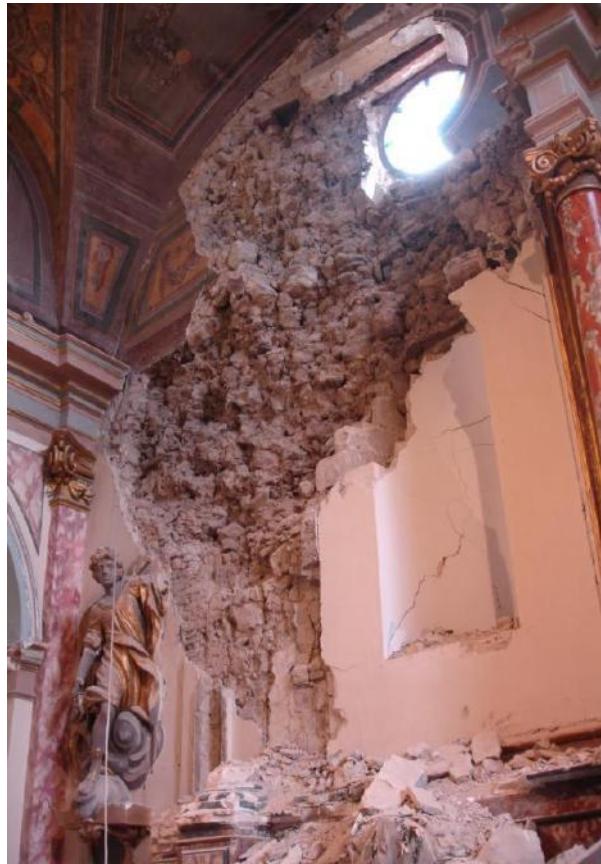
San Michele Arcangelo, Celano

# DAMAGE CATALOGUE: POOR QUALITY MASONRY

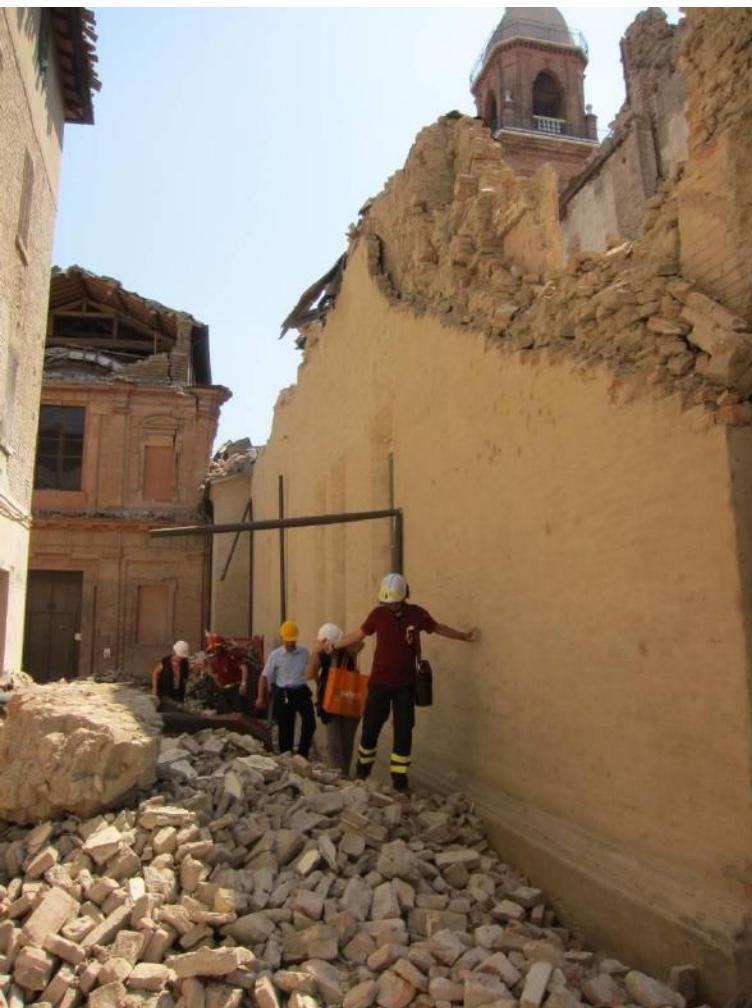
Collegiata Santa Maria Maggiore, Mirandola

- Thick walls made with solid clay brick
- Multi-layer walls with scarce interconnection

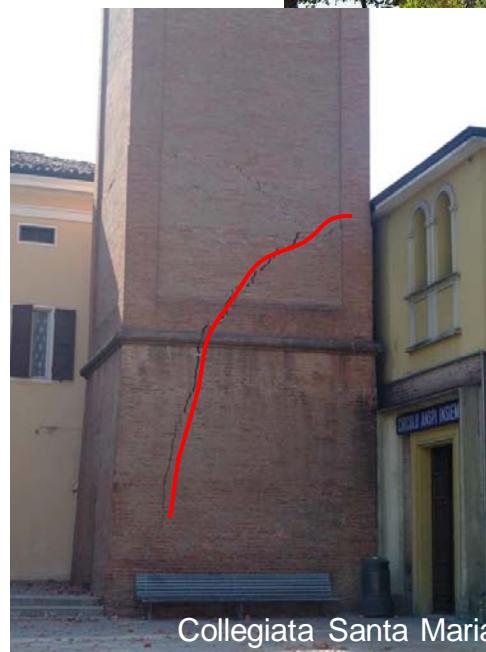
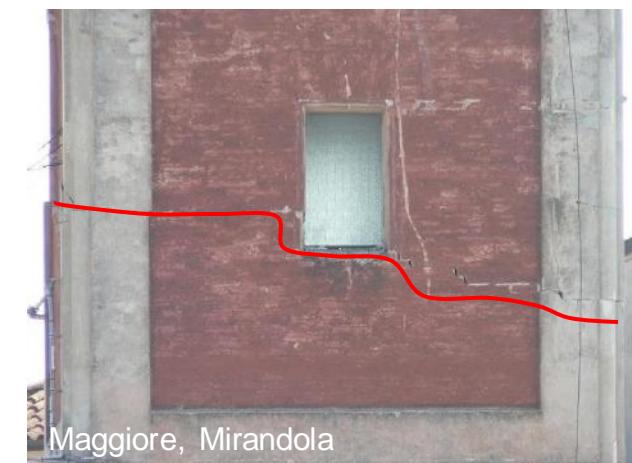
Collegiata Santa Maria

- Cracking and mortar joint sliding

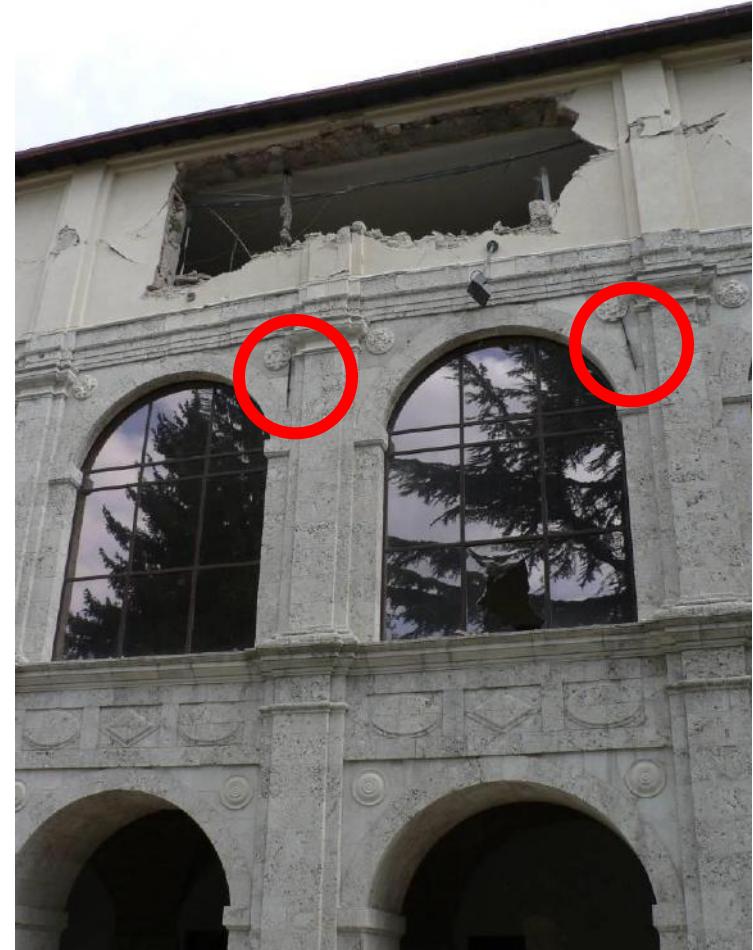
Forte Spagnolo, L'Aquila

# EFFECT OF INTERVENTIONS: ABSENCE OF TIES

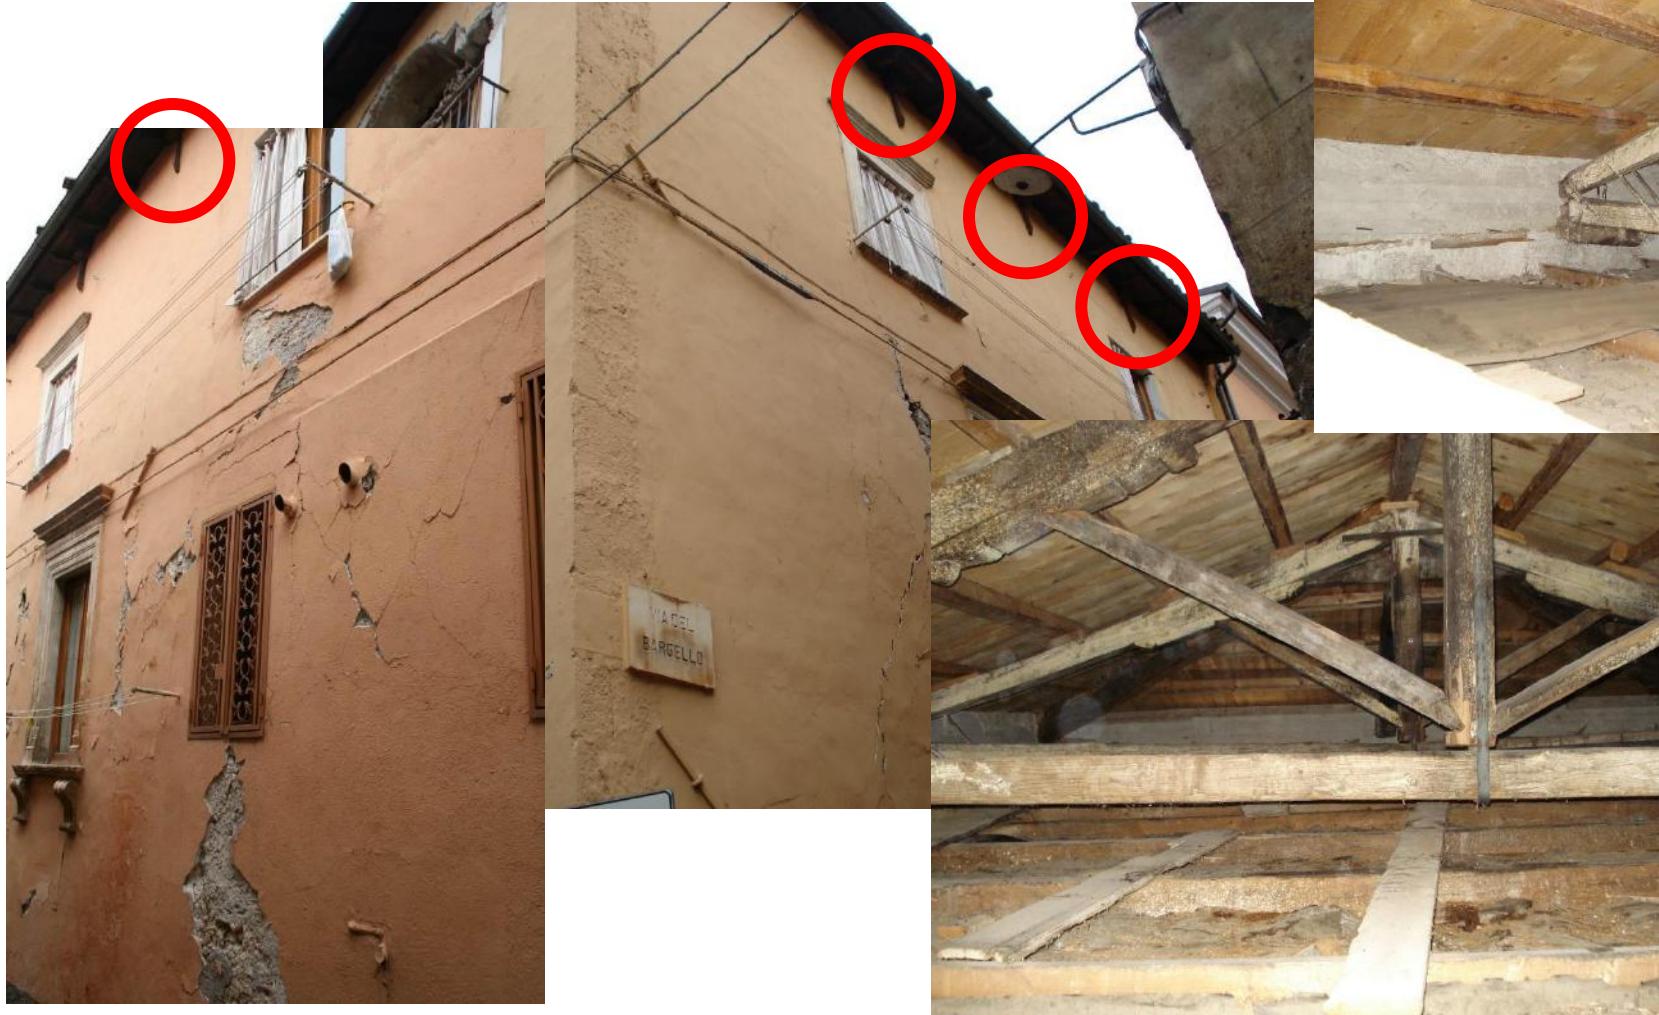
Palazzo in via Buccio di Ranallo: wood elements for ties and fixing

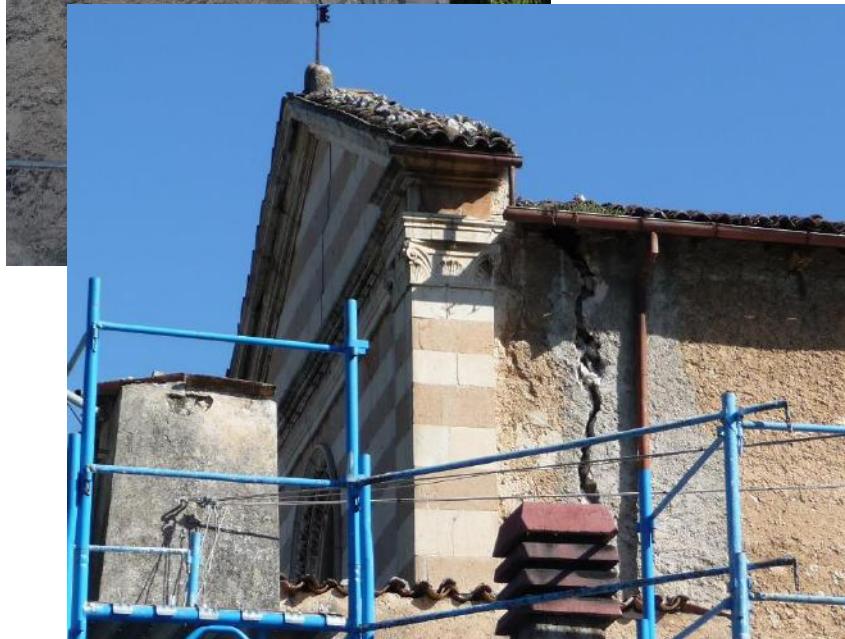
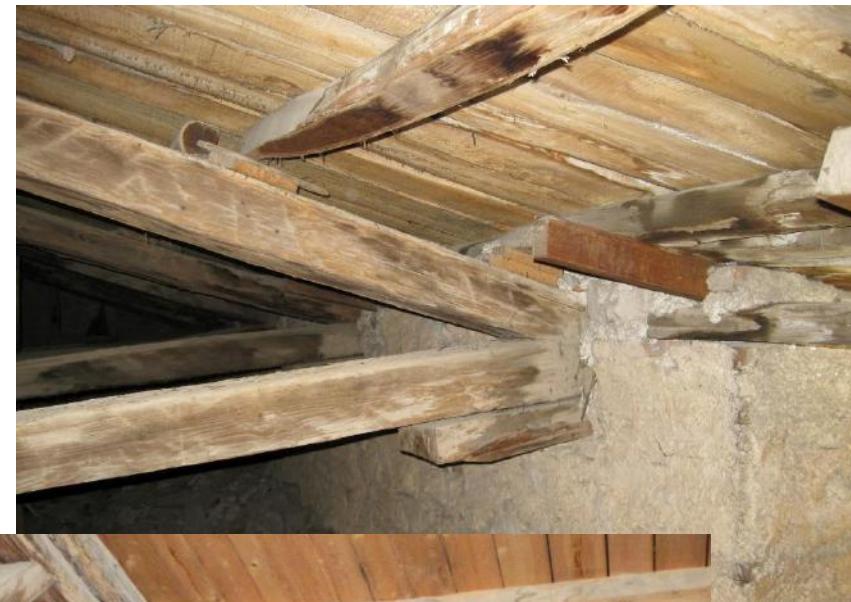
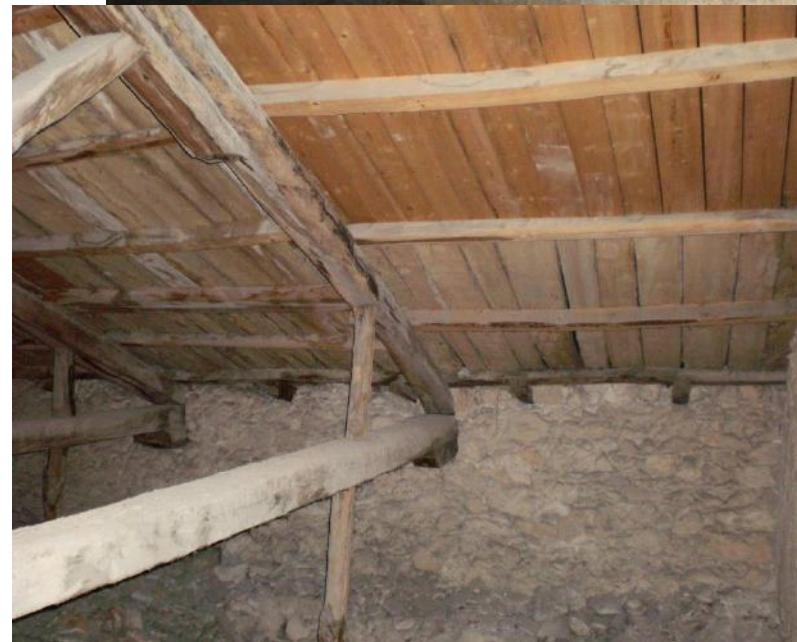
Santa Maria del Soccorso:  
**wood elements for ties  
and fixing**

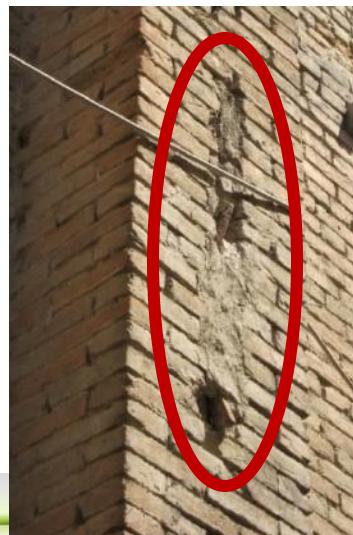
**2012** Collegiata Santa Maria Maggiore, Mirandola

- Presence of ties but not adequately evaluated
- Damage of fixing elements

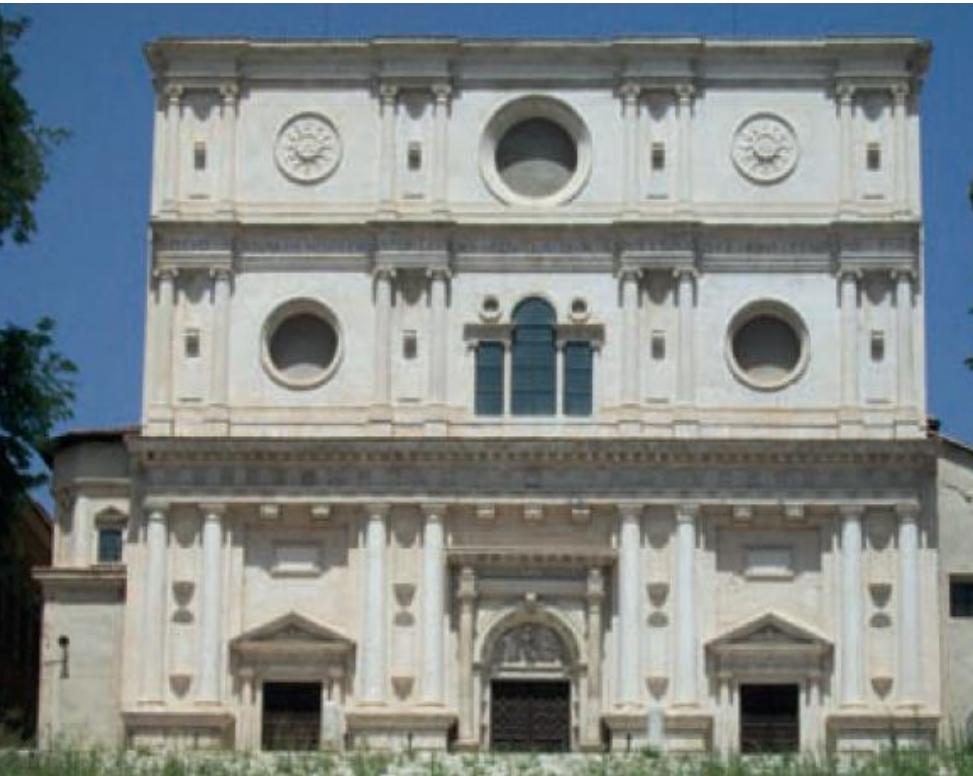
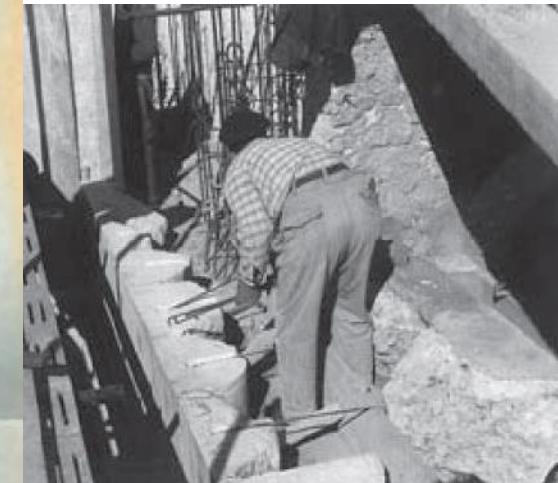
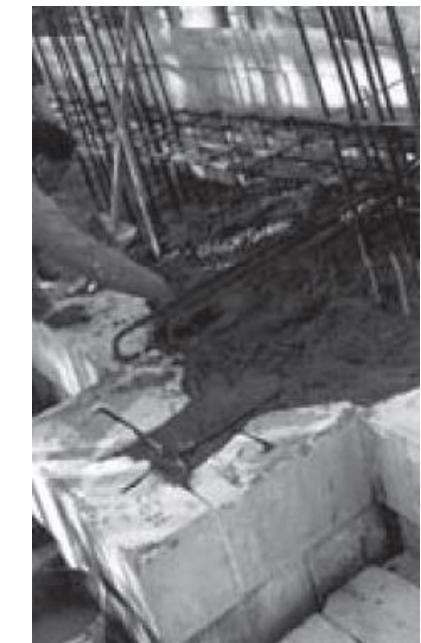
SAN BERNARDINO, L'AQUILA

The façade is supported by a R.C. frame  
executed on 1960

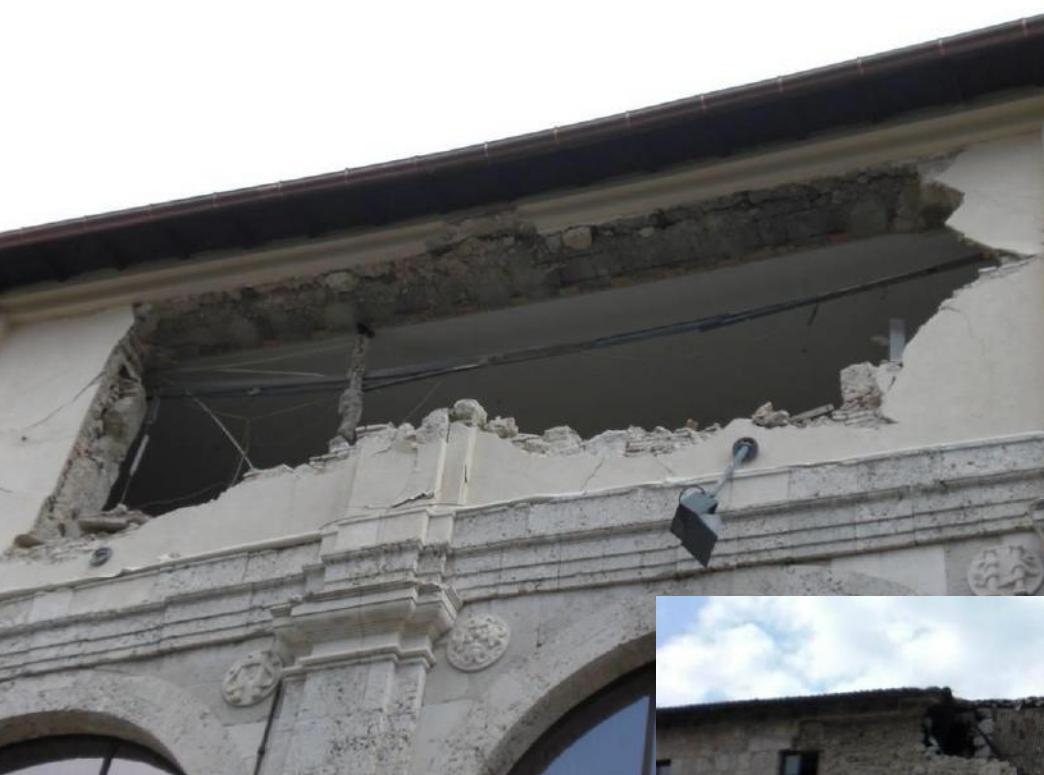
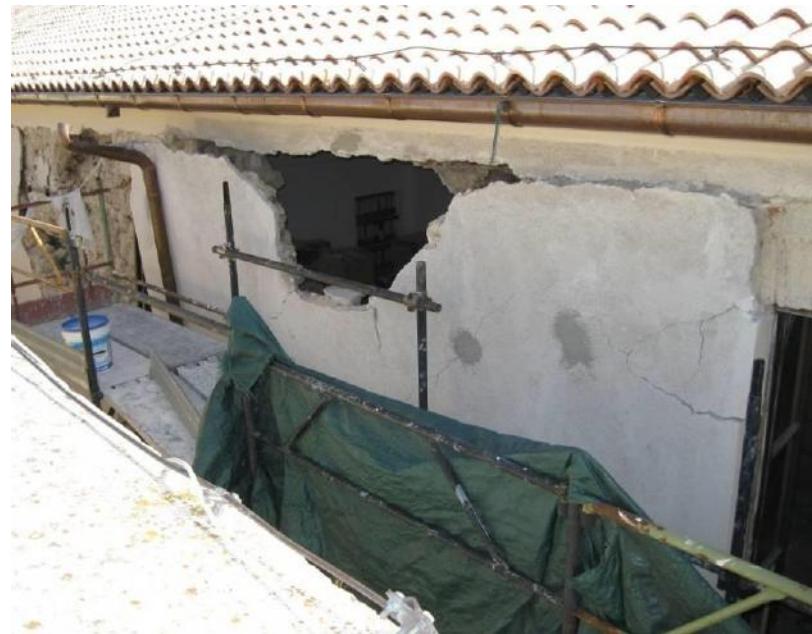
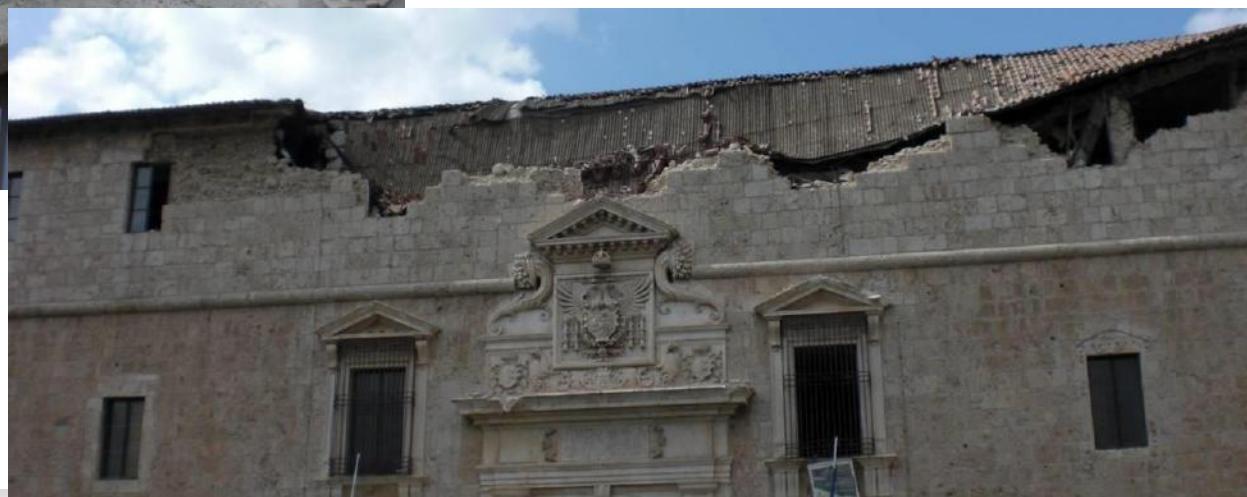
FORTE SPAGNOLO, L'AQUILA

# EFFECT OF INTERVENTIONS: USE OF REINFORCED CONCRETE

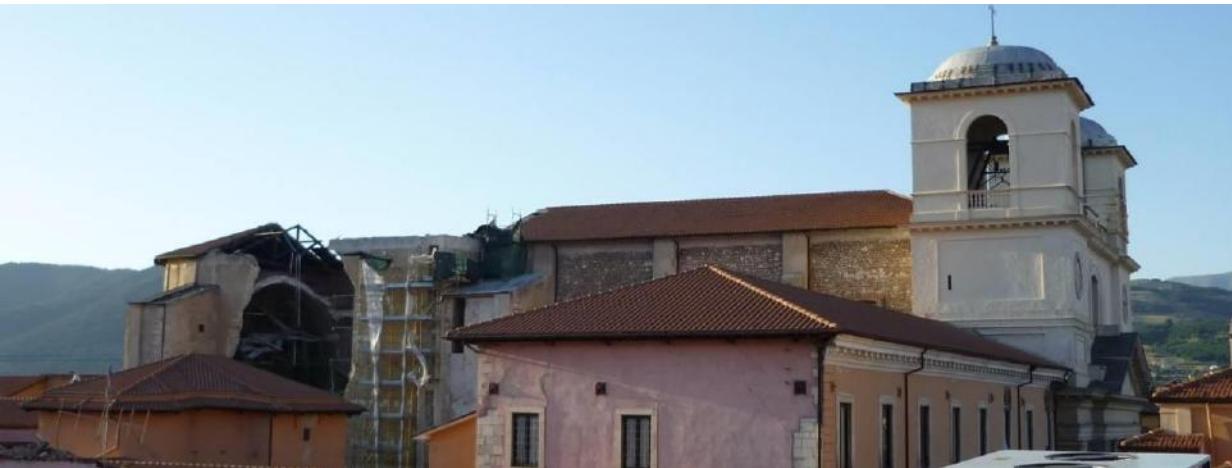
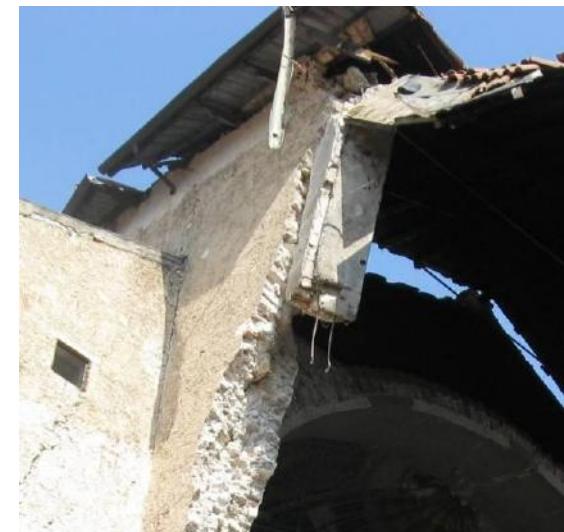
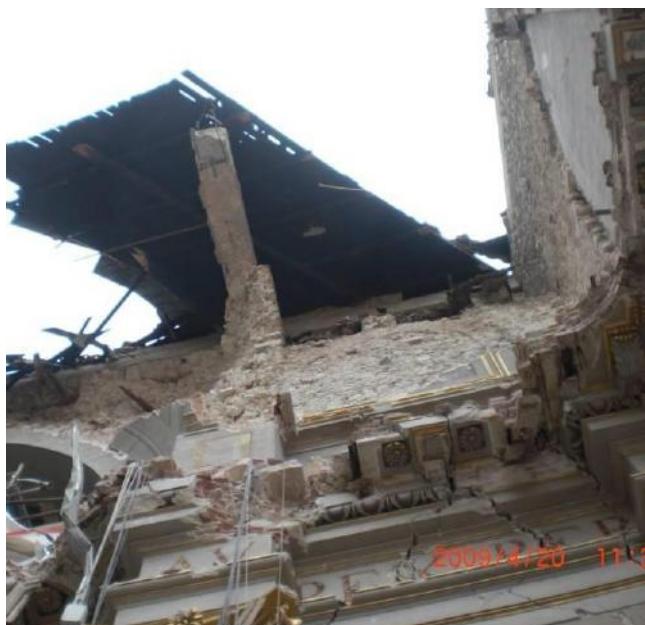
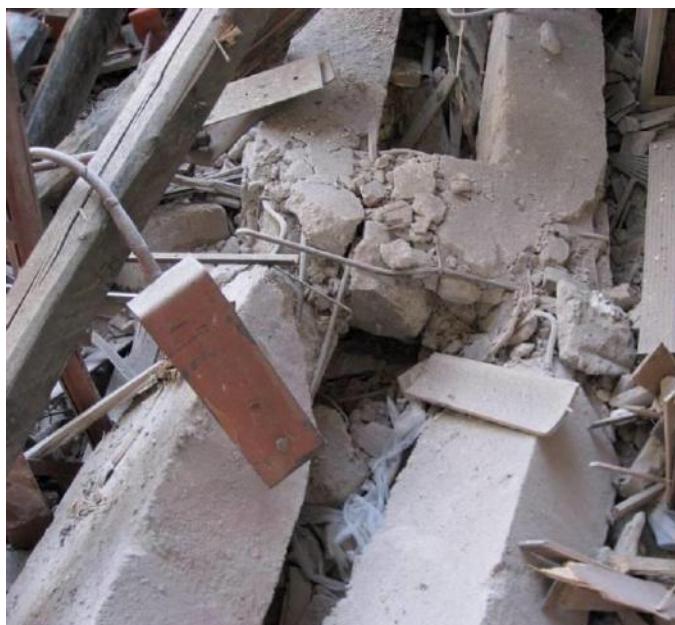
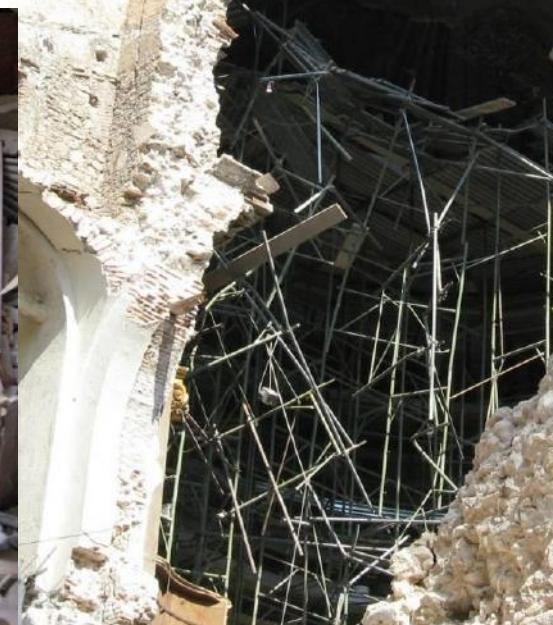
DUOMO, L'AQUILA

# EFFECT OF INTERVENTIONS: USE OF REINFORCED CONCRETE

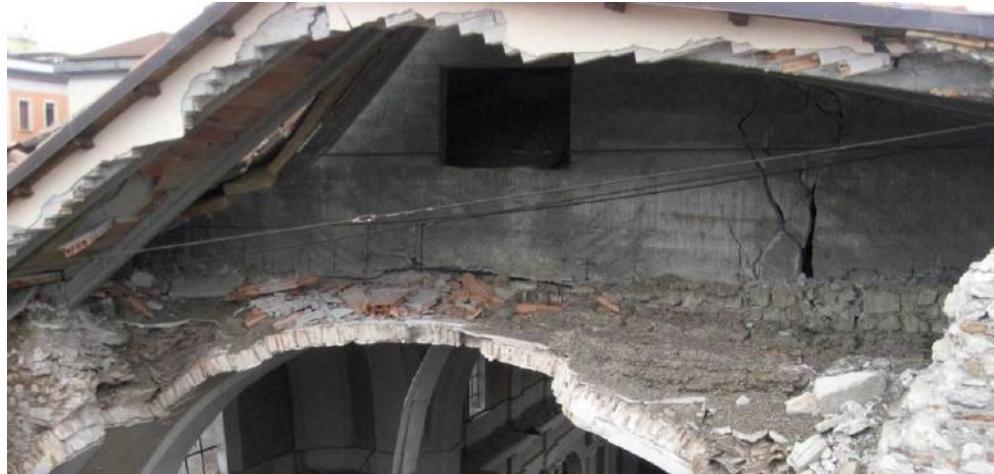
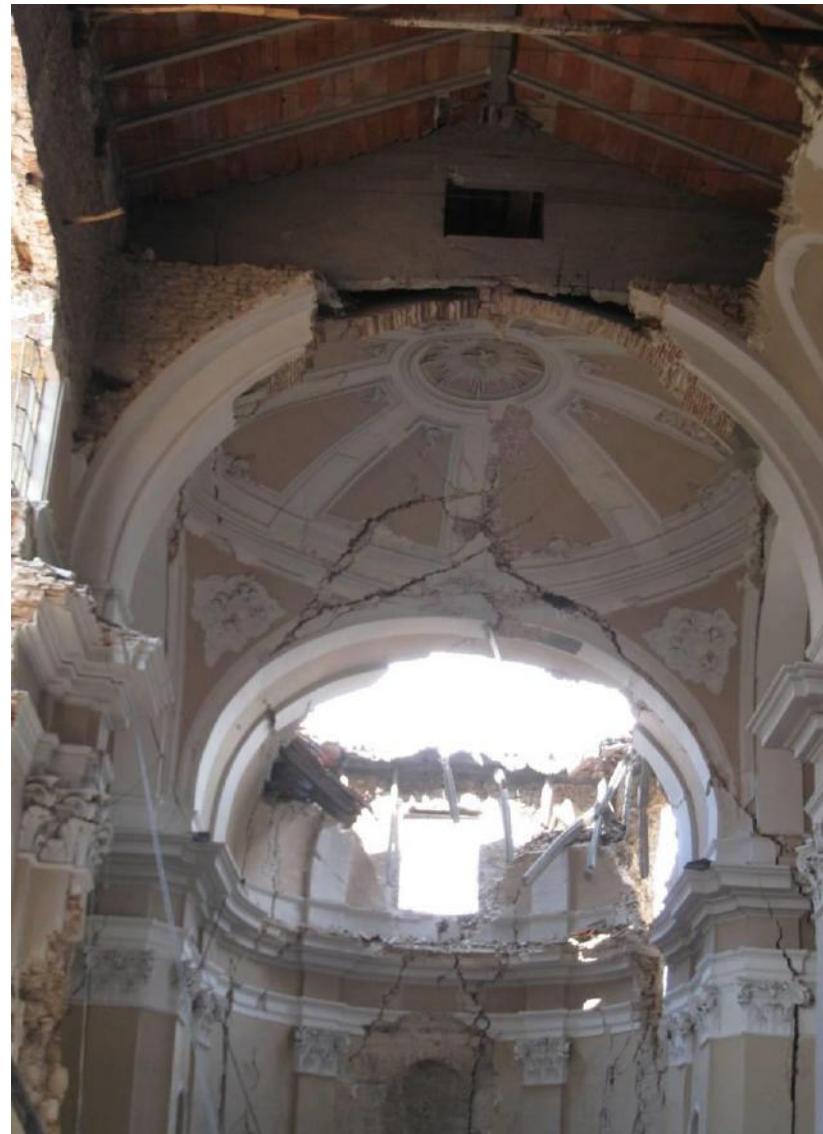
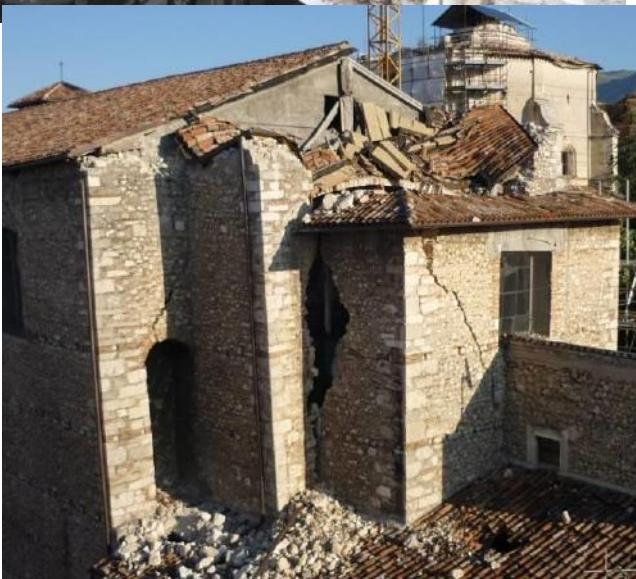
SAN MARCO, L'AQUILA

# EFFECT OF INTERVENTIONS: USE OF REINFORCED CONCRETE

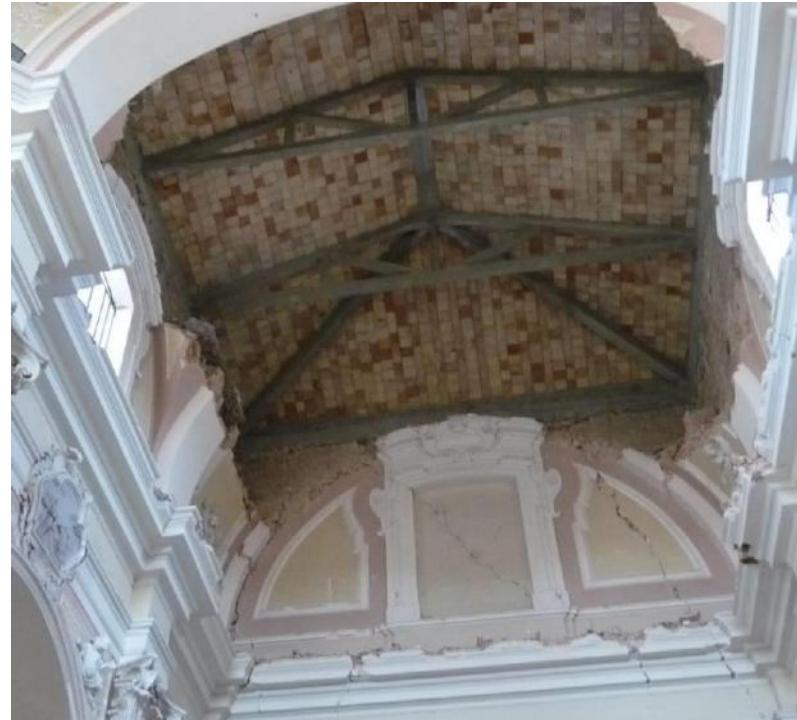
San Domenico, L'Aquila

# EFFECT OF INTERVENTIONS: USE OF REINFORCED CONCRETE

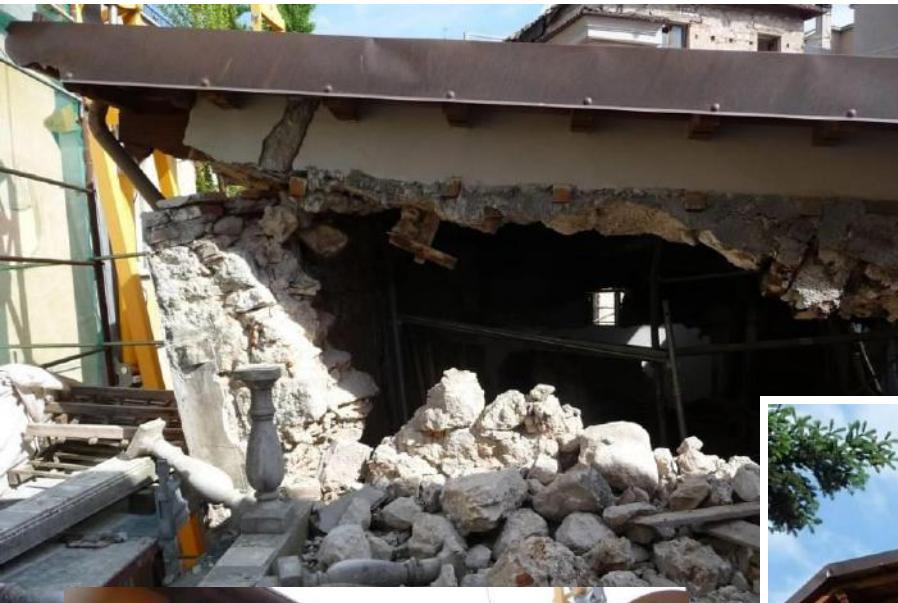
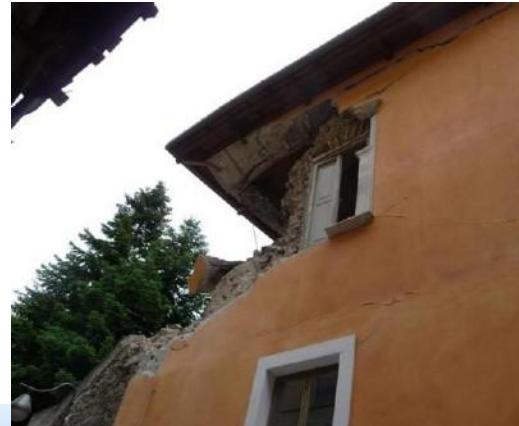
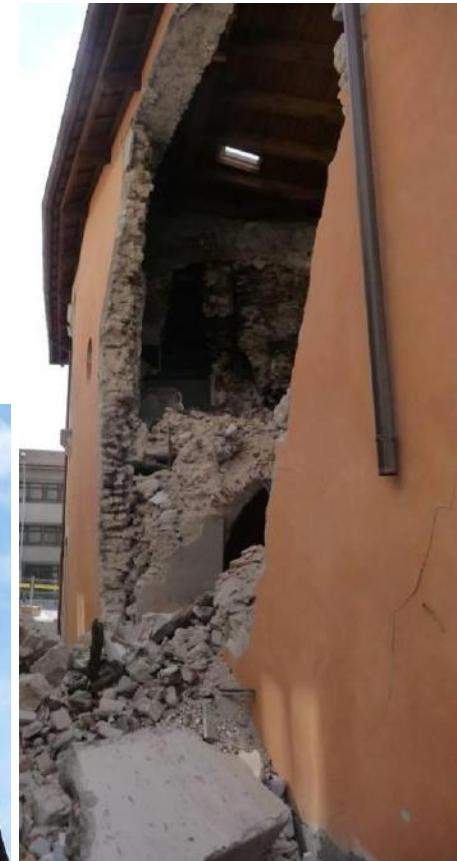
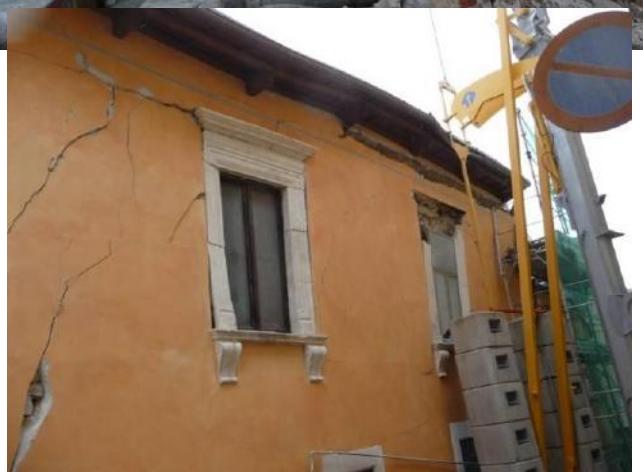
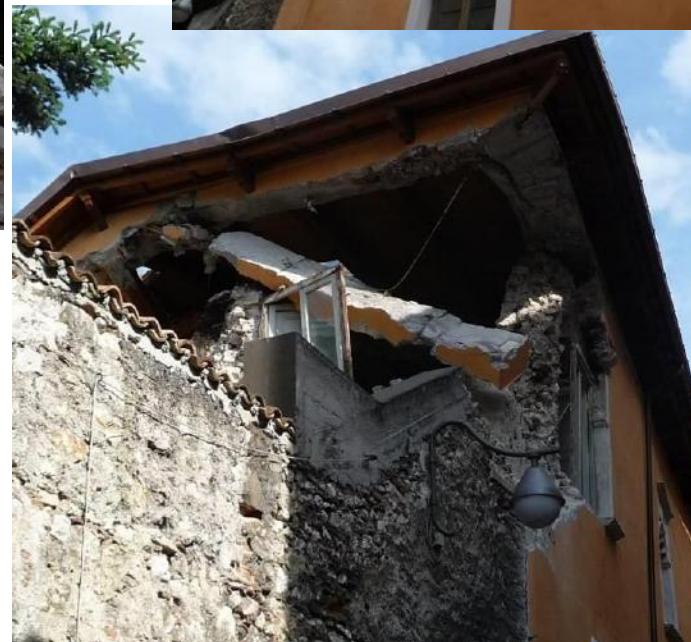
Asilo via Antonelli, L'Aquila

# EFFECT OF INTERVENTIONS: USE OF REINFORCED CONCRETE
