### Assessment and improvement of structural safety under seismic actions of existing constructions: Reinforced Concrete Structures and Historical buildings

### Lessons learned from the past earthquakes: damages catalogues and interpretation

Prof. Maria Rosa Valluzzi

University of Padova, Department of Cultural Heritage  
[mariarosa.valluzzi@unipd.it](mailto:mariarosa.valluzzi@unipd.it)

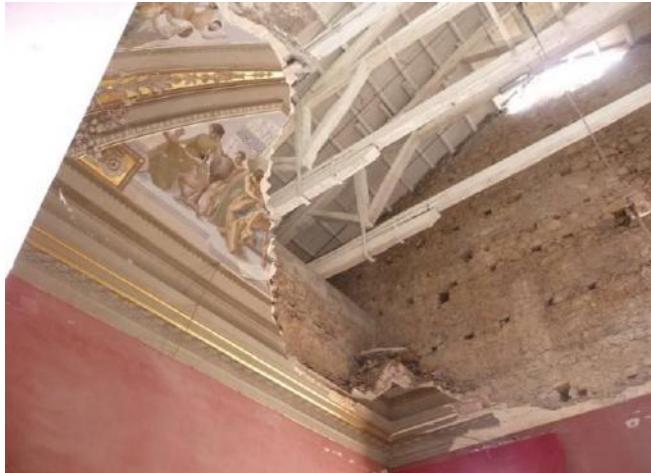
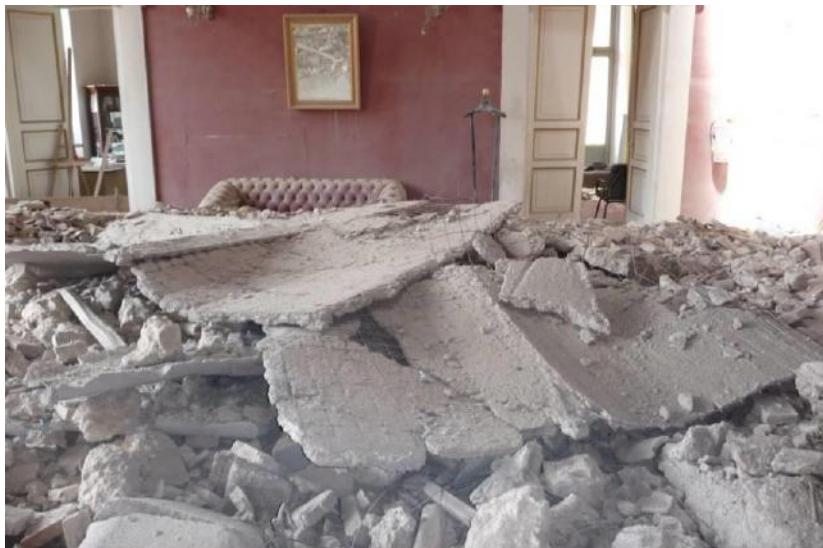
Teatro Comunale,  
L'Aquila

# EFFECT OF INTERVENTIONS: USE OF REINFORCED CONCRETE

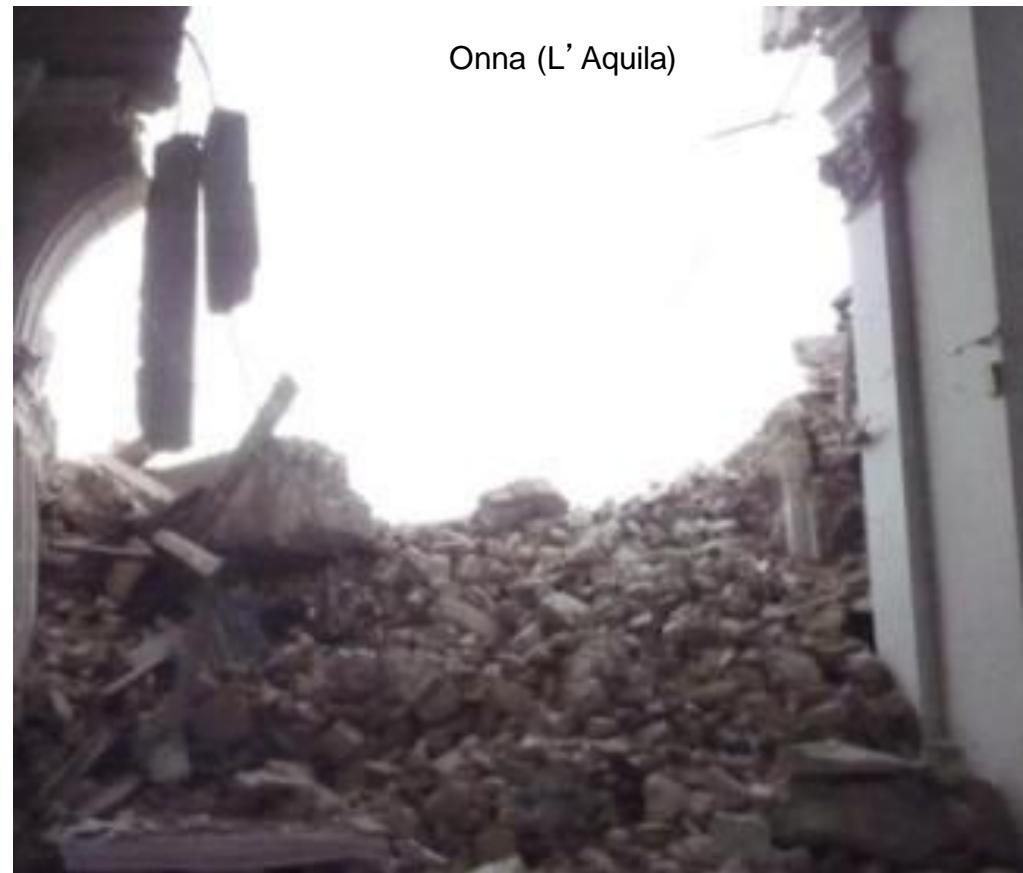
Onna (L'Aquila)

## EFFECT OF INTERVENTIONS: STITCHING OF MASONRY

- obtrusive
- low effective connections
- problem of bond between masonry and rebars

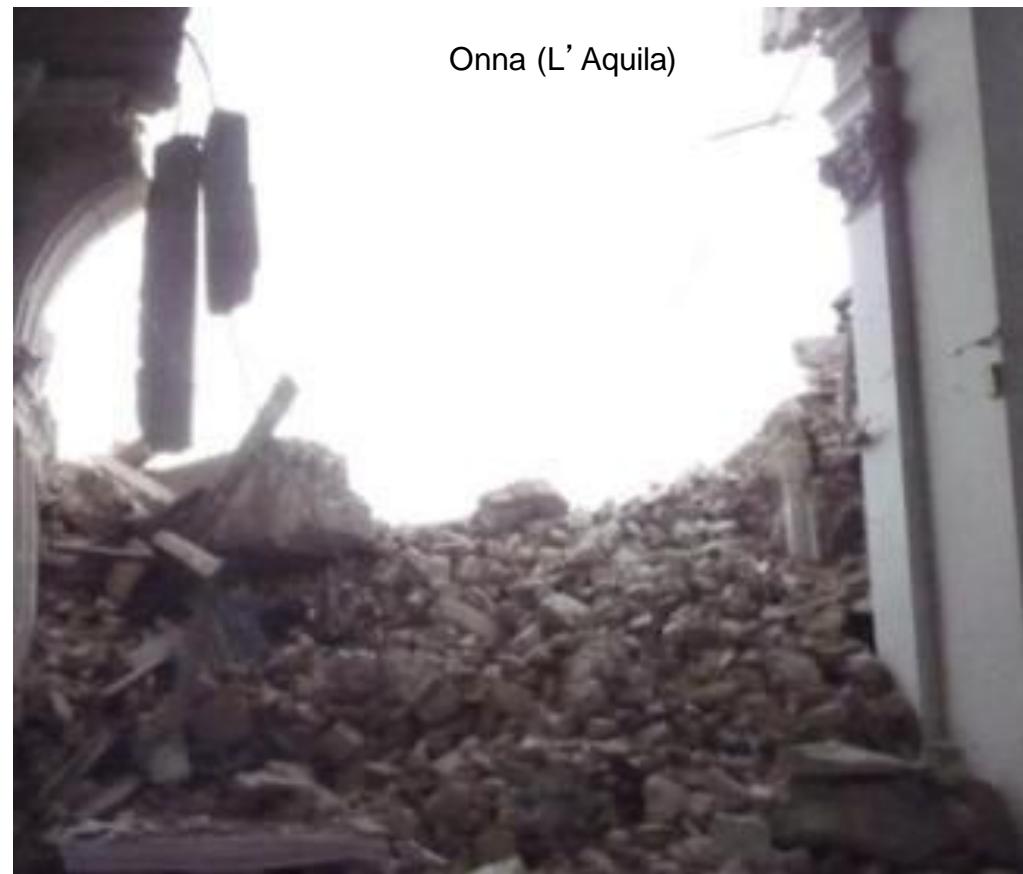
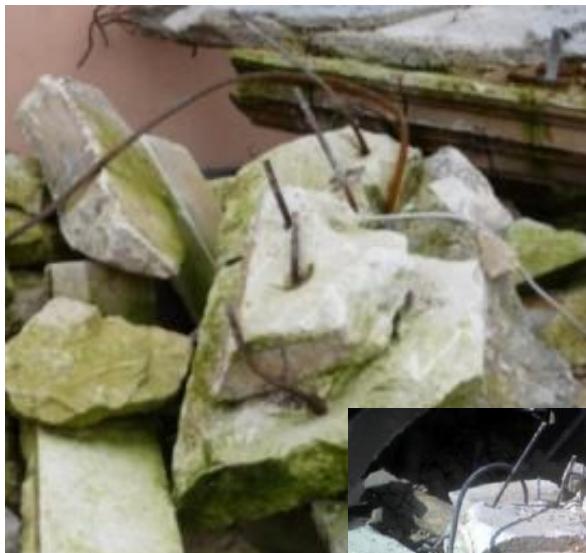
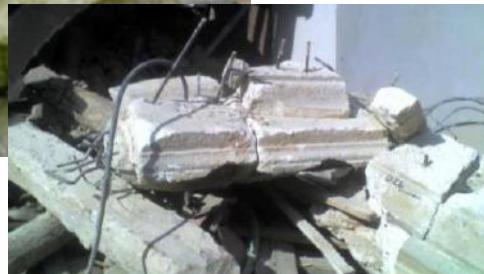
## EFFECT OF INTERVENTIONS: STITCHING OF MASONRY

- obtrusive
- low effective connections
- problem of bond between masonry and rebars
